Wates Development Ltd

August 2021

1620011691

WIXAMS END, BEDFORDSHIRE PHASE 1 PRELIMINARY RISK ASSESSMENT

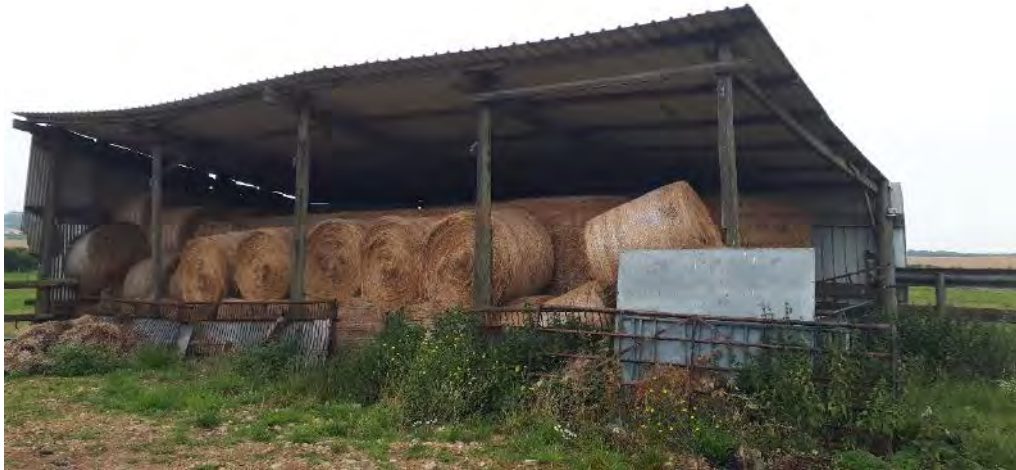
Photo 1. Building 1, photo facing west. Lean-to shed with corrugated steel cladding, used for hay bale storage (see Figure 2 for location).

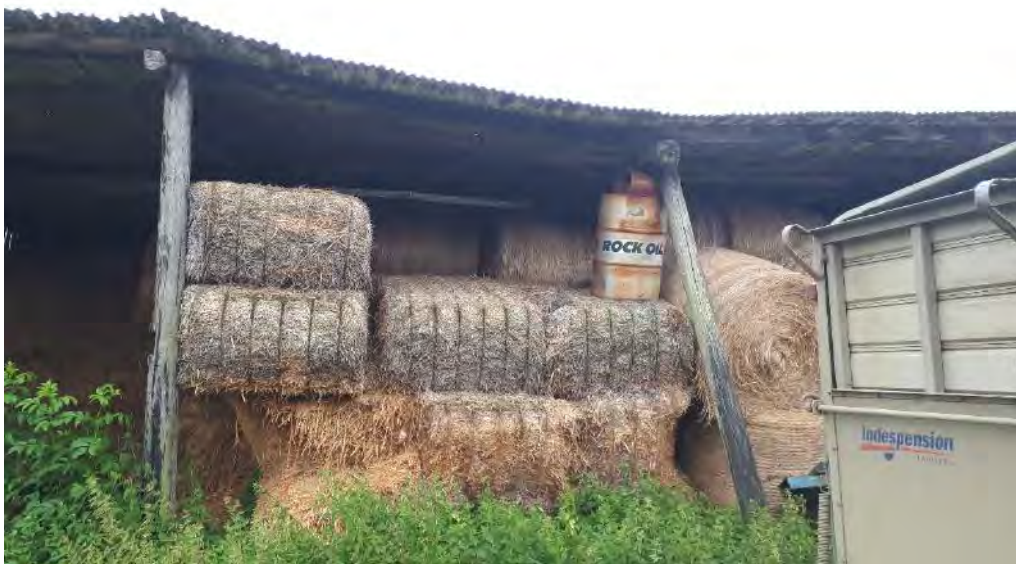
No ACMs were observed to be present in the surface of the brick and rubble piles located in the southern half of the site. ACMs may be present in the existing farmyard buildings, in particular the cement cladding of buildings 2 to 6. An asbestos survey would be required to confirm the presence or absence of ACM in building fabric at the site, and should ACM be present these would need to be effectively managed under Control of Asbestos Regulations (2012) during any refurbishment or demolition works.

Photo 2. Building 2, photo facing south. Lean-to shed with corrugated cement cladding, used for hay bale storage. Empty oil drum used as support. (see Figure 2 for location).

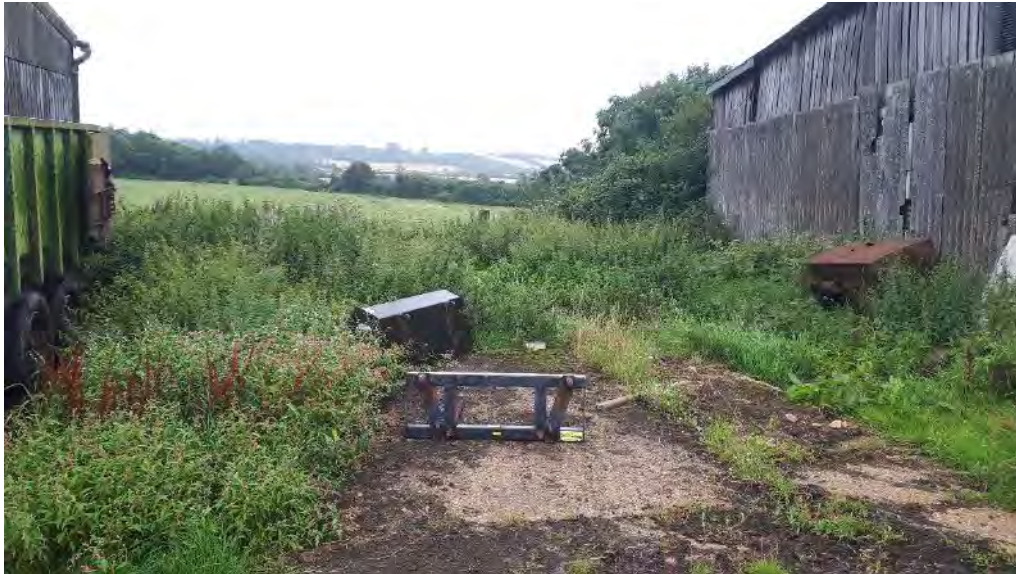
Two corroded and punctured metal-skinned rectangular tanks were observed by Ramboll to have been discarded adjacent to the east of Building 2 (1000L tank) and to the northwest of the farmyard (approximately 4,000L tank). The landowner advised that these are scrapped water tanks and, as such, are not considered further.

Photo 3. Between Buildings 2 and 3, photo facing south. Scrap water tank visible against wall in right of photo (see Figure 2 for location).

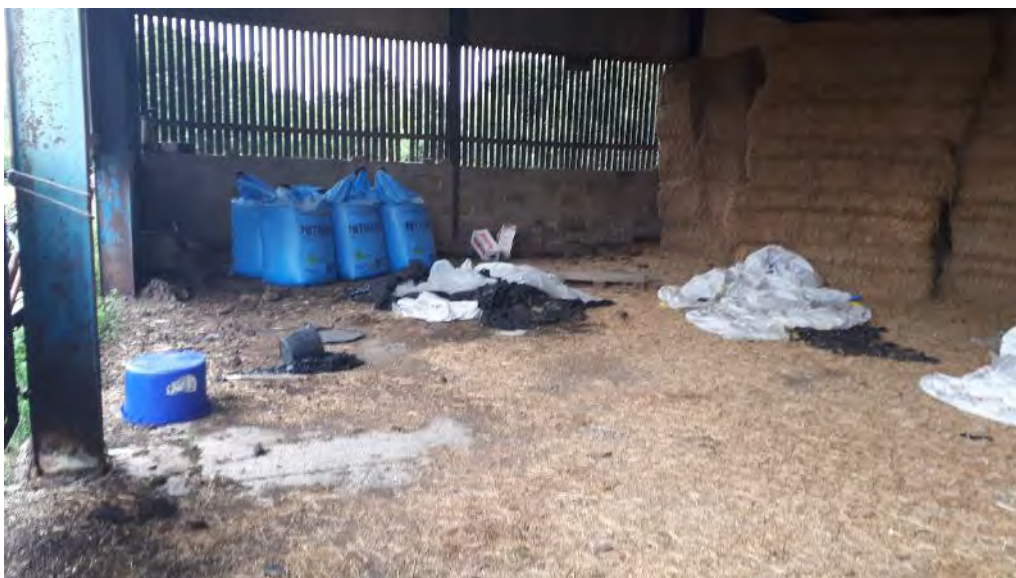
Photo 4. Building 3, photo facing east. Steel A frame shed with corrugated cement cladding, used as cattle pen and fertiliser storage (blue bags) (see Figure 2 for location).

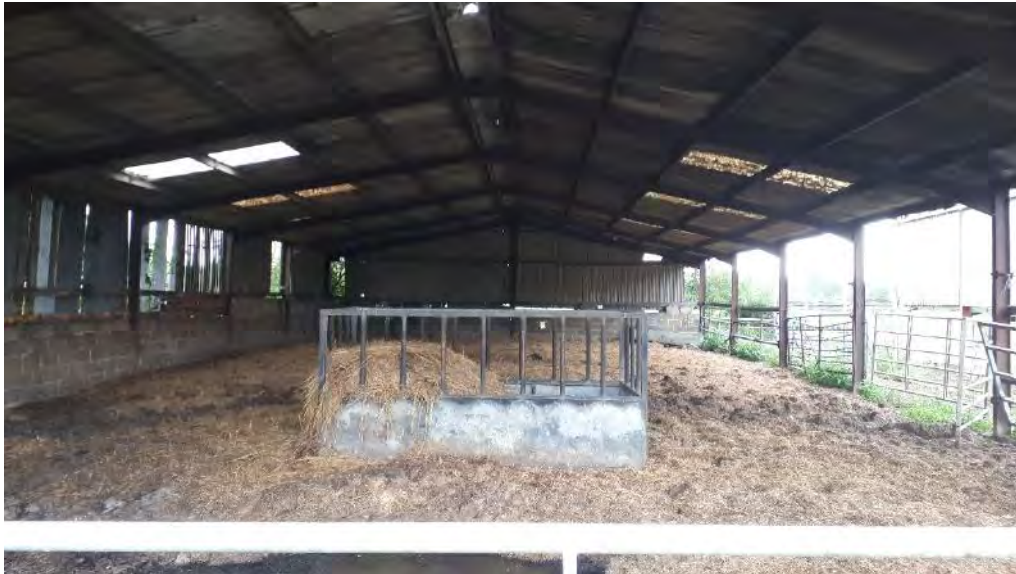
Photo 5.

Building 4, photo facing north. Steel A frame shed with corrugated cement cladding, used as cattle pen (see Figure 2 for location).

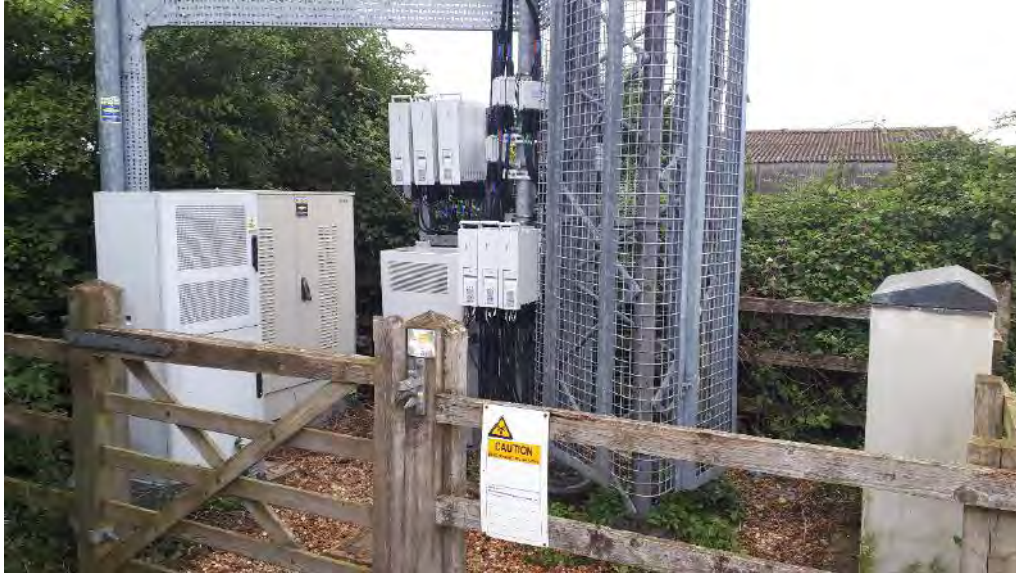
Photo 7. Telecommunications mast in west of farmyard (see Figure 2 for location).

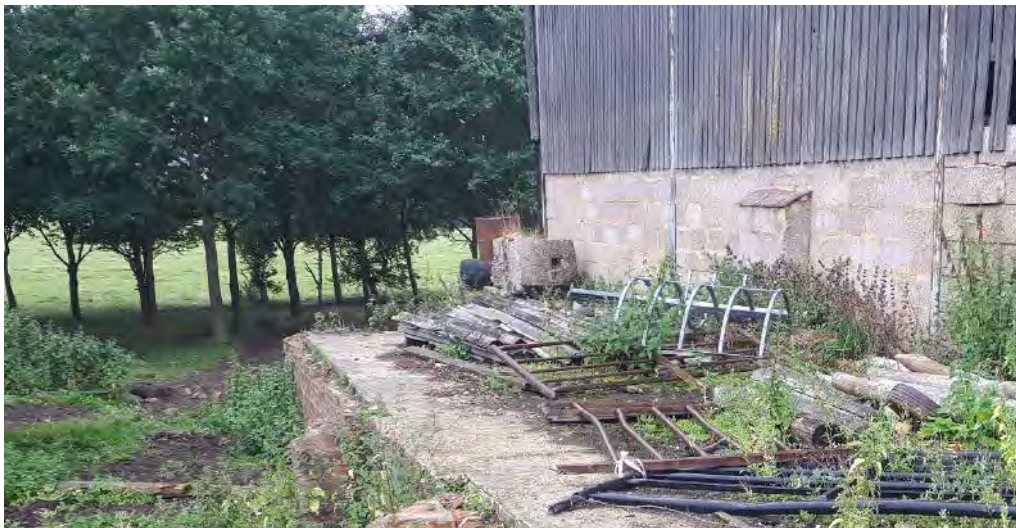
A 1,000L diesel AST for refuelling of vehicles had previously been located on concrete hardstanding adjacent to the east of Building 3 in the farmyard; the date of removal of the tank is unknown, however the landowner advised that no historical leaks or spillages of diesel have occurred on the site. The concrete hardstanding on which the tank had been located was approximately 1 m higher than undeveloped ground to the east, supported by a brick retaining wall. No evidence of historical below-ground pipework or bunding was visible. No evidence of staining was observed on the concrete hardstanding.

Photo 8. Location of former diesel tank east of Building 3, photo facing south. Brick retaining wall below concrete hardstanding. Empty oil drum and stack of corrugated cement sheeting in centre of photo (see Figure 3 for location).

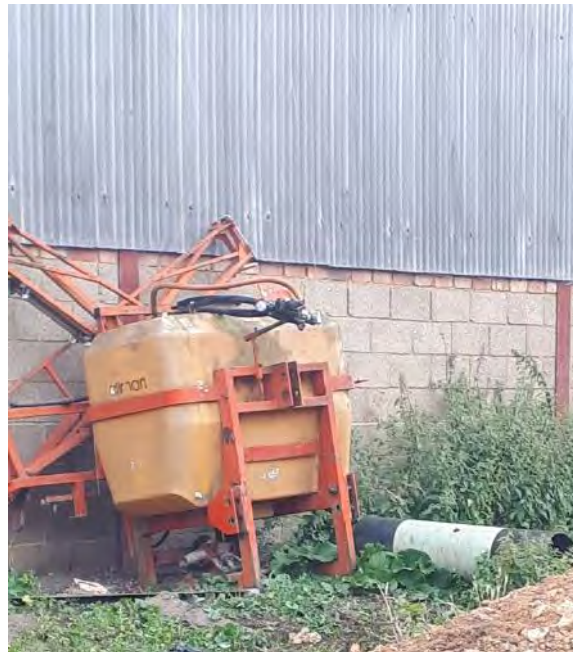
Pesticide sprayer	East of Building 6	A discarded pesticide sprayer was observed to be located on soft landscaping adjacent to Building 6. The landowner advised that the sprayer has never been used on site as spraying of the site with pesticides is undertaken by an external contractor.

Photo 9. Empty pesticide sprayer against eastern wall of Building 6. Aggregate pile immediately to right of photo (visible in bottom right corner) (see Figure 2 / 3 for location).

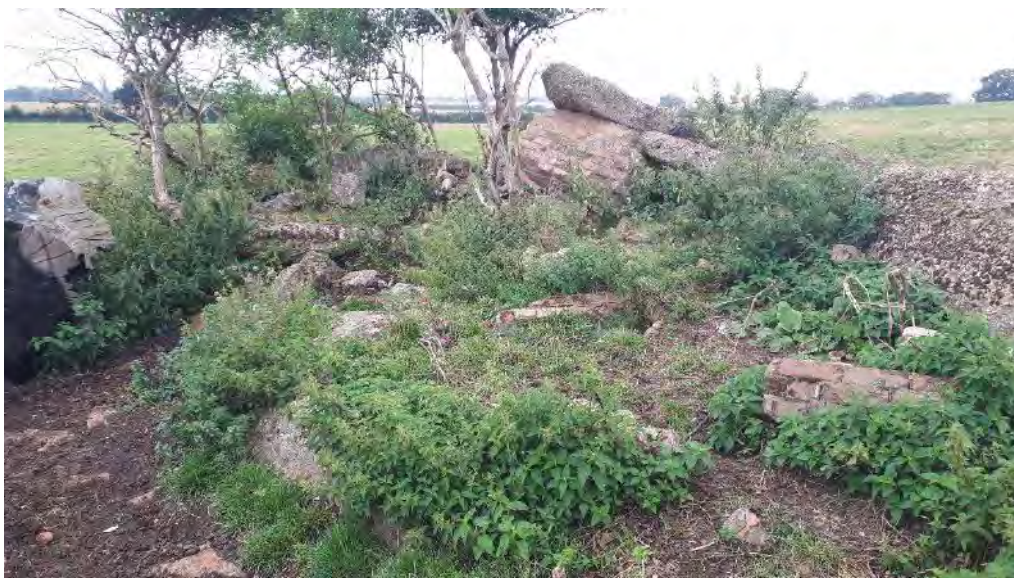
Photo 10. Rubble pile to southwest of farmyard, photo facing west (see Figure 3 for location).

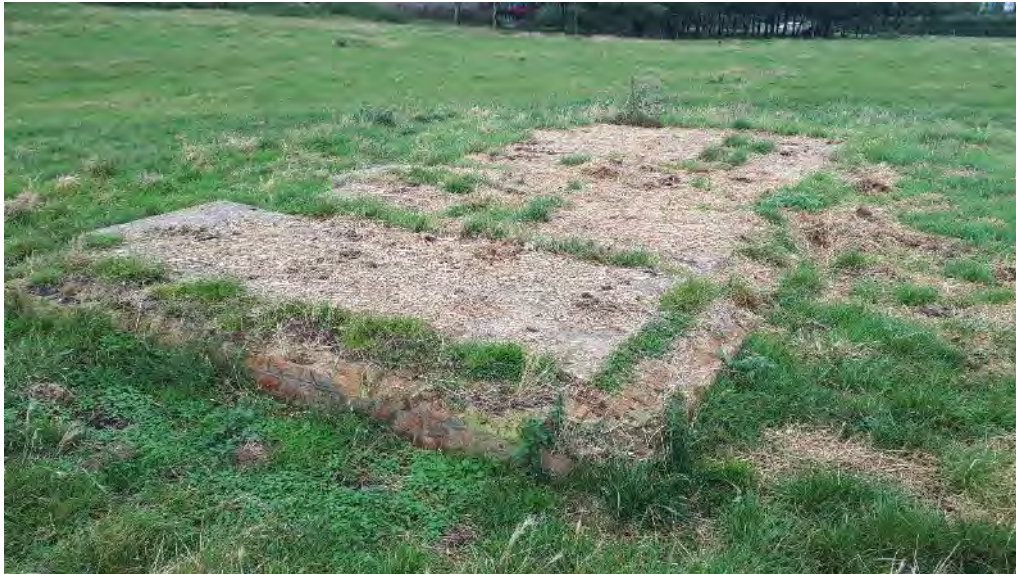
Photo 11. Abandoned foundation of 'shower block' located to south of farmyard (see Figure 2 for location).

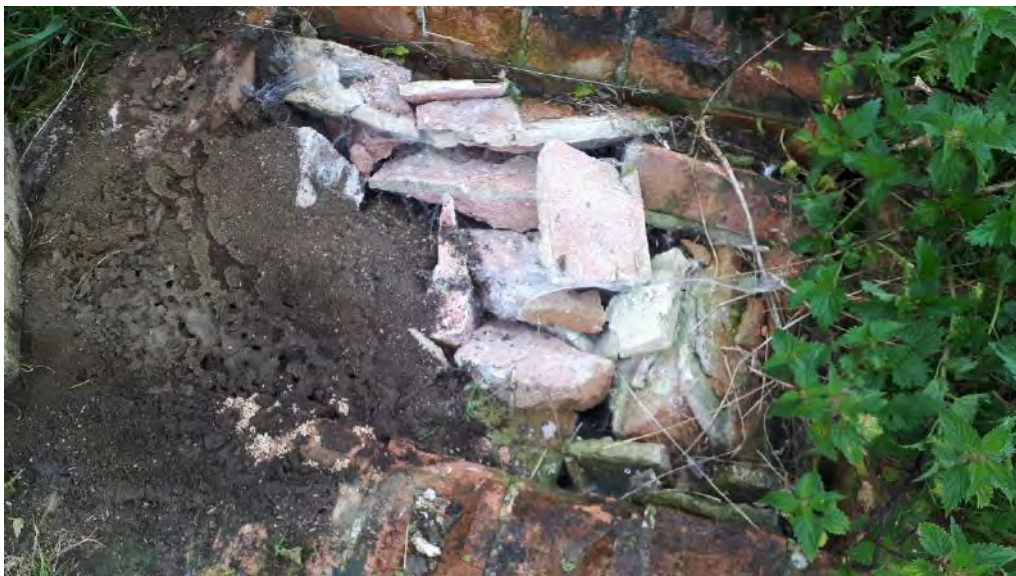
Photo 12. Abandoned drainage chamber filled in with rubble, located to south of farmyard (see Figure 2 for location).

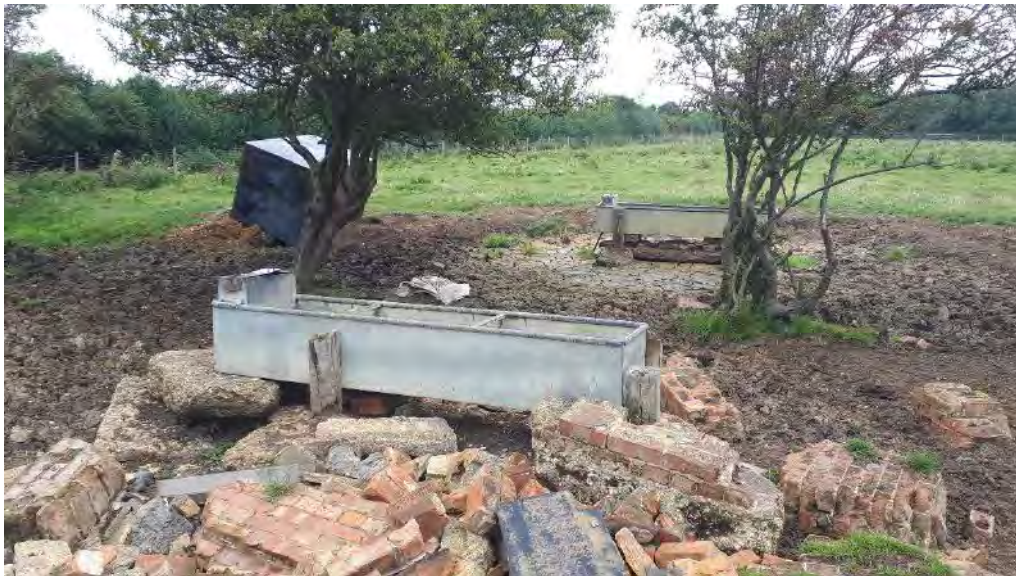
A drainage drawing for the site was not available for review by Ramboll during the site visit. The landowner advised that the farmyard was supplied by the mains water supply from Wilstead to the east of the site. The landowner also noted that a mains water supply had been discovered to a number of troughs to the northwest of the farmyard, however this was in the process of being decommissioned and broken out by the landowner.

Photo 13. Rubble pile and troughs to north of farmyard, photo facing north. Scrapped water tank visible in left rear ground, sitting in hole left by landowner while decommissioning mains water supply to troughs (see Figure 3 for location).

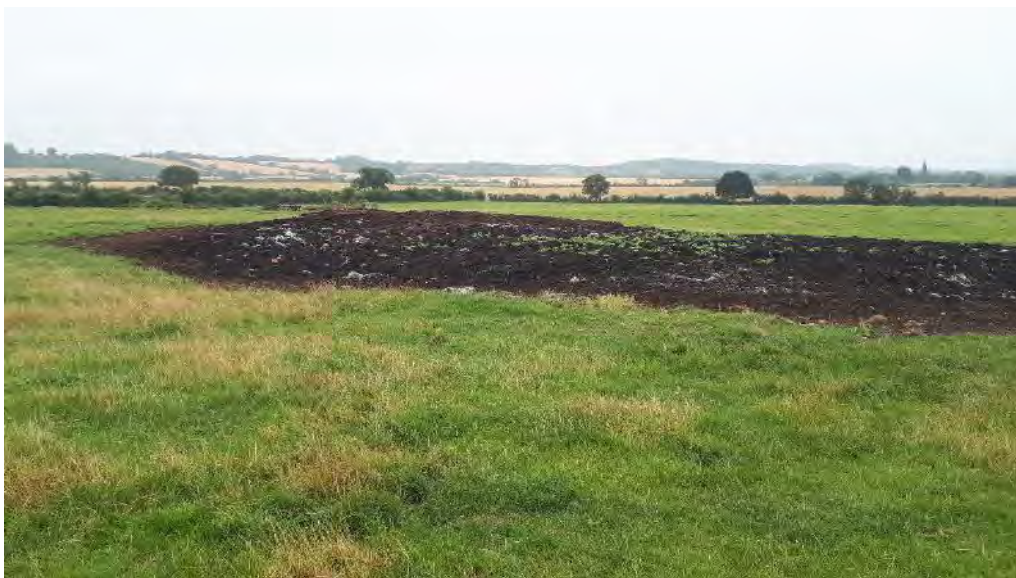
Photo 14. Muck pile to northwest of farmyard, photo facing west (see Figure 3 for location)

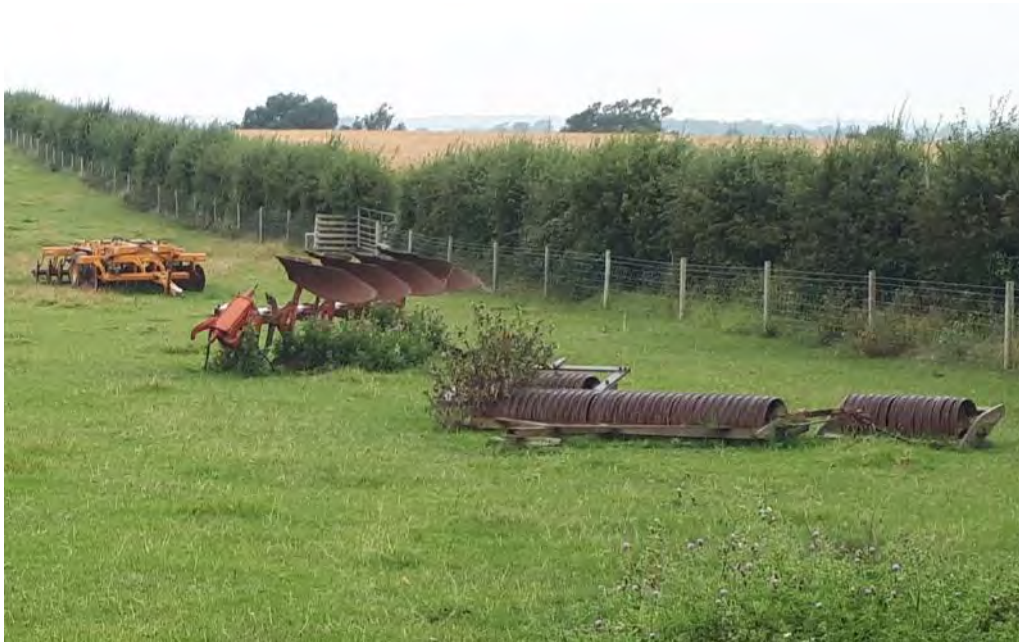
A tractor was observed in Building 6 and an excavator on undeveloped ground to the east of the farmyard during the site walkover. The landowner advised that no fuel leaks or spillages from farm machinery have occurred on the site. Various other pieces of farm machinery such as trailers or ploughs were located within the farmyard and elsewhere on the southern half of the site, but were not observed to contain fuel or chemicals.

Photo 15. Farm machinery (no fuel or chemicals) located immediately to north of muck pile (see Figure 3 for approximate location).

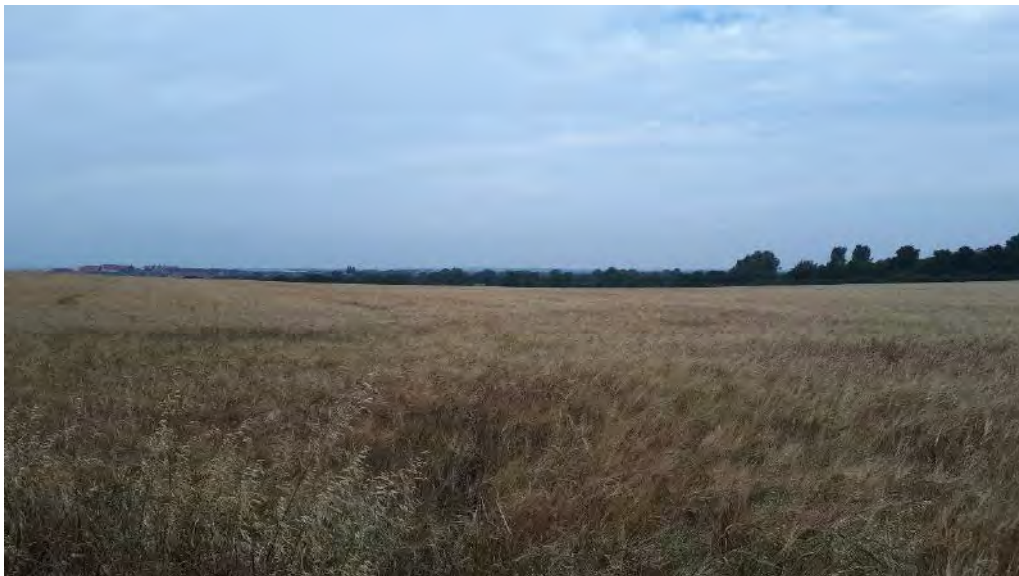
Photo 16. Overview of northern half of site, facing north from hedgerow immediately north of muck pile. Barley crop visible in middle distance, recent residential development in left background (see Figure 3 for approximate location).

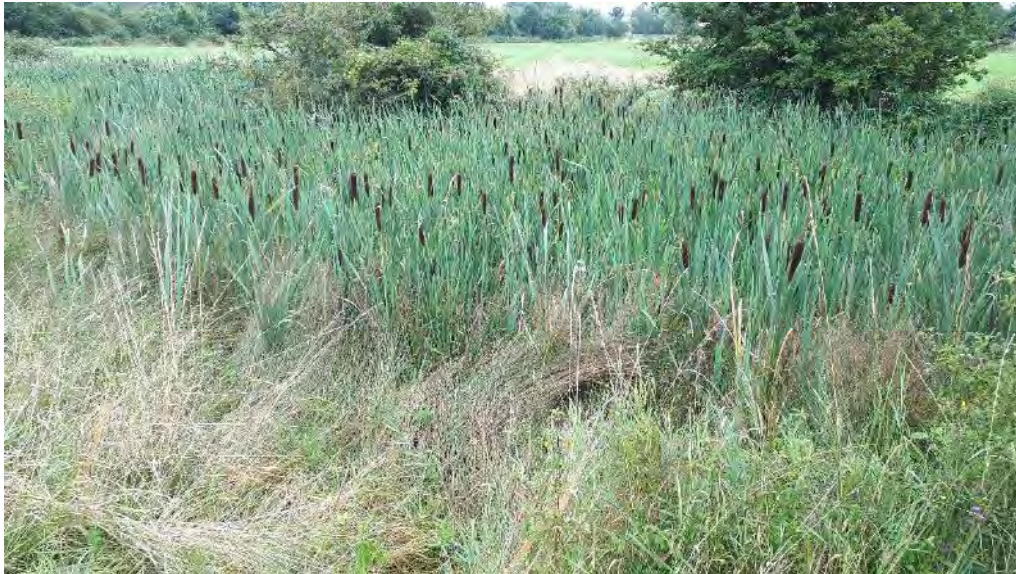
Photo 17. Pond located in centre of triangular parcel of site east of A6 road (see Figure 2 for location).

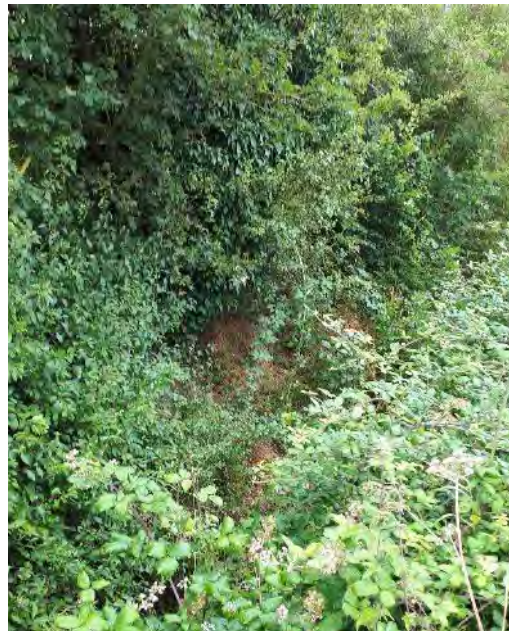
Photo 18. Unnamed drain running through centre of site, photo facing west (see Figure 2 for location).
