Wates Development Ltd

WIXAMS END, BEDFORDSHIRE PHASE 1 PRELIMINARY RISK ASSESSMENT

Project No. **1620011691**
Issue No. -
Date **23 August 2021**
Made by [REDACTED]
Checked by [REDACTED]
Approved by [REDACTED]

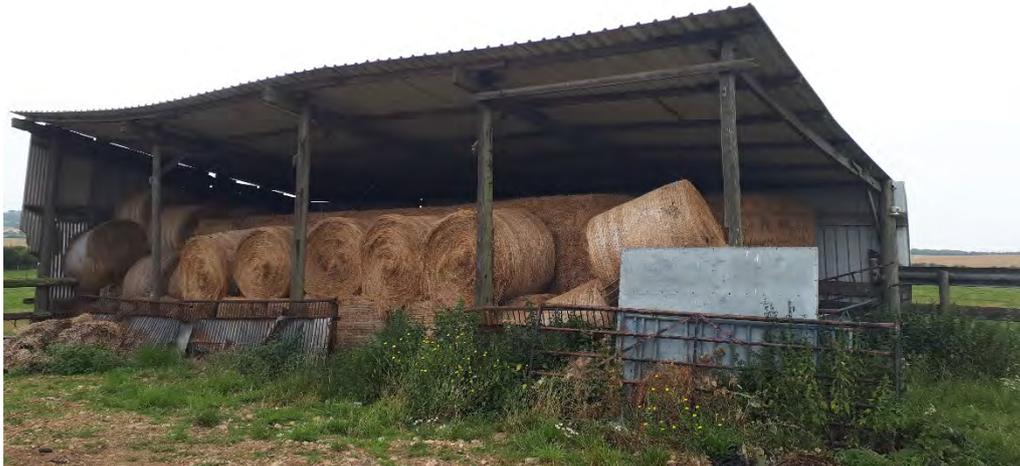
Photo 1. Building 1, photo facing west. Lean-to shed with corrugated steel cladding, used for hay bale storage (see Figure 2 for location).

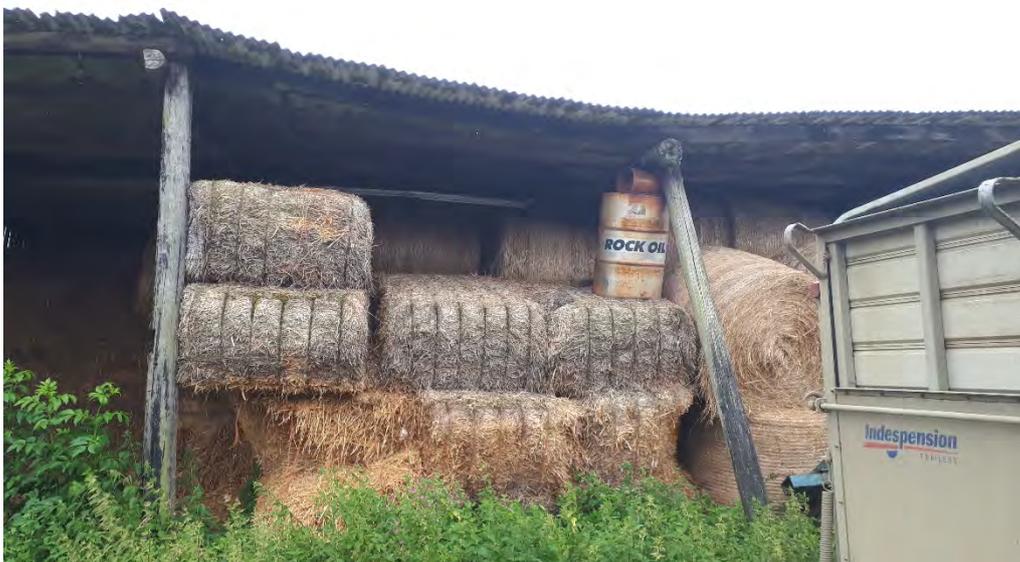
Photo 2. Building 2, photo facing south. Lean-to shed with corrugated cement cladding, used for hay bale storage. Empty oil drum used as support. (see Figure 2 for location).

No ACMs were observed to be present in the surface of the brick and rubble piles located in the southern half of the site. ACMs may be present in the existing farmyard buildings, in particular the cement cladding of buildings 2 to 6. An asbestos survey would be required to confirm the presence or absence of ACM in building fabric at the site, and should ACM be present these would need to be effectively managed under Control of Asbestos Regulations (2012) during any refurbishment or demolition works.

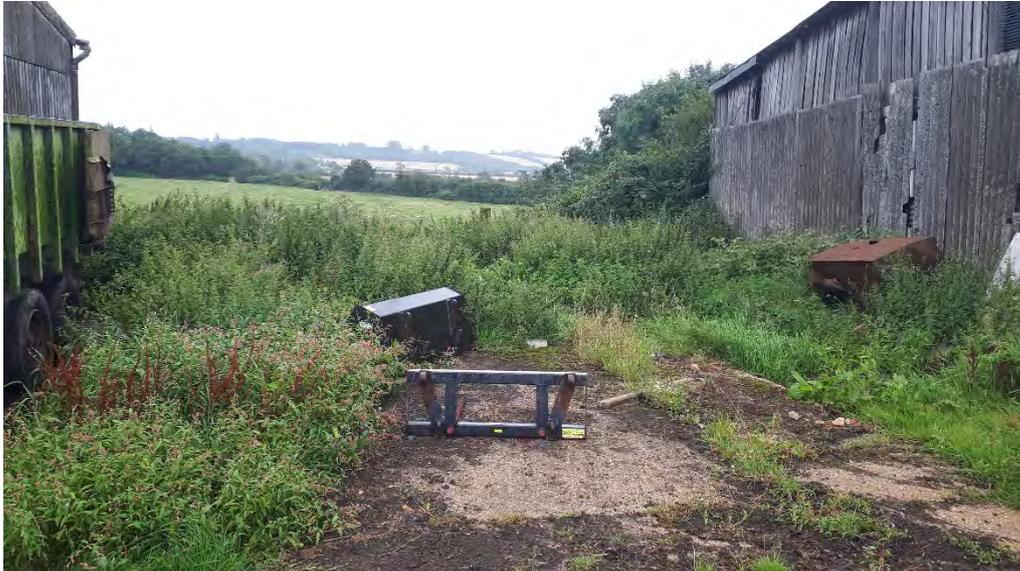
Two corroded and punctured metal-skinned rectangular tanks were observed by Ramboll to have been discarded adjacent to the east of Building 2 (1000L tank) and to the northwest of the farmyard (approximately 4,000L tank). The landowner advised that these are scrapped water tanks and, as such, are not considered further.

Photo 3. Between Buildings 2 and 3, photo facing south. Scrap water tank visible against wall in right of photo (see Figure 2 for location).

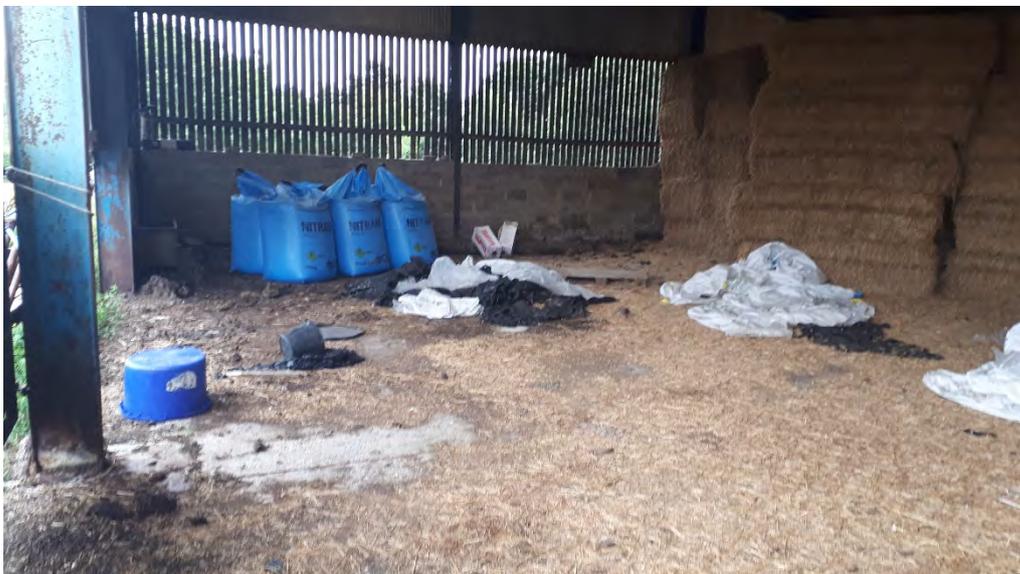
Photo 4. Building 3, photo facing east. Steel A frame shed with corrugated cement cladding, used as cattle pen and fertiliser storage (blue bags) (see Figure 2 for location).

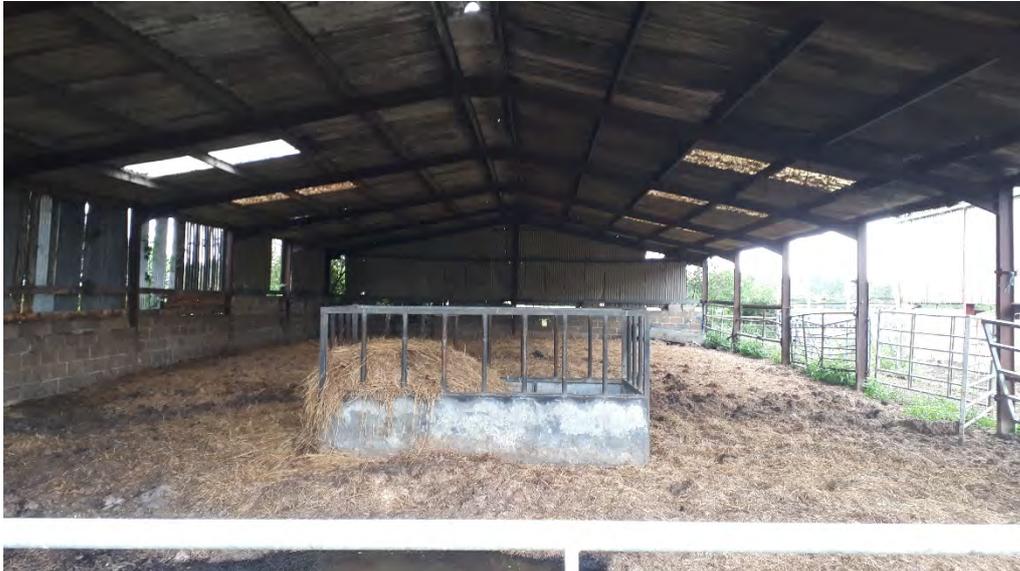
Photo 5.

Building 4, photo facing north. Steel A frame shed with corrugated cement cladding, used as cattle pen (see Figure 2 for location).

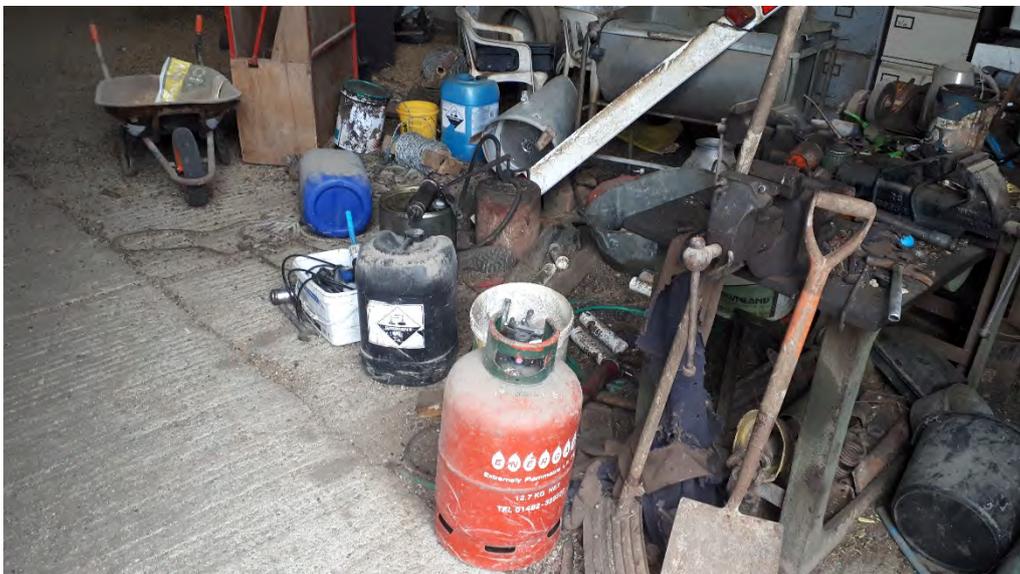
Photo 6.

Item	Location	Containment and other comments
20L metal cans and plastic containers	Building 6	Several 20L metal cans and plastic containers were observed on concrete hardstanding in Building 6. These included tractor oil, engine oil (two to three metal cans), engine grease (one plastic container), sodium hydroxide (one plastic containers) and hypochlorite solution (two plastic containers) and paint (one plastic container). These containers were generally noted to be old and with some evidence of leakage (particularly engine grease).
Two 205L oil drums	Building 2 and east of Building 3.	A 205L oil drum was noted to be propping up the roof of Building 2, and a second oil drum was located on the concrete hardstanding east of Building 3 (the location of the historical diesel tank) serving as an ad-hoc cattle barrier. The landowner advised that the oil drums have never contained oil on site.
Nine 600kg fertiliser bags	Building 3	Fertiliser bags were noted to be present on the concrete hardstanding in Building 3, and were due to be spread on the site at a later date.

Building 6, photo facing east. Vehicle maintenance workshop. Located on concrete flooring with occasional wide (5-10 mm) gaps – nearest gap out of frame to left. (see Figure 2 for location).

- ii. In the event that visual/olfactory evidence of contamination is identified during enabling works at the farmyard, localised ground investigation to be undertaken to delineate and quantify impact of contamination and recommend potential further works;
- iii. Limited ground investigation (comprising shallow trial pits and chemical testing of soil samples) to be undertaken in areas proposed for ecological water features.

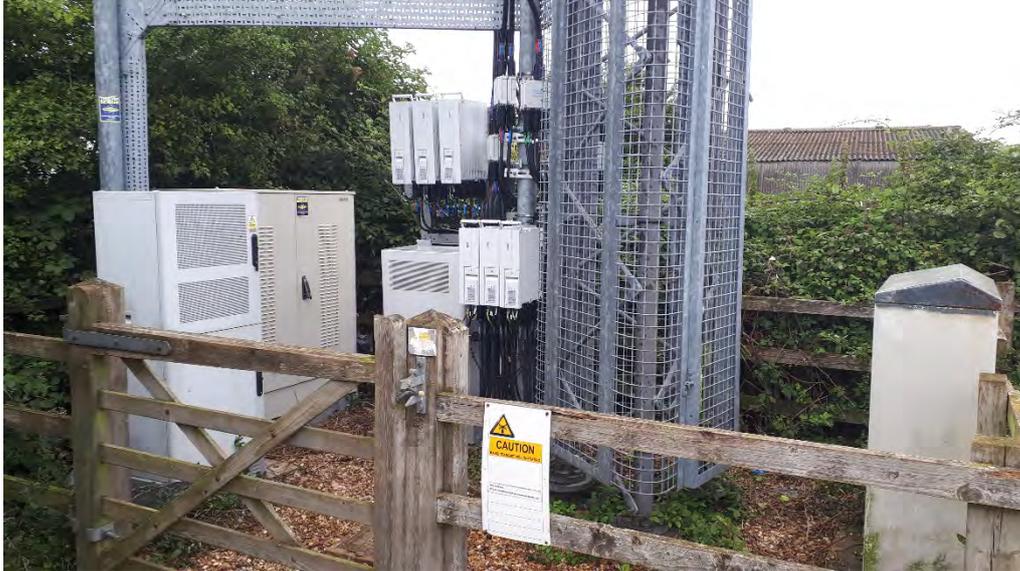
Photo 7. Telecommunications mast in west of farmyard (see Figure 2 for location).

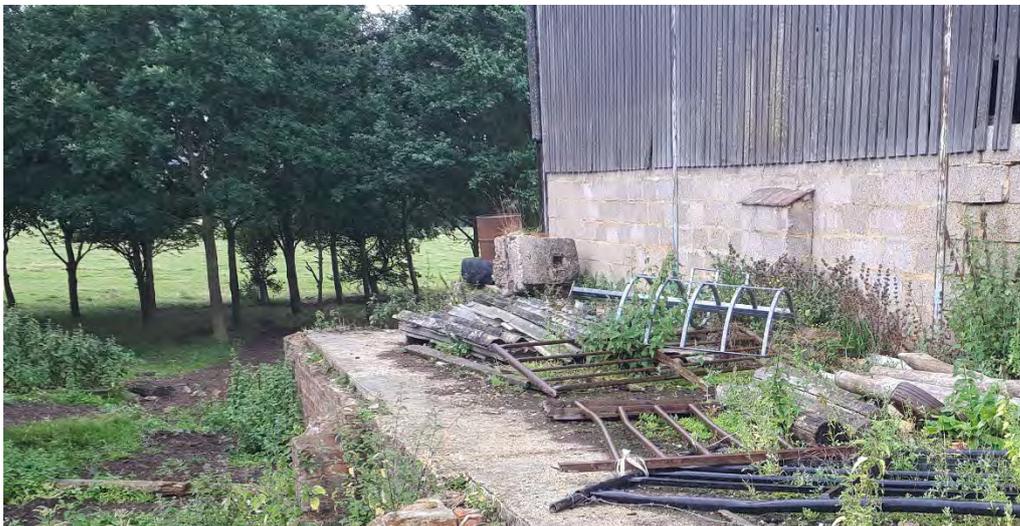
A 1,000L diesel AST for refuelling of vehicles had previously been located on concrete hardstanding adjacent to the east of Building 3 in the farmyard; the date of removal of the tank is unknown, however the landowner advised that no historical leaks or spillages of diesel have occurred on the site. The concrete hardstanding on which the tank had been located was approximately 1 m higher than undeveloped ground to the east, supported by a brick retaining wall. No evidence of historical below-ground pipework or bunding was visible. No evidence of staining was observed on the concrete hardstanding.

Photo 8. Location of former diesel tank east of Building 3, photo facing south. Brick retaining wall below concrete hardstanding. Empty oil drum and stack of corrugated cement sheeting in centre of photo (see Figure 3 for location).

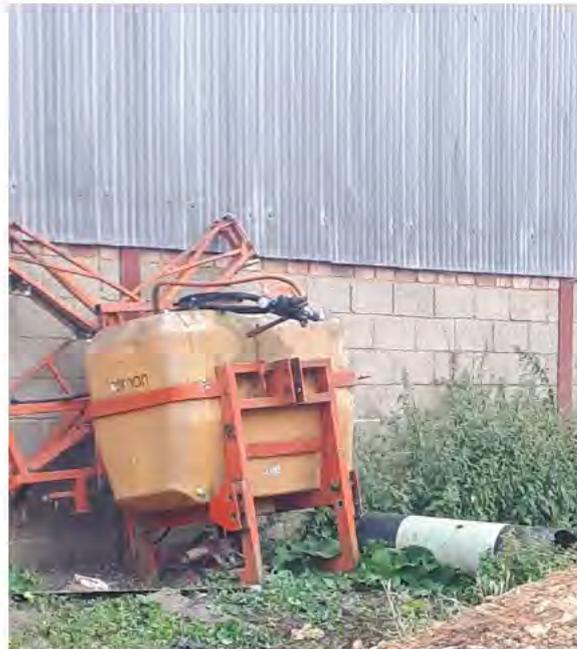
Photo 9.

Pesticide sprayer	East of Building 6	A discarded pesticide sprayer was observed to be located on soft landscaping adjacent to Building 6. The landowner advised that the sprayer has never been used on site as spraying of the site with pesticides is undertaken by an external contractor.

Empty pesticide sprayer against eastern wall of Building 6. Aggregate pile immediately to right of photo (visible in bottom right corner) (see Figure 2 / 3 for location).

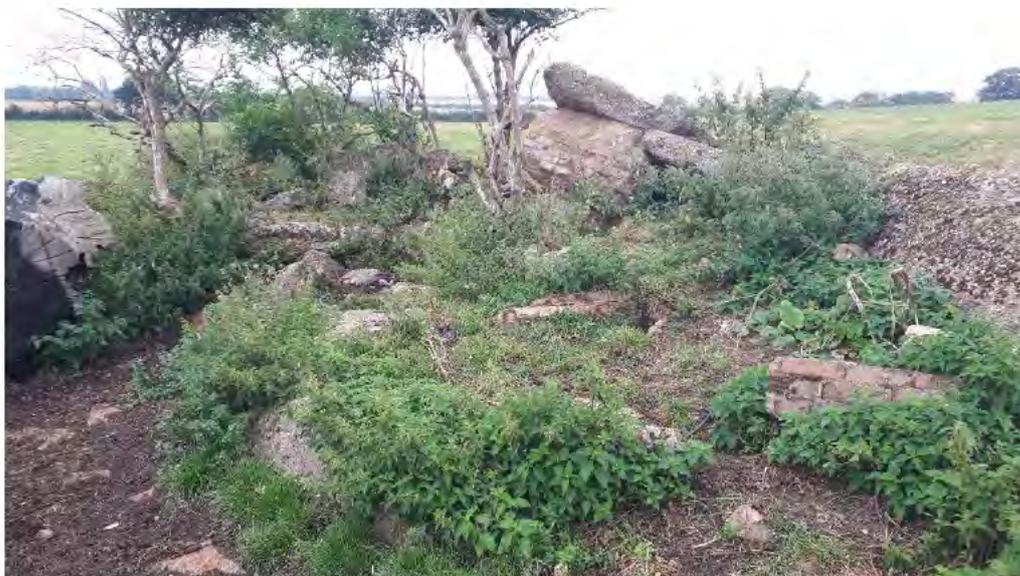
Photo 10.

Rubble pile to southwest of farmyard, photo facing west (see Figure 3 for location).

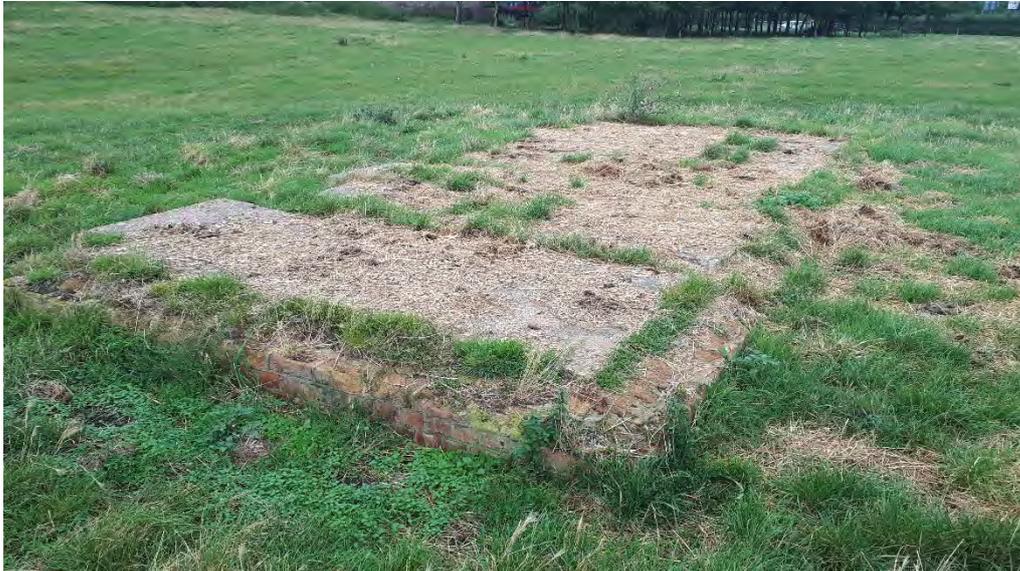
Photo 11. Abandoned foundation of 'shower block' located to south of farmyard (see Figure 2 for location).

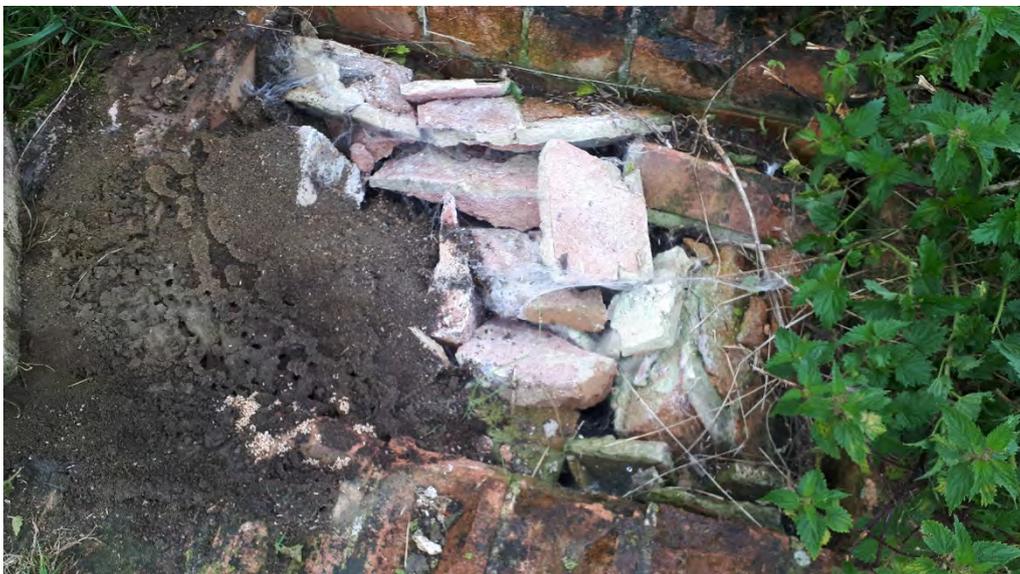
Photo 12. Abandoned drainage chamber filled in with rubble, located to south of farmyard (see Figure 2 for location).

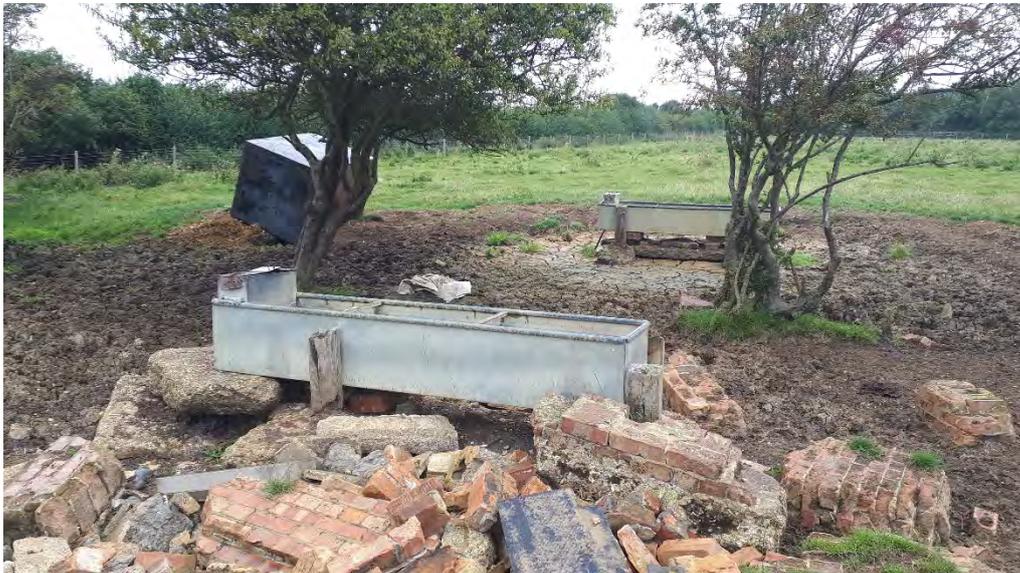
Photo 13. Rubble pile and troughs to north of farmyard, photo facing north. Scrapped water tank visible in left rear ground, sitting in hole left by landowner while decommissioning mains water supply to troughs (see Figure 3 for location).

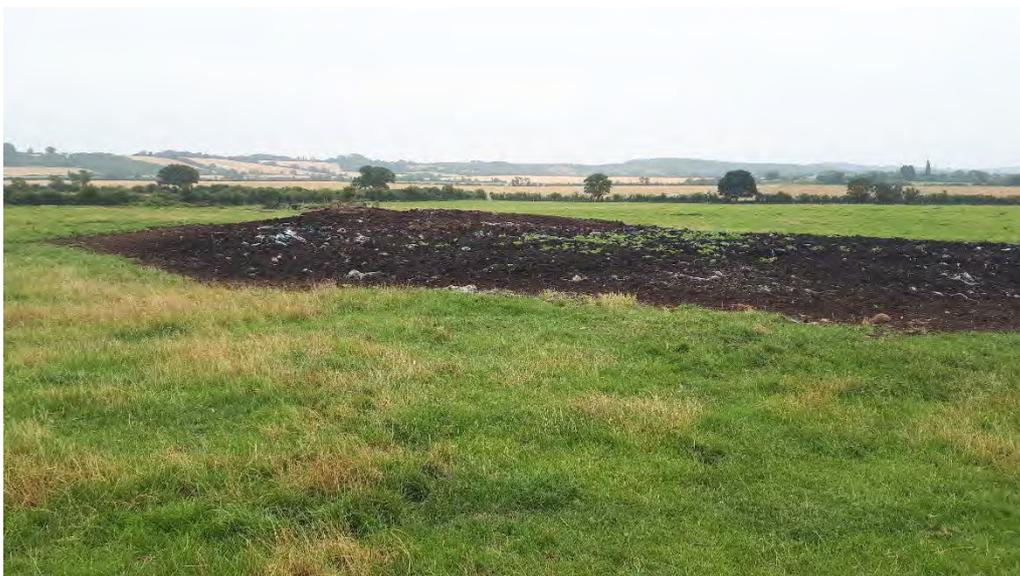
Photo 14. Muck pile to northwest of farmyard, photo facing west (see Figure 3 for location)

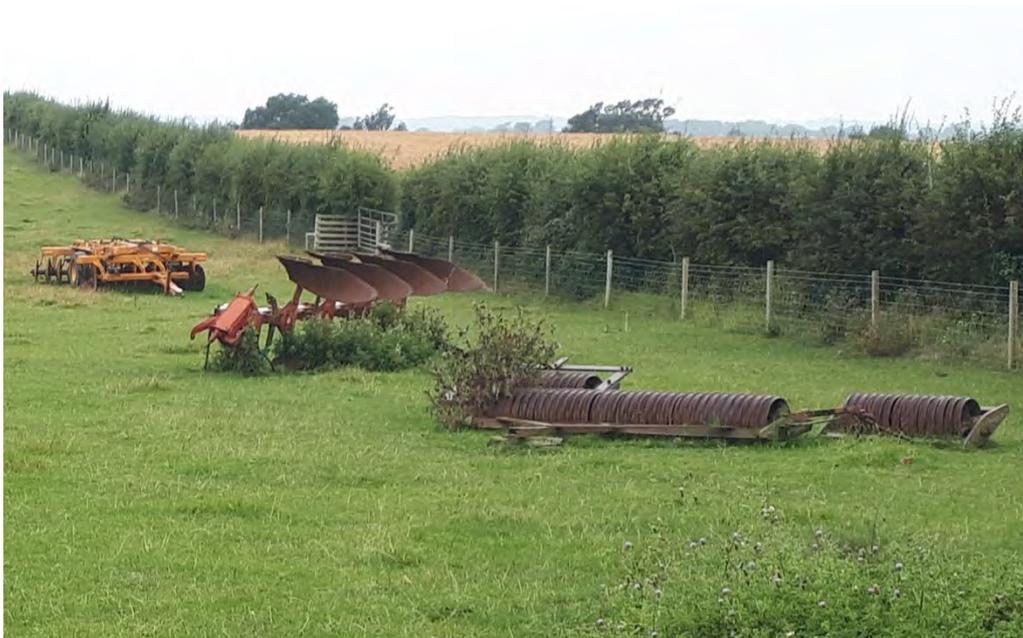
A tractor was observed in Building 6 and an excavator on undeveloped ground to the east of the farmyard during the site walkover. The landowner advised that no fuel leaks or spillages from farm machinery have occurred on the site. Various other pieces of farm machinery such as trailers or ploughs were located within the farmyard and elsewhere on the southern half of the site, but were not observed to contain fuel or chemicals.

Photo 15. Farm machinery (no fuel or chemicals) located immediately to north of muck pile (see Figure 3 for approximate location).

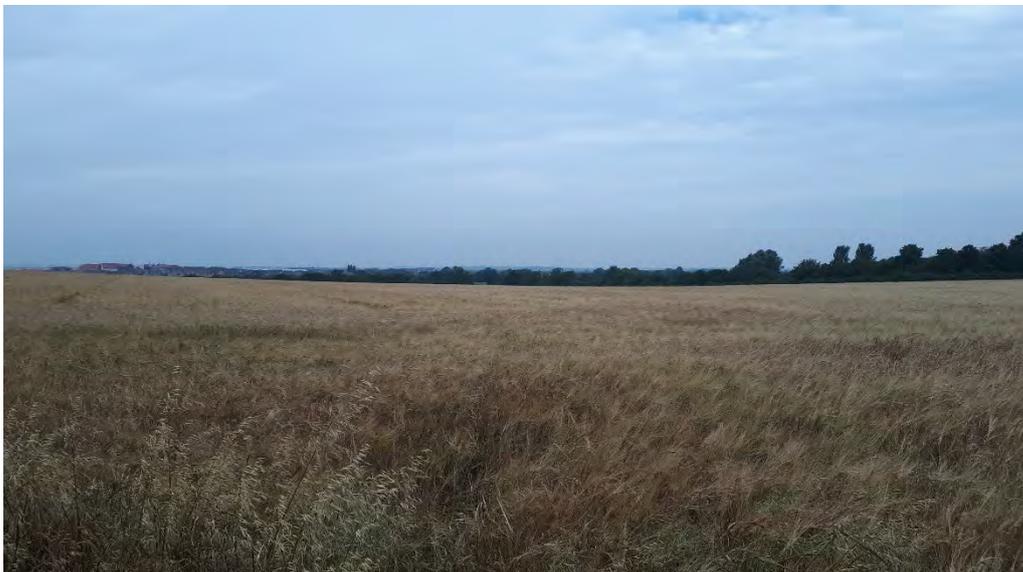
Photo 16. Overview of northern half of site, facing north from hedgerow immediately north of muck pile. Barley crop visible in middle distance, recent residential development in left background (see Figure 3 for approximate location).

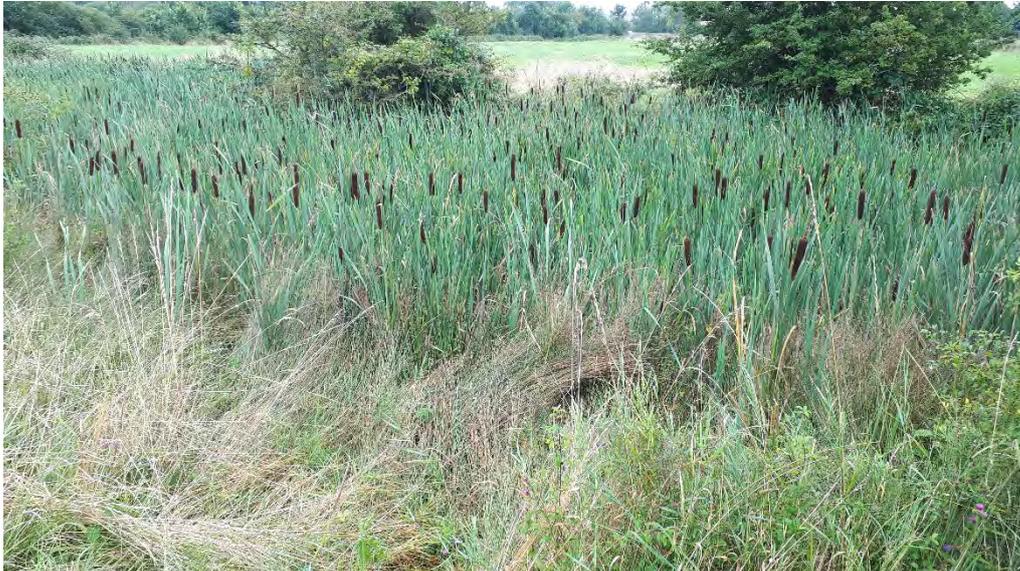
Photo 17. Pond located in centre of triangular parcel of site east of A6 road (see Figure 2 for location).

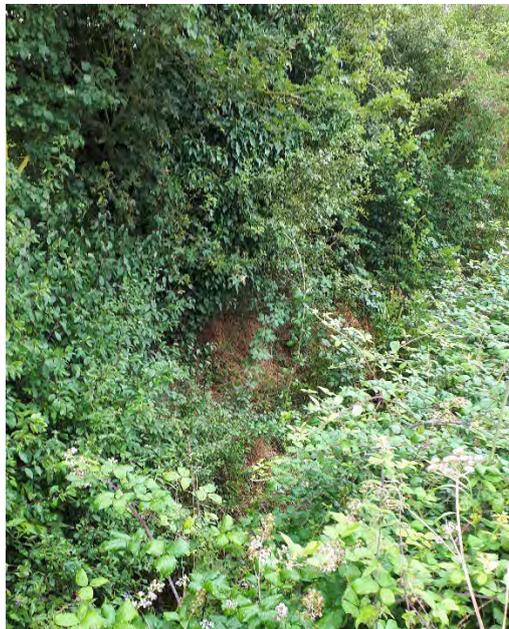
Photo 18. Unnamed drain running through centre of site, photo facing west (see Figure 2 for location).
