**Allocation Site: 768  
Church Lane  
Bedford**

*Heritage Appraisal*

CA Project: MK0614

CA Report: MK0614\_768

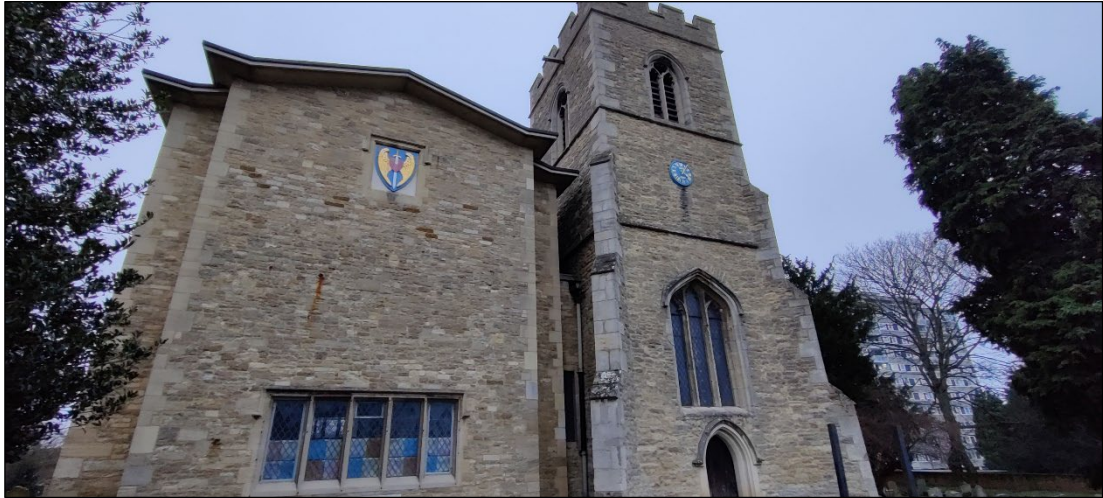
coursed rubble, with later additions in brick faced with stone from the old aisle, as such the extension is sympathetic to the original phase of the building (Photo 3).

**Photo 3** The modern extension to the Church on the left next to the 15th century Church tower on the right

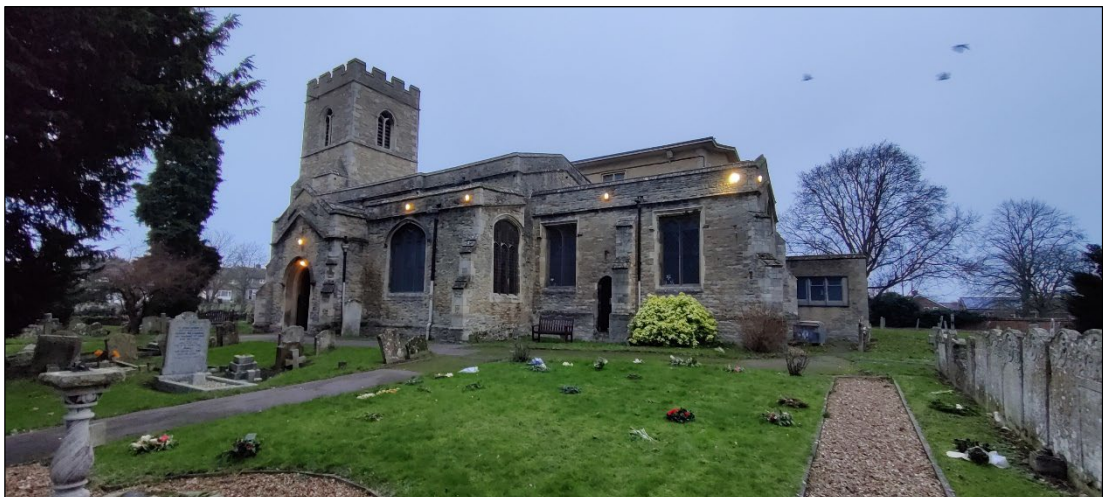
- 3.6. The Church is set within a modest churchyard which is enclosed by a stone wall on all sides. The spaces within the churchyard, and the treatment of its boundaries are key factors of the physical surrounds of the Church (Photo 4). Mature trees within the churchyard frame the Church and are positive aspect of the setting of the Church as they provide a visual screen and a sense of enclosure. The boundary wall contains the churchyard and encloses the Church, allowing for a distinct space around the graveyard.

**Photo 4** The Church within its churchyard

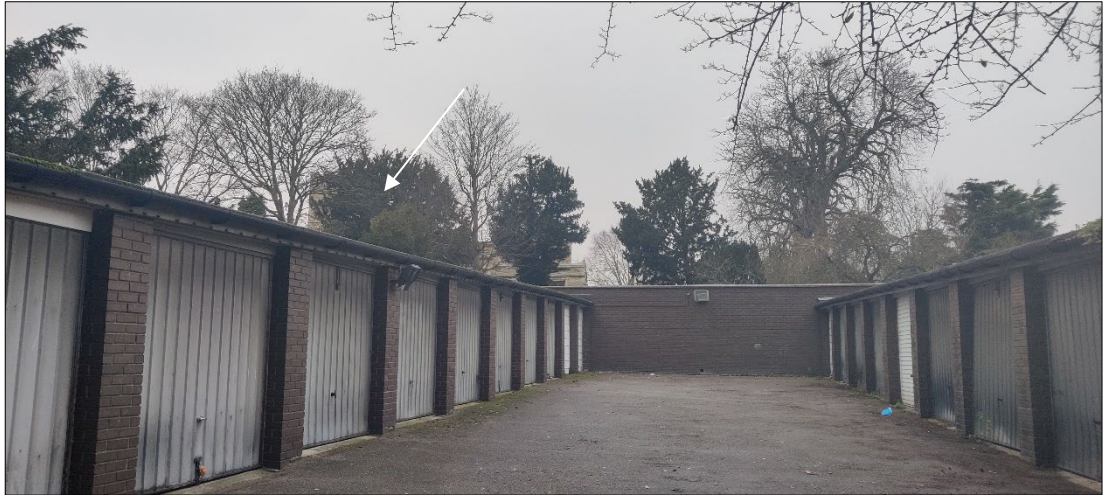
- 3.11. The garages (Photo 9) in the west of the Site do not contribute a positive aspect to the setting of the Church. At present their presence can be described as neutral, they neither detract from the setting of the Church nor do they enhance it. The garages are set down in the slope and the Church retains its prominence over them as seen in Photo Garages. The garages within the Site are in a depression which means that they do not impact upon the setting of the Church and have limited presence within the Site (Photo 10). The top of the garage building is visible from within the churchyard (Photo 8), the presence of this blocks out some views of the green space and trees to the south. The garage buildings are not of an aesthetically pleasing design, however the bricks match with the brickwork in the retaining Church wall in the south, as such the garage wall blends with the overall character.

**Photo 9 View of the garages in the west of the Site looking north towards the Church**

- 3.12. Development within the Site as part of the allocation is expected to demolish the existing garages, to be replaced with a Church Hall building, which would not be at a greater scale than the existing wall shown in Photo 9. This would result in a change of function in this area which would translate as a small positive change to the character of the land. The proposals also show a private garden associated with the Church Hall to the south of the Church, this change would constitute a small positive change within the Site, as from this garden area, views of the Church could be obtained.

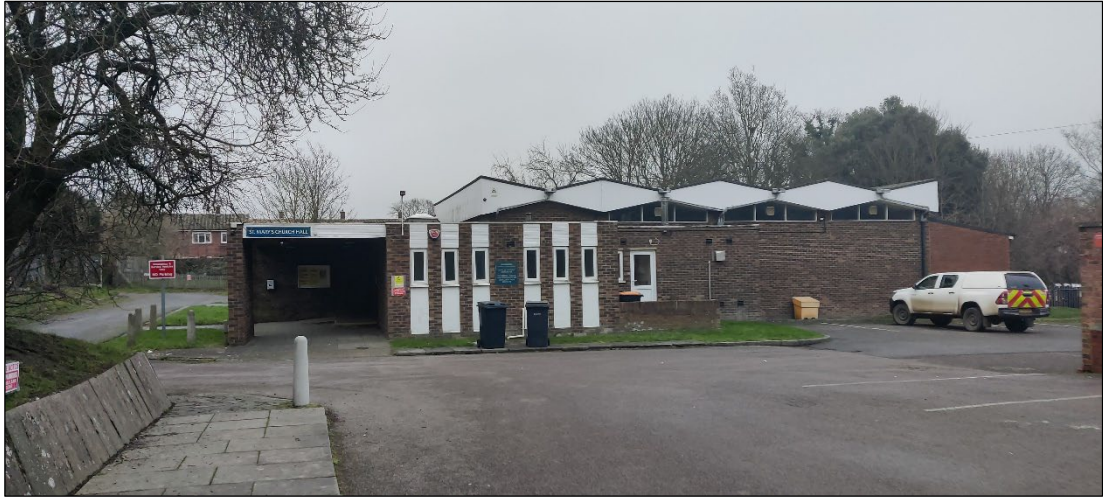
- 3.13. The existing Church Hall lies in the east of the Site (Fig. 10). This building (Photo 11) lies on lower ground to the Church, and makes up a neutral aspect of the setting of the Church as it is a 20th century building of modern character, with a flat roofed element and is backed by a taller element with an undulating roof. To the east of this is a small area of green space which can be used as a secure play area (Photo 1). Topography and the presence of mature trees minimize its overall visual effect within the churchyard; however, it brings the less sympathetic forms of modern development within proximity to the churchyard. Despite sharing a functional relationship, the Church Hall does not contribute to the setting of the Church, equally it does not detract from its setting (i.e., a neutral component).

**Photo 11 View of St Mary's Church Hall**

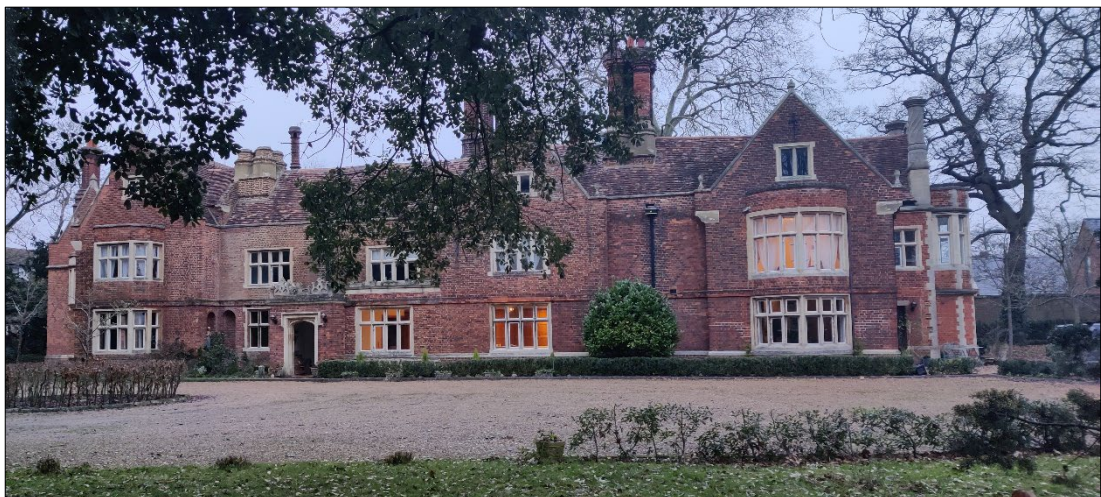
- 3.18. Grade II Listed Goldington Hall (Photo 12) is a former manor house constructed in the 17th century and has since been much altered and extended. The hall is built of red brick with a tiled roof and comprises two storeys and attics. The hall was converted into a pub and restaurant in the 1970s and has since been returned to a private residence.

**Photo 12 Goldington Hall**

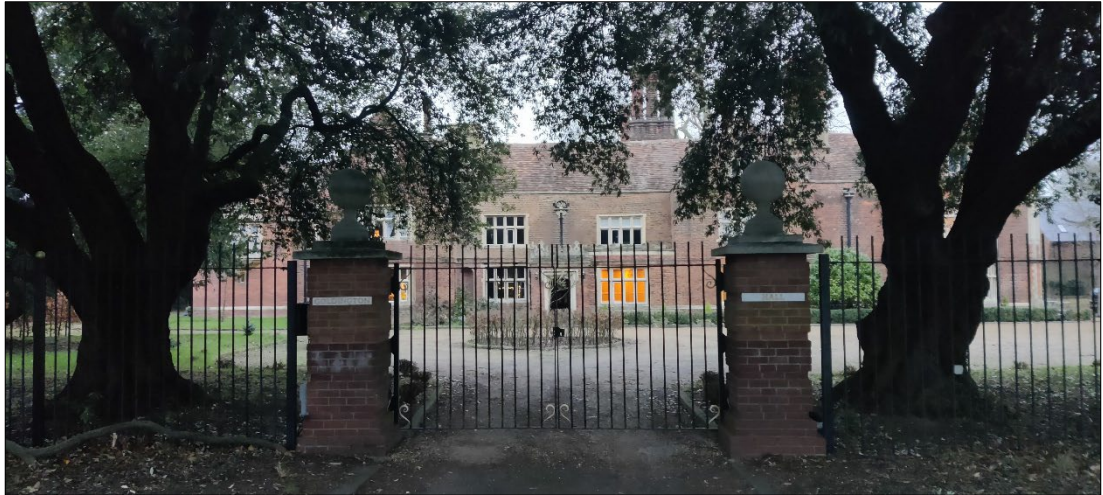
**Photo 13 View of Goldington Hall front gates**

- 3.19. The Hall is enclosed by a metal gate which surrounds the boundary (Photo 13), this provides a clear indication of the boundary between the Hall and the surrounding area. A line of shrubs and trees also mark the boundary of the Hall, in an attempt to provide privacy to the occupants (Photo 14). The trees which surround the Hall make a positive aspect of its setting, as the mature trees mark the Hall as historic whilst granting privacy to the occupants.
