Land Off Vicars Close, Biddenham, Site Appraisal

Prepared for: Phillips Planning Services Ltd

August 2020

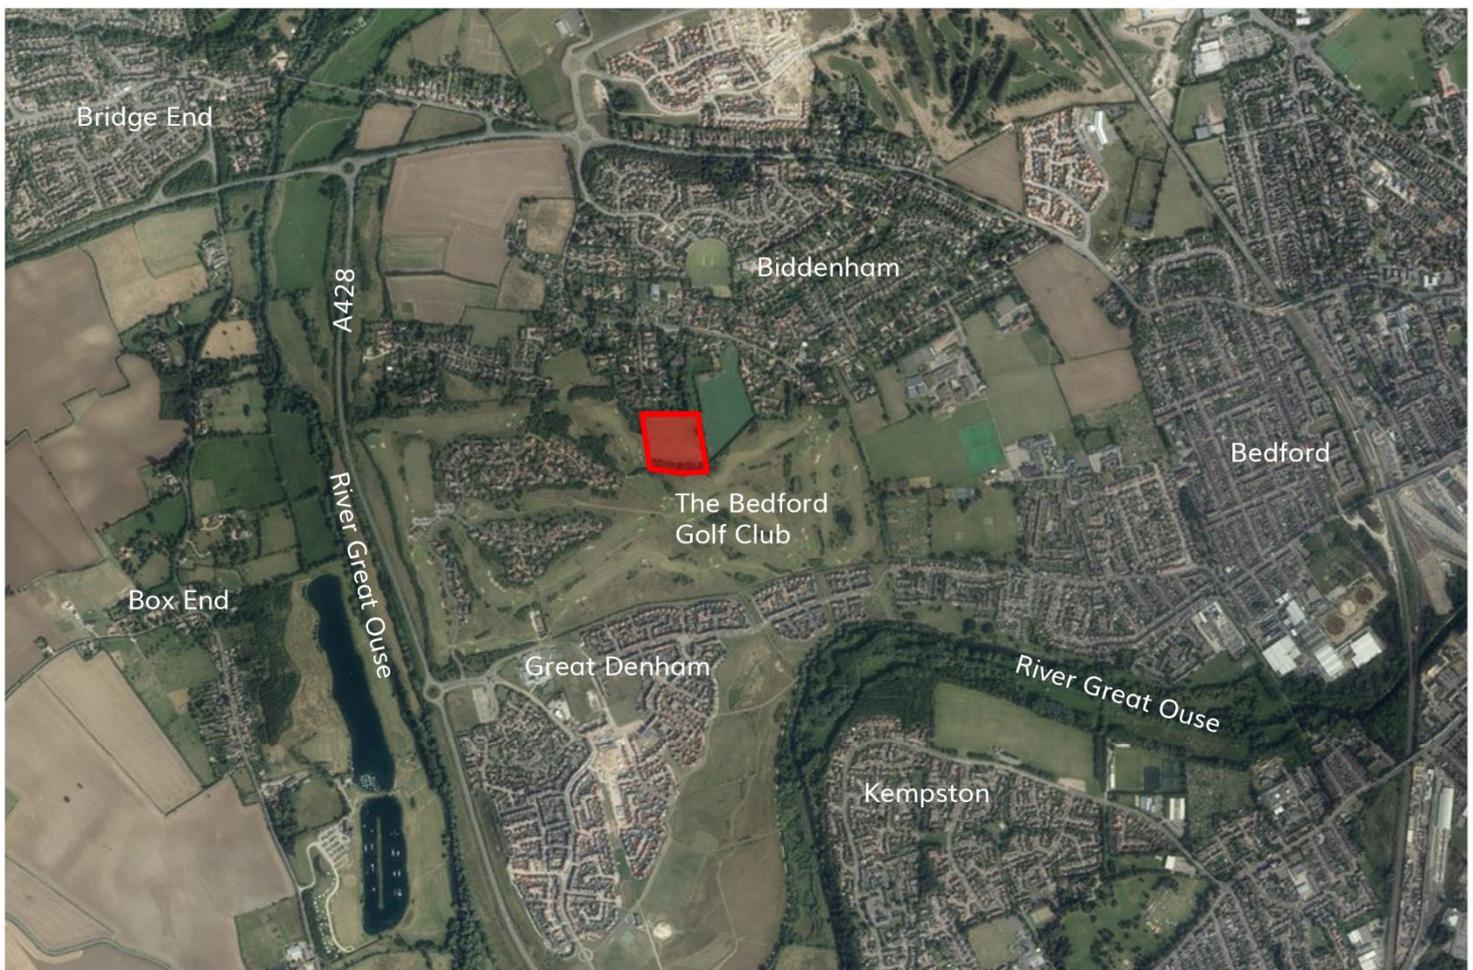
Figure 1 – Site Location Plan

Appraisal site

Wynne-Williams Associates has been appointed by Phillips Planning Services Ltd to appraise the suitability of a site for development with regard to the potential landscape and visual effects. The site is located off Vicars Close, Biddenham, and has potential for residential development [Figure 1]. Wynne-Williams Associates is a practice registered with the Landscape Institute with many years' experience in landscape design and various aspects of landscape planning consultancy.

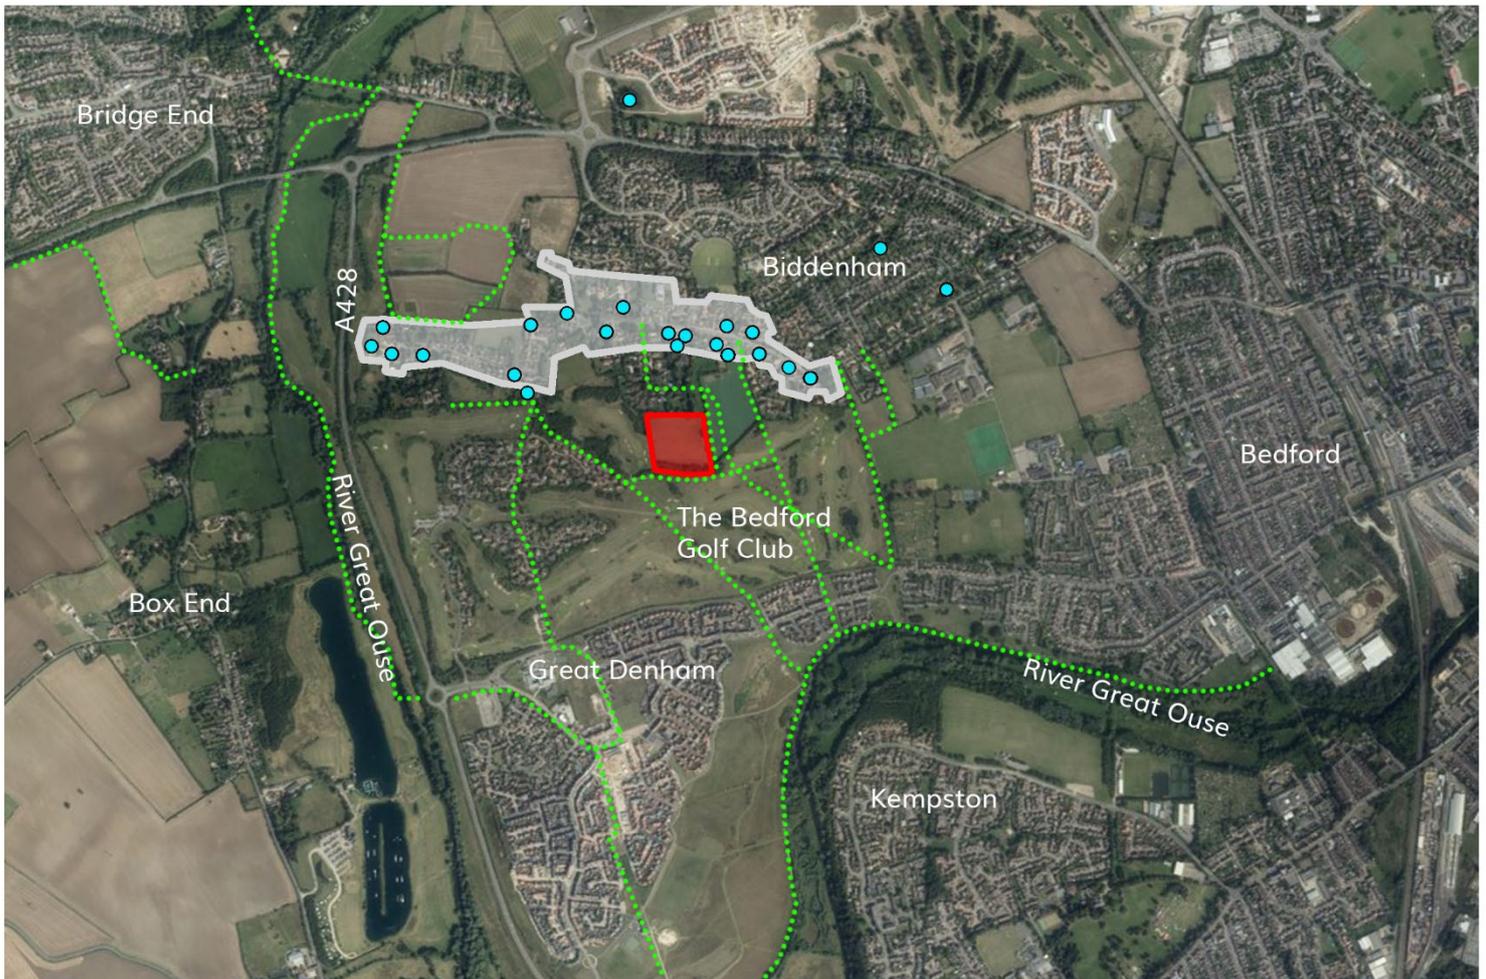
Figure 2 – Planning Context Plan

There are various landscape planning sensitivities within the wider area surrounding the site, these are identified in **Figure 2**.

The historic core of Biddenham is a conservation area, with the boundary lying 200m north of the appraisal site, and in total there are 25 listed buildings or features within 1km. As the site is so well screened by existing buildings and vegetation, it is unlikely that development on the land will affect the setting of these heritage assets.

Biddenham Pit Site of Special Scientific Interest (SSSI) is located 600m north of the appraisal site, with a considerable amount of existing housing situated in the intervening space. An Ecological Appraisal of the site may be required as part of a future planning application and this would assess potential ecological effects of development.

There are multiple public rights of way (PRoW) serving the landscape to the south, east, and west of the site. Mature trees along all of the site boundaries screen the land to all PRoWs except for a short section of the footpath running directly adjacent to the north-east corner of the site (further assessment of visibility is included in section 3). Development of the site will therefore have minimal effects on recreation routes in the area.

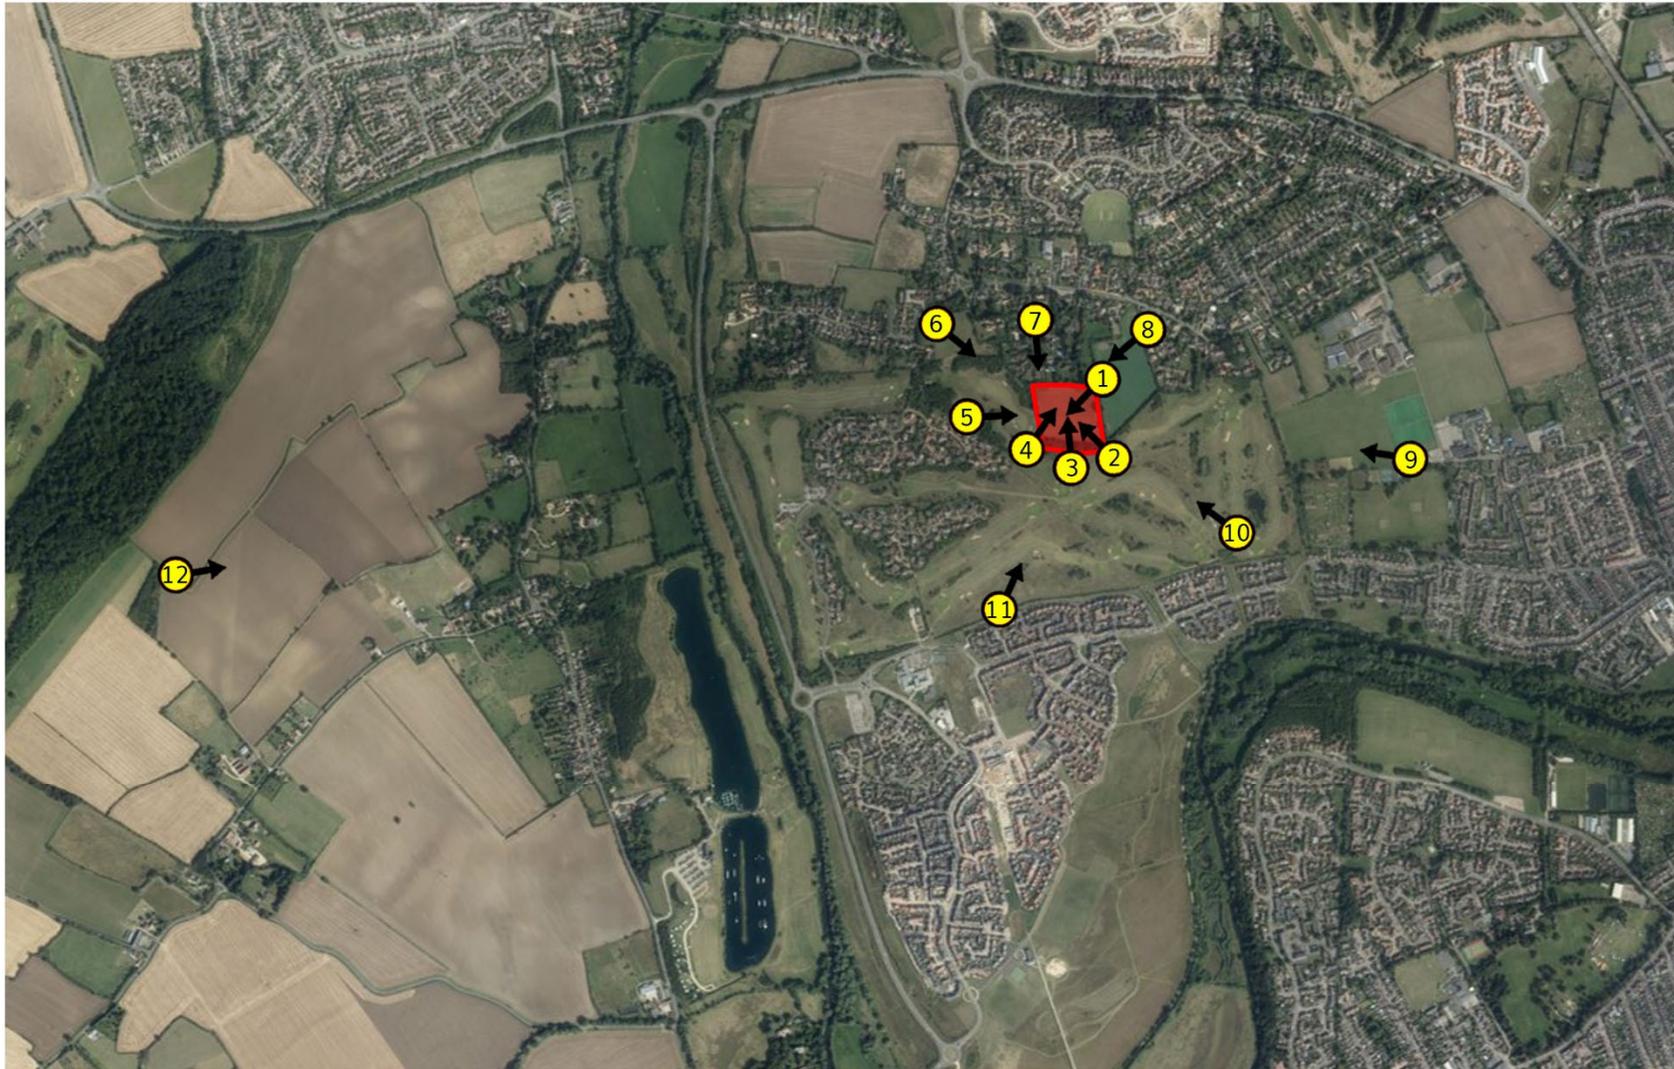
Figure 3 – Viewpoint Location Map

A selection of viewpoints was chosen to be representative of views into the site from the surrounding area. **Figure 3** shows the location of each viewpoint with marker numbers correlating to full analysis available in **Section 5, Appendix A**. The viewpoints are all taken from publicly accessible locations.

Assessment of viewpoints 1-12 shows that the site is extensively screened by existing vegetation on all four sides, and by existing buildings to the north. The only viewpoint where views into the site were observed was from viewpoint 1. This is due to a small gap in the tree line at the north-east corner of the site. To reduce potential visual effects on receptors using the adjacent footpath, boundary tree planting in this gap is recommended.

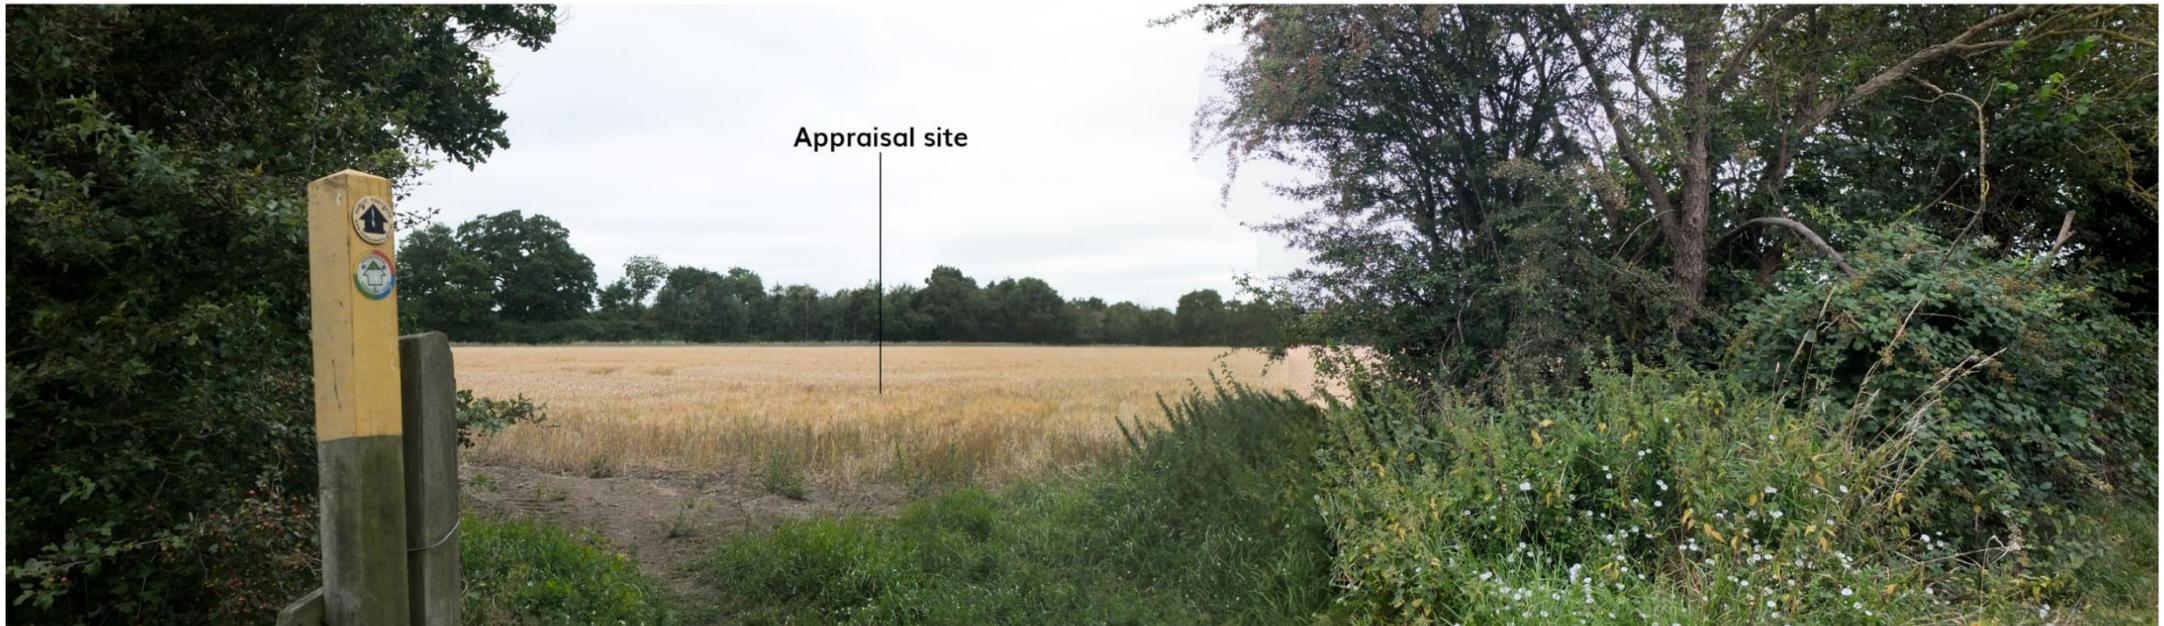
Viewpoint 1

Location of viewpoint: Taken along public footpath that runs adjacent to north-east corner of the appraisal site, looking south-west.

Description of view: Gap in existing boundary vegetation can be seen in the foreground with views available into the appraisal site in use for crop production.

Character and visual sensitivities: Sensitive receptors will use the footpath as a recreational route.

Comment: Development may result in some character and visual effects, but boundary tree planting in the gap would reduce this to a minimal level.

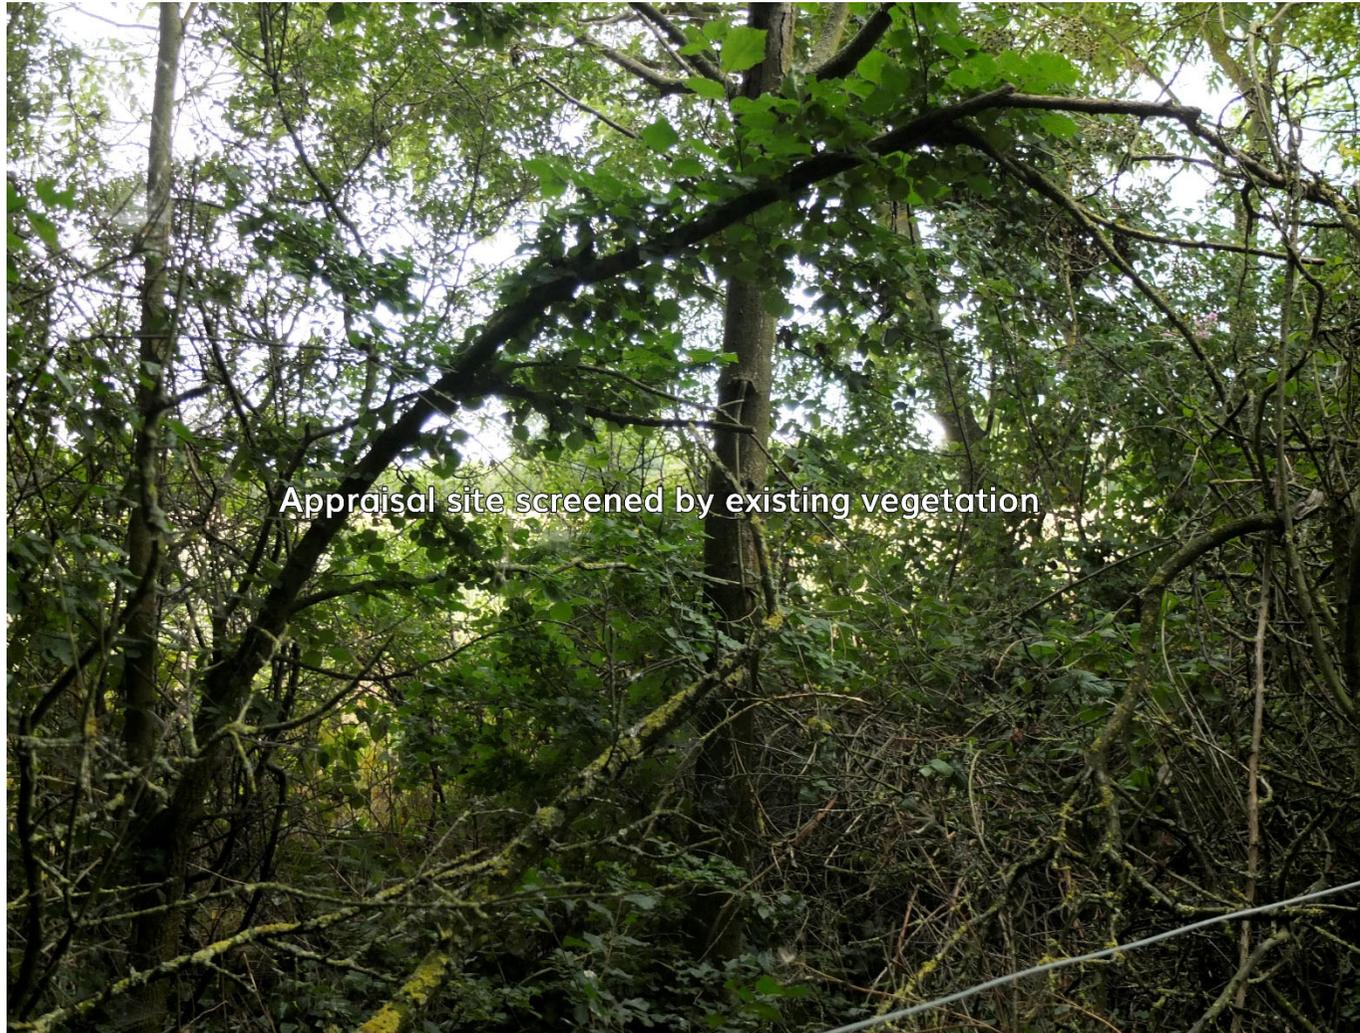
Viewpoint 2

Location of viewpoint: Taken along public footpath that runs adjacent to south-east corner of the appraisal site, looking north-west.

Description of view: Dense existing vegetation along the appraisal site boundary is visible.

Character and visual sensitivities: Sensitive receptors will use the footpath as a recreational route.

Comment: No potential character or visual effects noted.

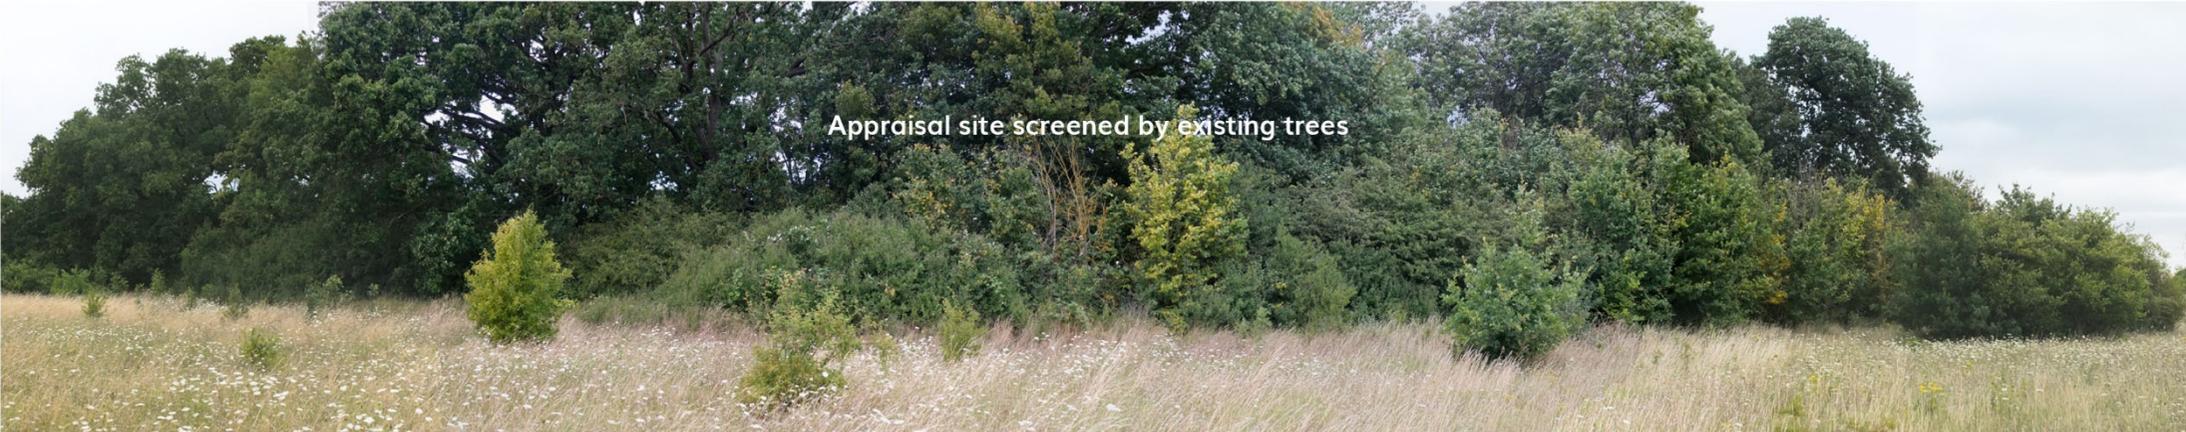
Viewpoint 3

Location of viewpoint: Taken along public footpath that runs adjacent to southern boundary of the appraisal site, looking north.

Description of view: Long grass at the edge of the golf course can be seen in the foreground, with existing boundary trees seen in the background.

Character and visual sensitivities: Sensitive receptors will use the footpath as a recreational route, and it forms part of the setting for the golf course.

Comment: No potential character or visual effects noted.

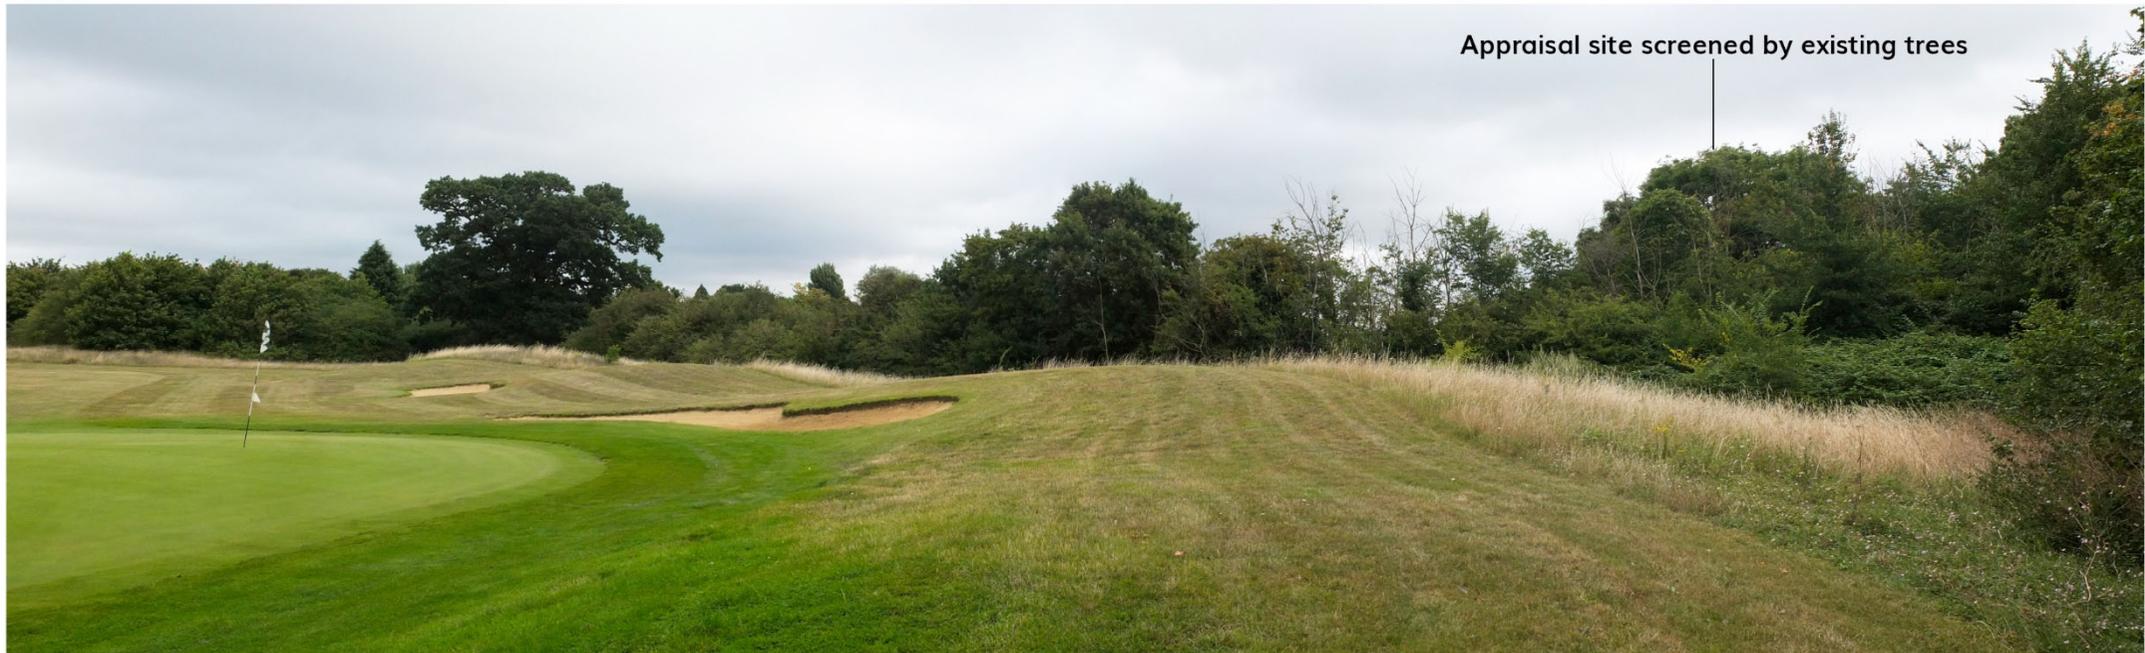
Viewpoint 4

Location of viewpoint: Taken along public footpath that runs through the golf course, between the appraisal site and the eastern edge of the golf course residential development. Looking north-east.

Description of view: Part of the golf course playing area is visible in the foreground with existing boundary trees seen in the background.

Character and visual sensitivities: Sensitive receptors will use the footpath as a recreational route, and it forms part of the setting for the golf course.

Comment: No potential character or visual effects noted.

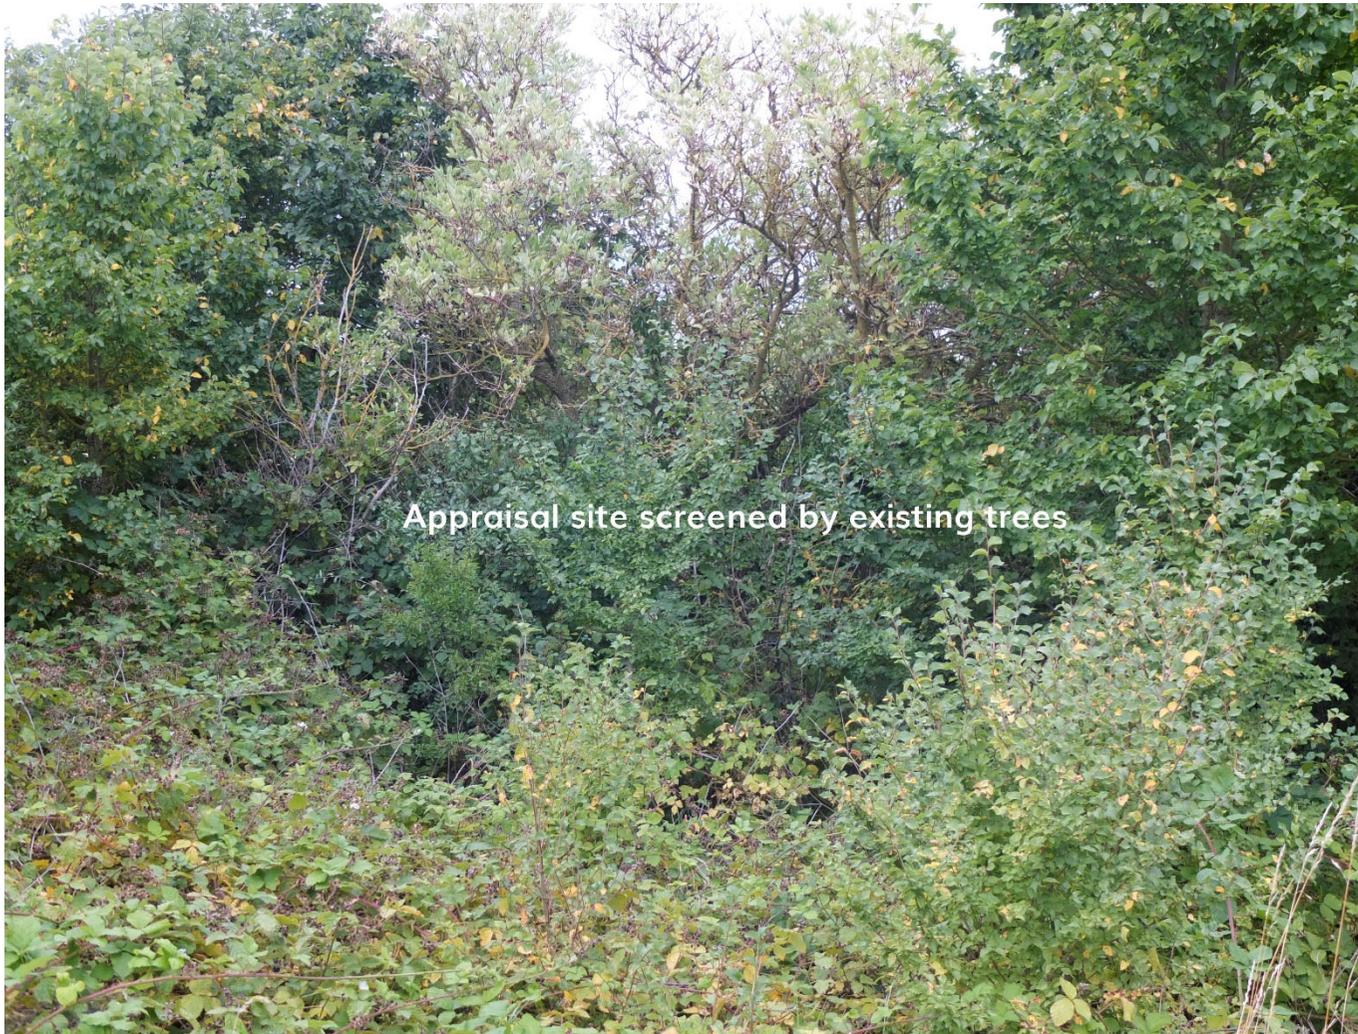
Viewpoint 5

Location of viewpoint: Taken along public footpath that runs adjacent to eastern edge of the golf course residential development, looking east.

Description of view: Dense existing vegetation along the edge of the golf course is visible.

Character and visual sensitivities: Sensitive receptors will use the footpath as a recreational route and it also lies adjacent to residential back gardens.

Comment: No potential character or visual effects noted.

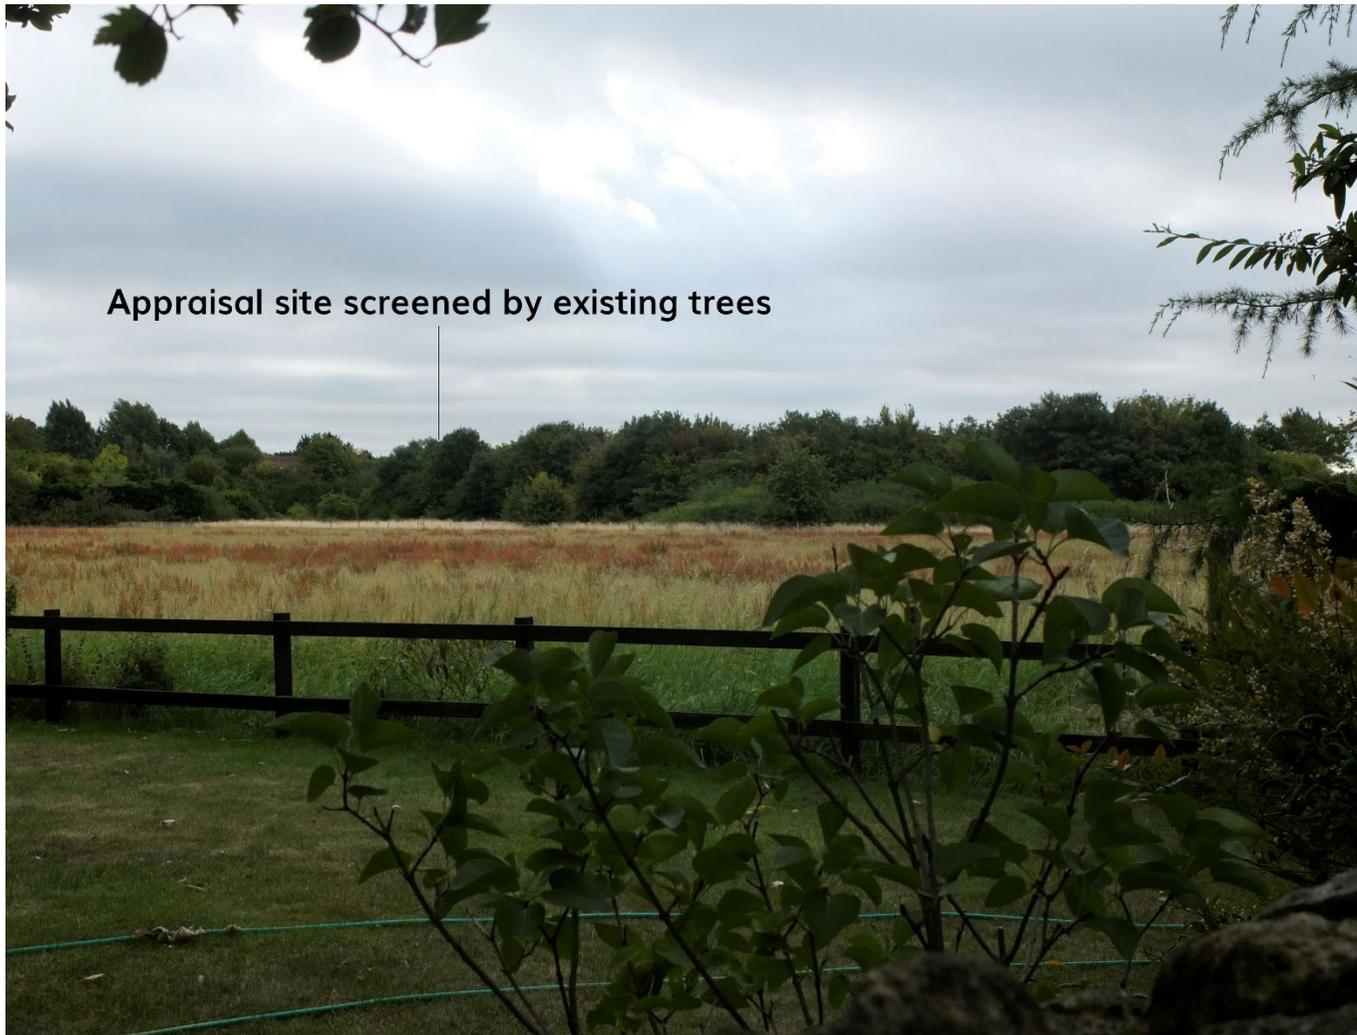
Viewpoint 6

Location of viewpoint: Taken from publicly accessible verge adjacent to church End in Biddenham village, looking south-east.

Description of view: Private back garden and fencing can be seen in the foreground, with arable field visible in the midground. Existing mature tree line can be seen in the distance.

Character and visual sensitivities: Sensitive receptors will use the footpath as a recreational route and it represents views out of the conservation area.

Comment: No potential character or visual effects noted.

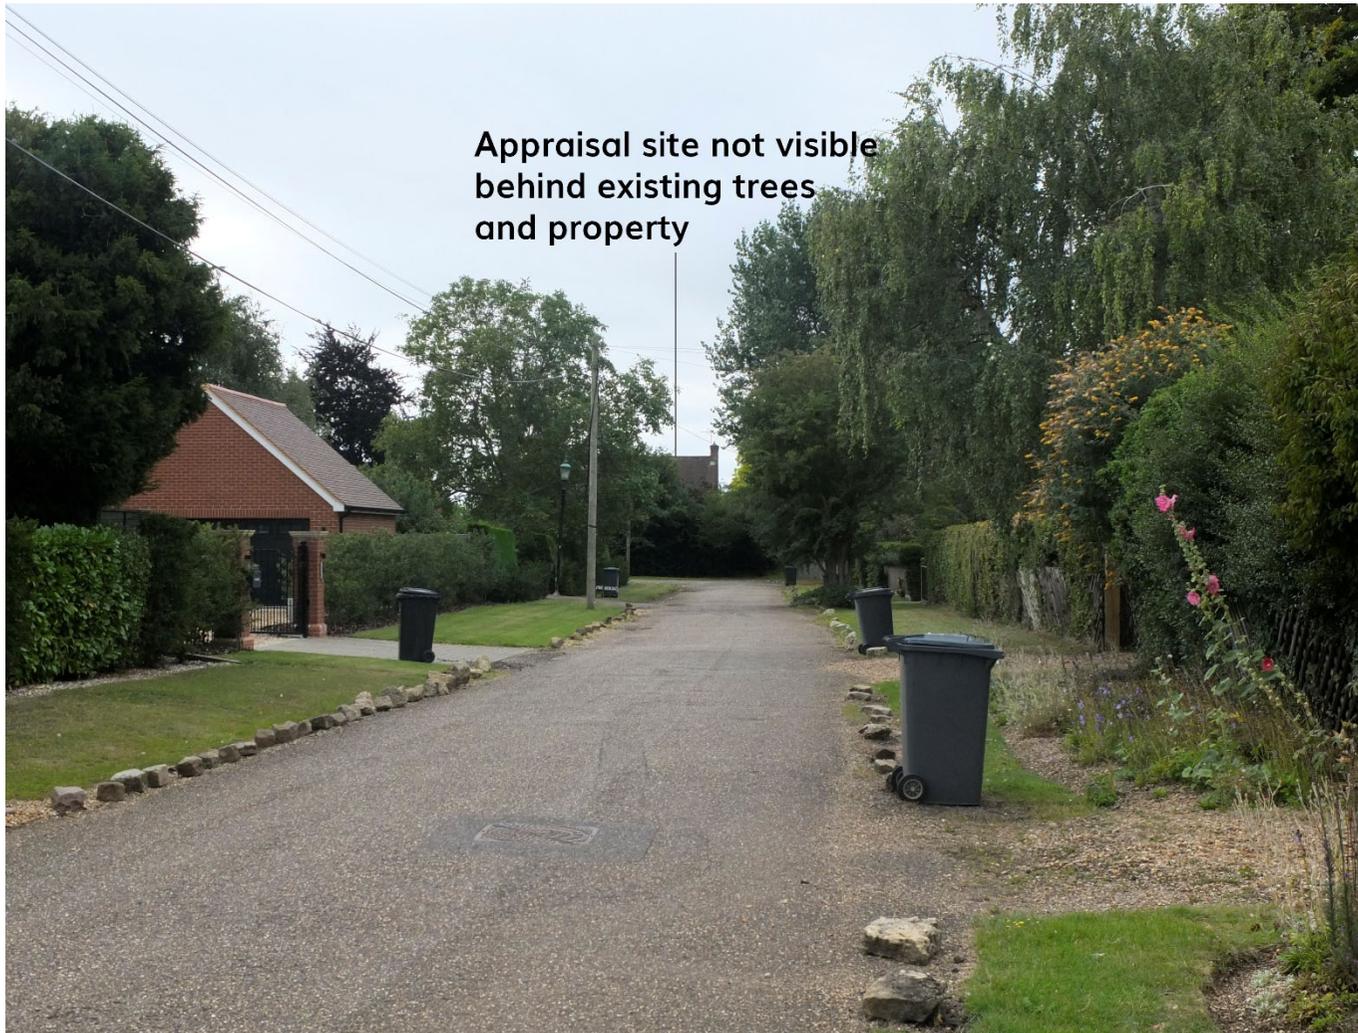
Location of viewpoint: Taken along public footpath that runs down Vicars Close north of the appraisal site, looking south.

Description of view: Private road can be seen in the foreground, with residential garage and hedgerow seen in the midground. Distant views to existing property and trees in the background.

Character and visual sensitivities: Sensitive receptors will use the footpath as a recreational route.

Viewpoint 7 shows the view from Vicars Close looking south towards the appraisal site. If a future access route were to be installed at the point where the road turns to the east, the access road may be visible from this viewpoint. Any potential visual and character effects would be minimised by using a material palette that complements the existing built development and retaining as much boundary vegetation as possible.

Comment: Potential site access may be visible. Appropriate material selection and retention of boundary trees will reduce visual and character effects to a minimal level.

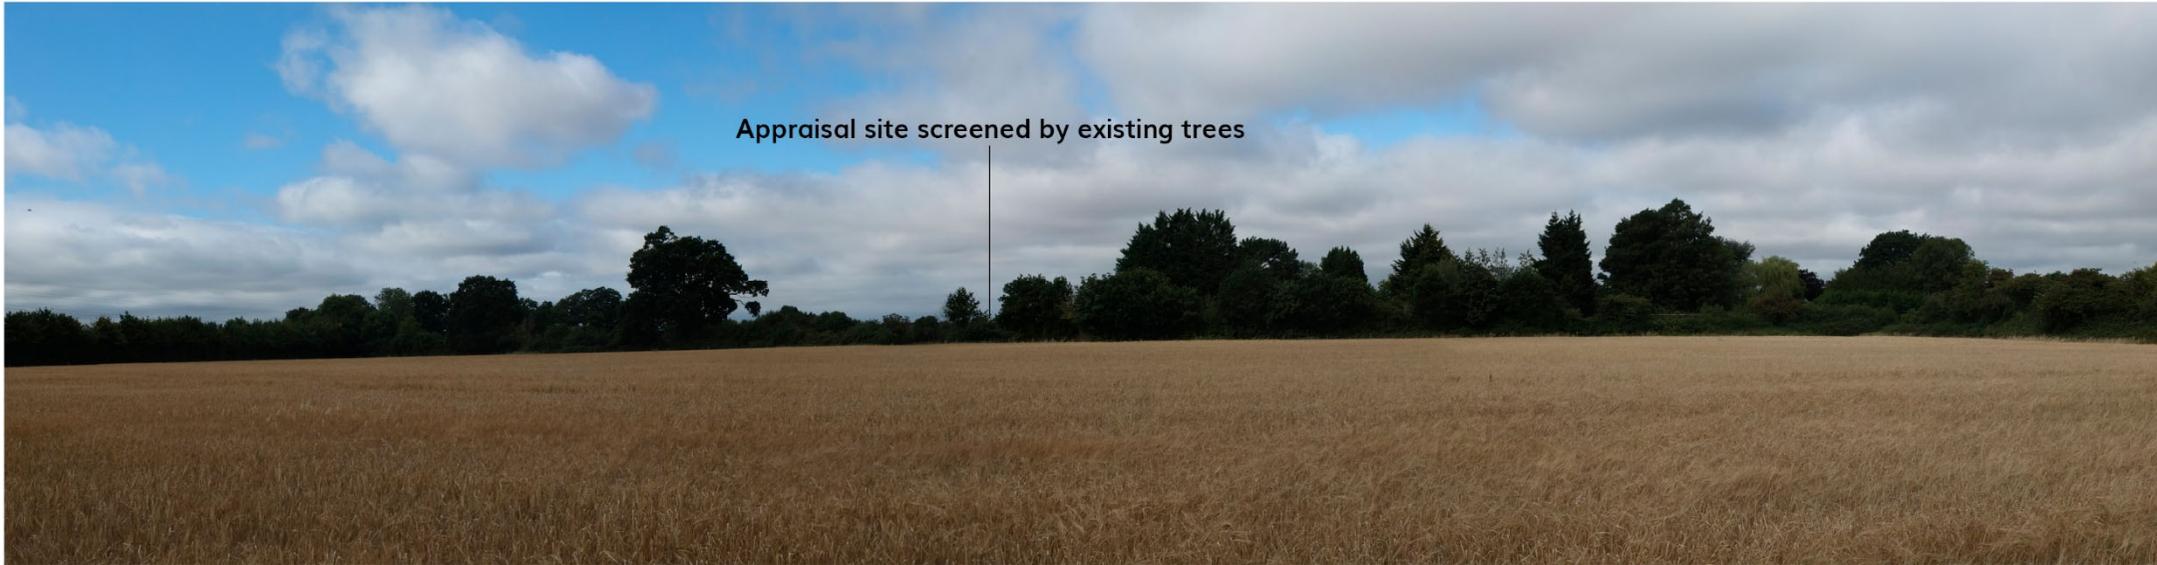
Viewpoint 8

Appraisal site screened by existing trees

Location of viewpoint: Taken along public footpath that runs adjacent to Merrill's Field east of the site, looking south-west.

Description of view: Arable field can be seen in the foreground, with existing boundary trees seen in the background.

Character and visual sensitivities: Sensitive receptors will use the footpath as a recreational route.

Comment: No potential character or visual effects noted.

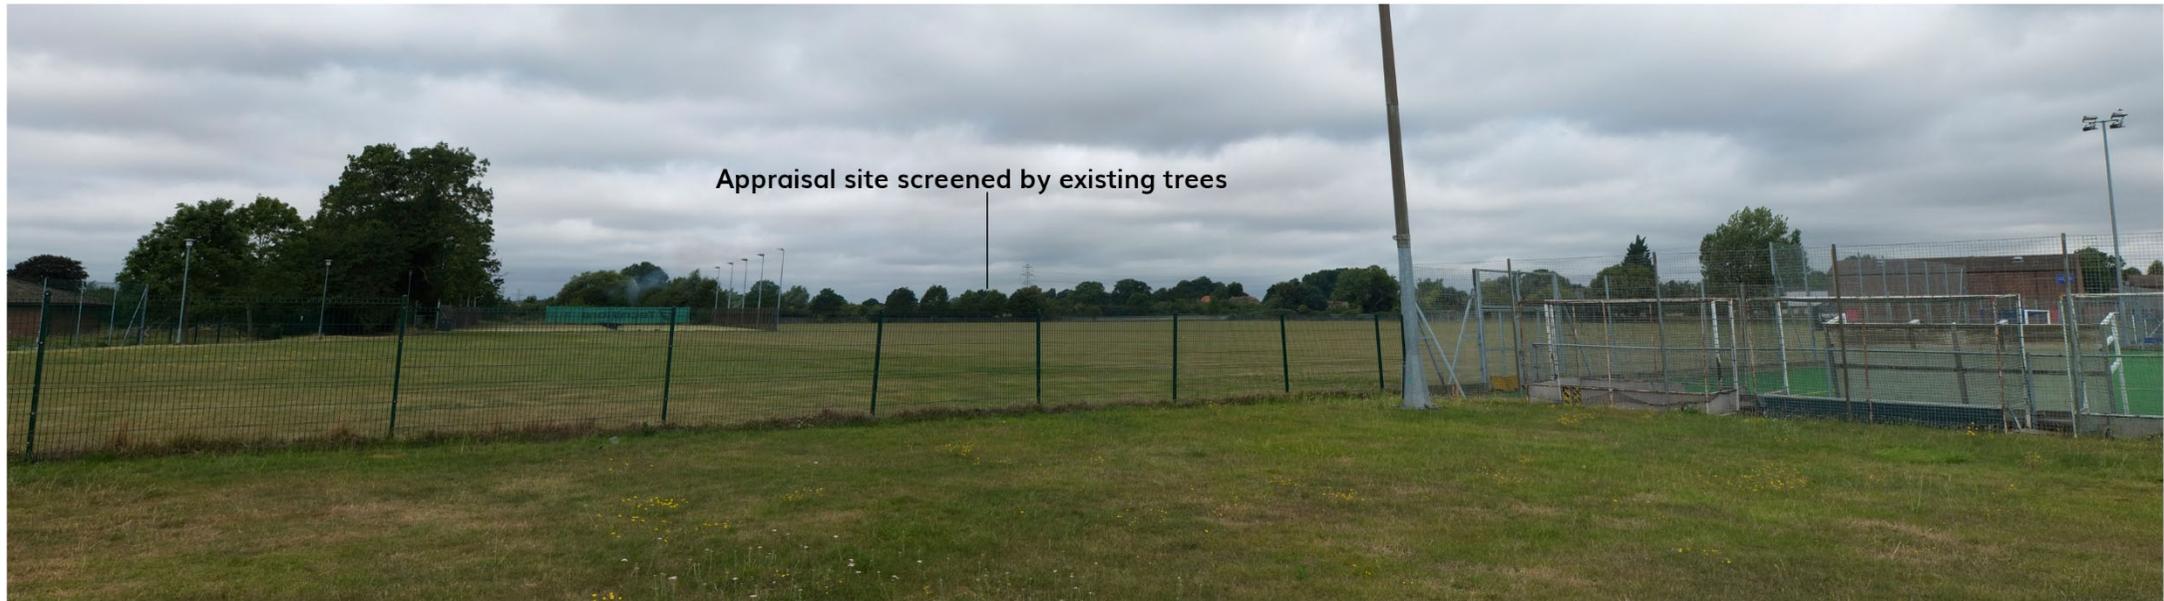
Viewpoint 9

Location of viewpoint: Taken from publicly accessible land adjacent to Bedford Sports and Hockey Centre, looking west.

Description of view: Sports pitches and fencing can be seen in the foreground, with existing mature trees seen in the background.

Character and visual sensitivities: Sensitive receptors will use the facilities for recreation.

Comment: No potential character or visual effects noted.

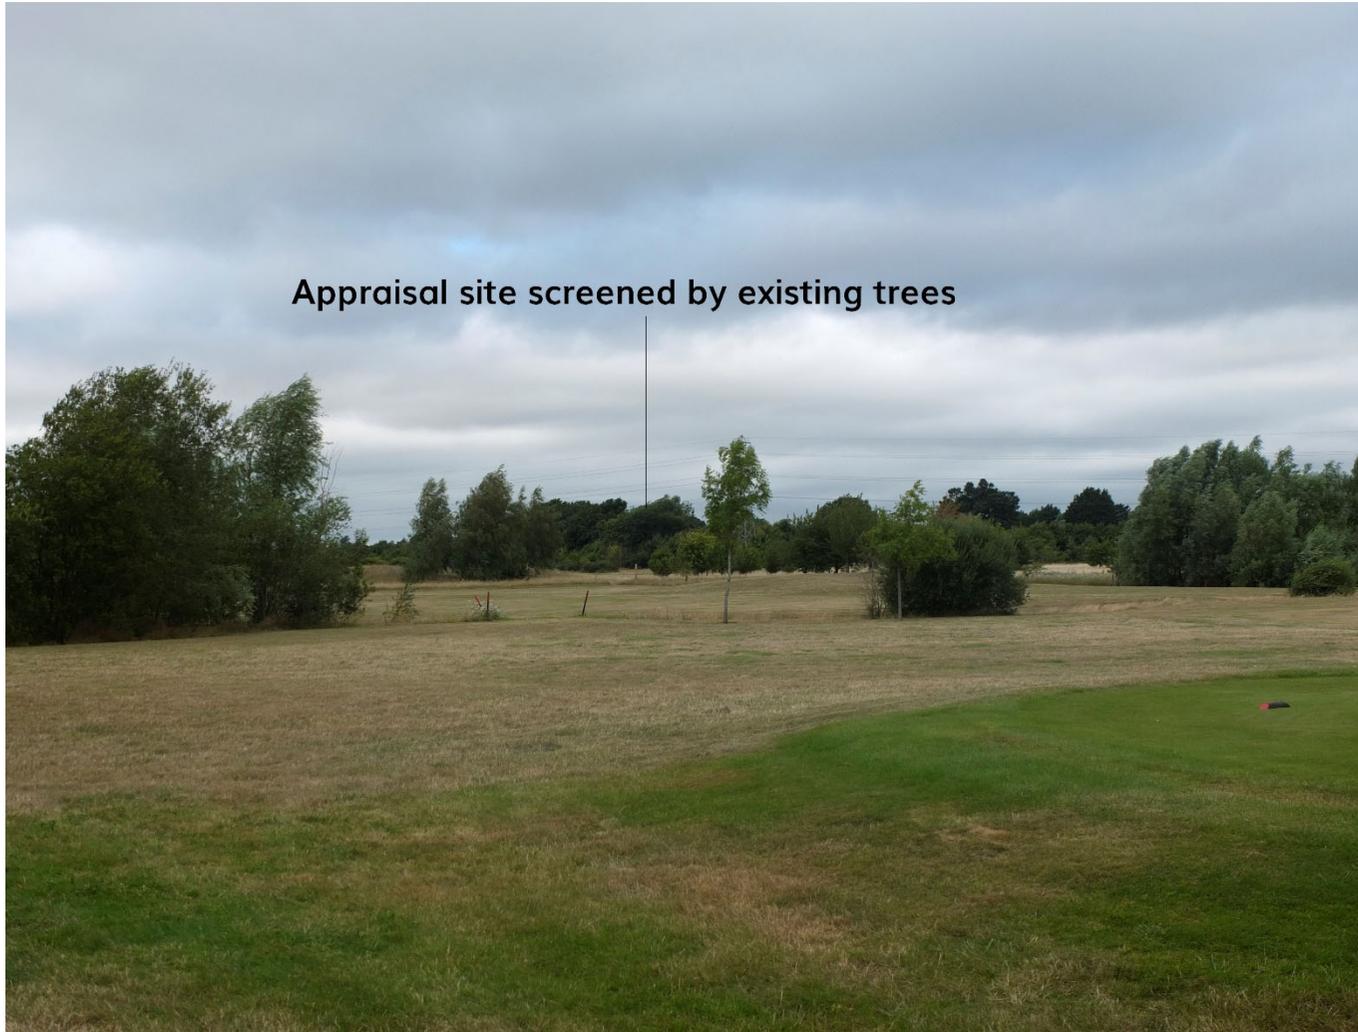
Viewpoint 10

Location of viewpoint: Taken along public footpath that runs through the golf course between the appraisal site and Old Ford End Road. Looking north-west

Description of view: Part of the golf course playing area is visible in the foreground with existing mature trees seen in the background.

Character and visual sensitivities: Sensitive receptors will use the footpath as a recreational route, and it forms part of the setting for the golf course.

Comment: No potential character or visual effects noted.

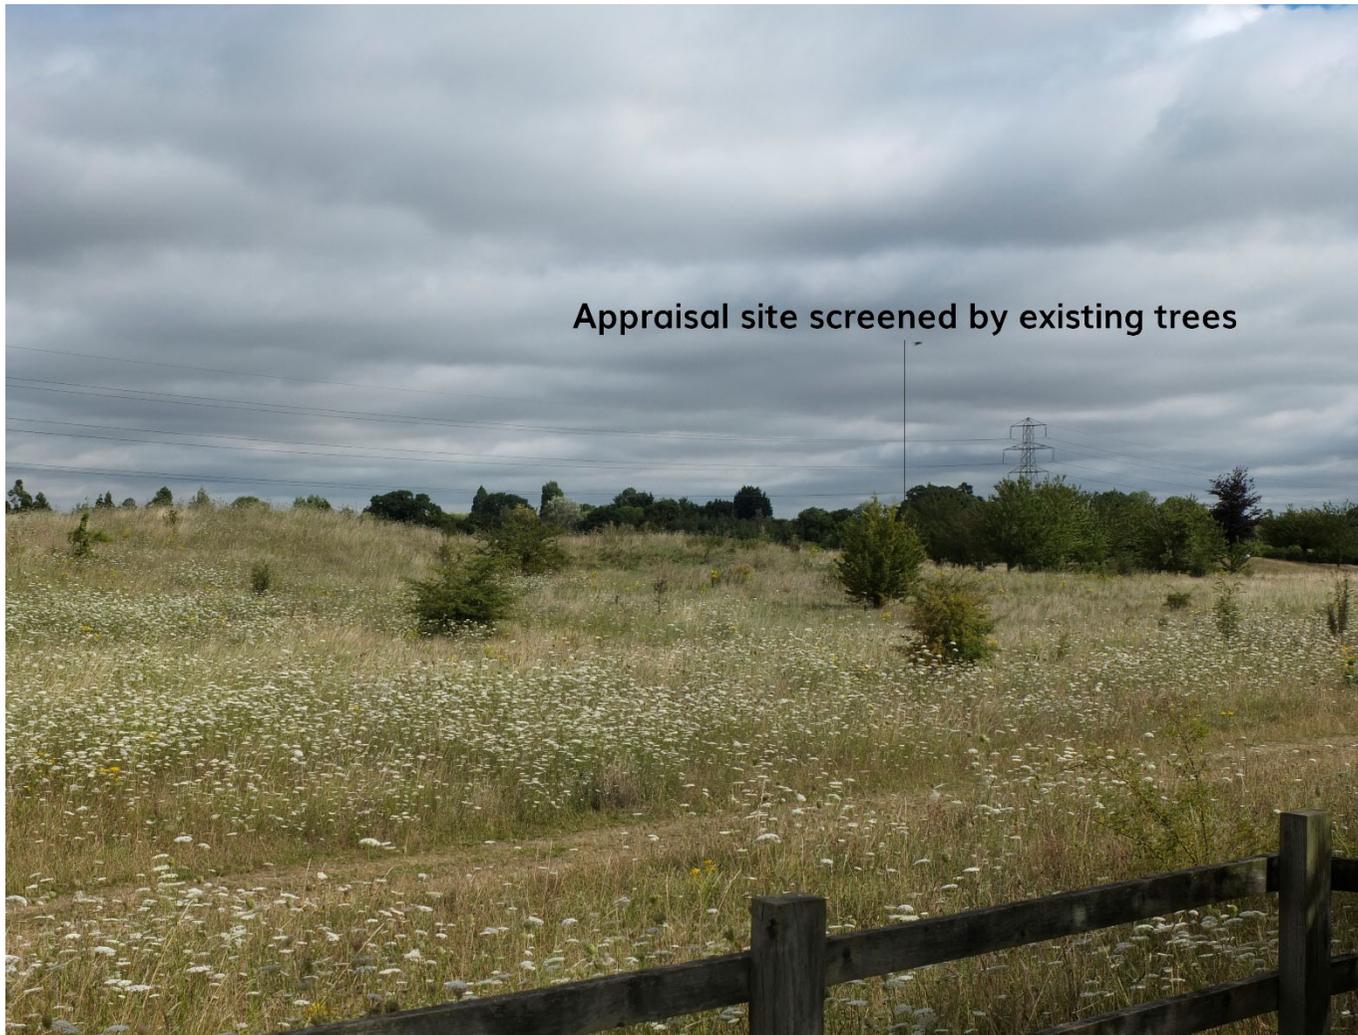
Viewpoint 11

Location of viewpoint: Taken from publicly accessible land north of Masters Close, looking north.

Description of view: Grass-covered bund at the edge of the golf course seen in the foreground, with existing mature trees seen in the background.

Character and visual sensitivities: Sensitive receptors will use the areas for recreational route, and it represents views from nearby properties.

Comment: No potential character or visual effects noted.
