Land Off Vicars Close, Biddenham, Site Appraisal

Prepared for: Phillips Planning Services Ltd

August 2020

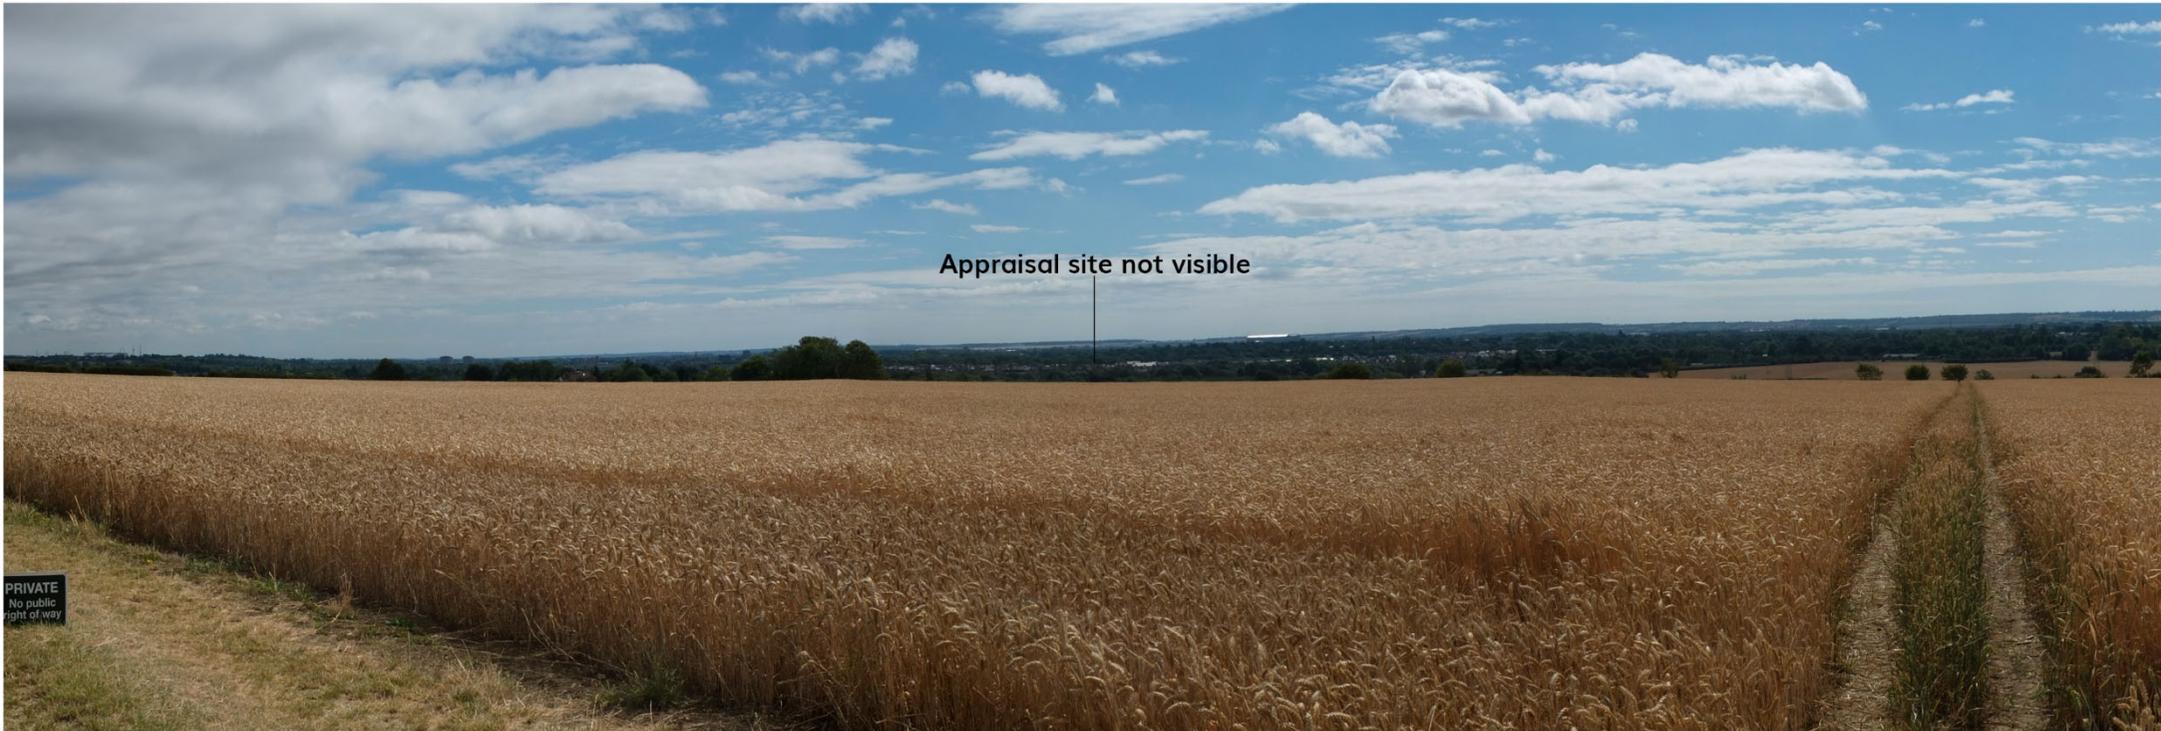
Viewpoint 12

Location of viewpoint: Taken along public footpath that runs along ridge close to Hangers Wood SSSI quite far west of the appraisal site, looking east. The viewpoint was selected for its high vantage point over the area.

Description of view: Arable field can be seen in the foreground, with existing residential development and mature tree lines seen in the far distance.

Character and visual sensitivities: Sensitive receptors will use the footpath as a recreational route.

Comment: No potential character or visual effects noted.
