**Land off Bedford
Road, Roxton**

**Representations
in Respect of
Landscape,
Ecological,
Heritage and
Arboricultural
Circumstances**

Prepared by:
**The Environmental
Dimension
Partnership Ltd**

August 2020
Report Reference
edp6100_r005a

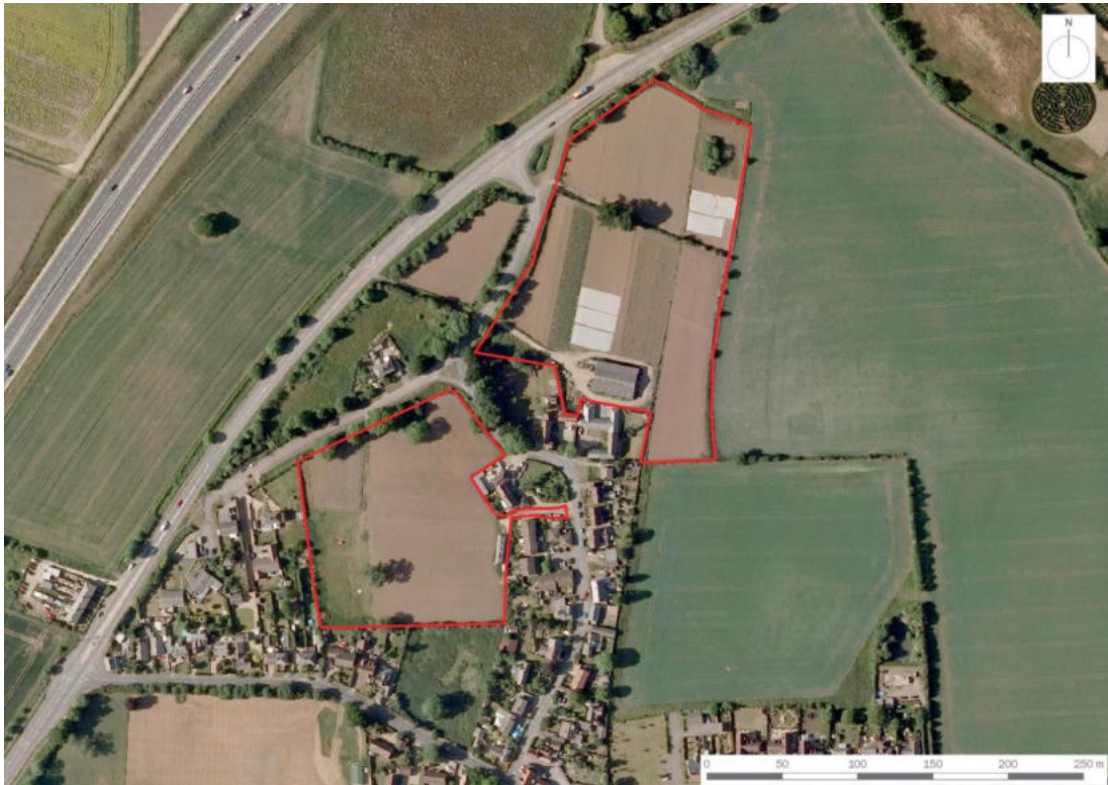
Image EDP 1.1: Aerial view of the site. Source: Google Map data 2020.

- 1.4 The site sits on the northern edge of Roxton, to the south-east of Bedford Road. The site comprises two plots, which are currently in agricultural use. The two plots are referred to as Parcel A (to the north) and Parcel B (to the south) within this document. The site context is illustrated in **Image EDP 1.1**.

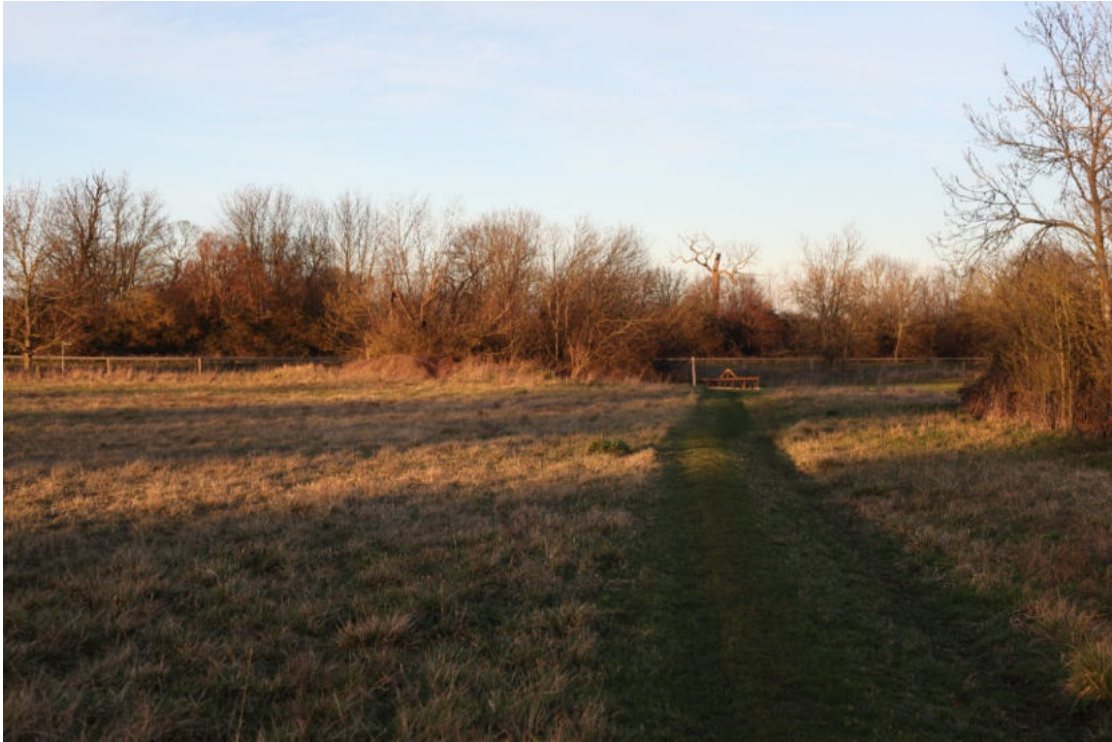
Image EDP 2.1: The site in its current form, taken from Parcel A looking north towards Bedford Road.

- 2.22 There is no enclosure to the northern boundary, and views to Bedford Road are only interrupted by small patches of scrub on the land to the north between the site boundary and the road. There is also no enclosure down the eastern boundary, with the site open to the arable field to the east, save for a couple of small trees scattered along its length.
- 2.23 The southern boundary is contained by a native hedgerow on its eastern end, about 3m in height, with a slightly gappy base, and by rear garden boundaries associated with the Grade II listed College Farmhouse, consisting of closed board fences and rough kept hedges towards its western end, running behind the agricultural barn.

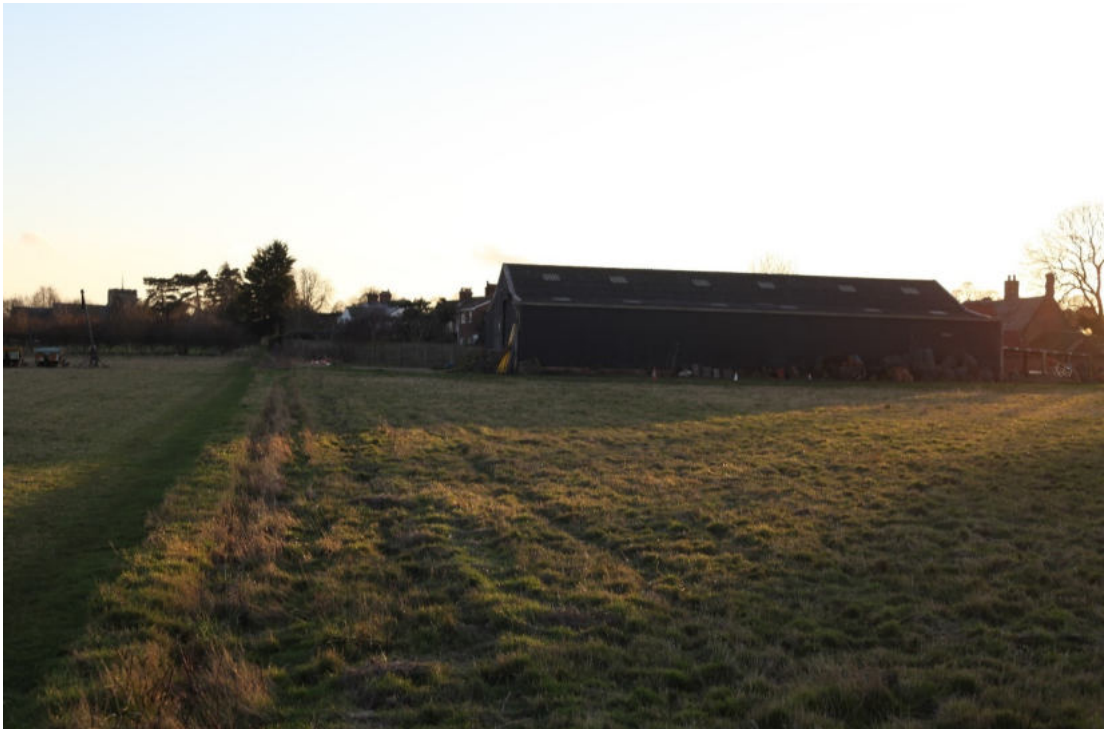
Image EDP 2.2: The site in its current form, taken from Parcel B looking south towards Roxton.

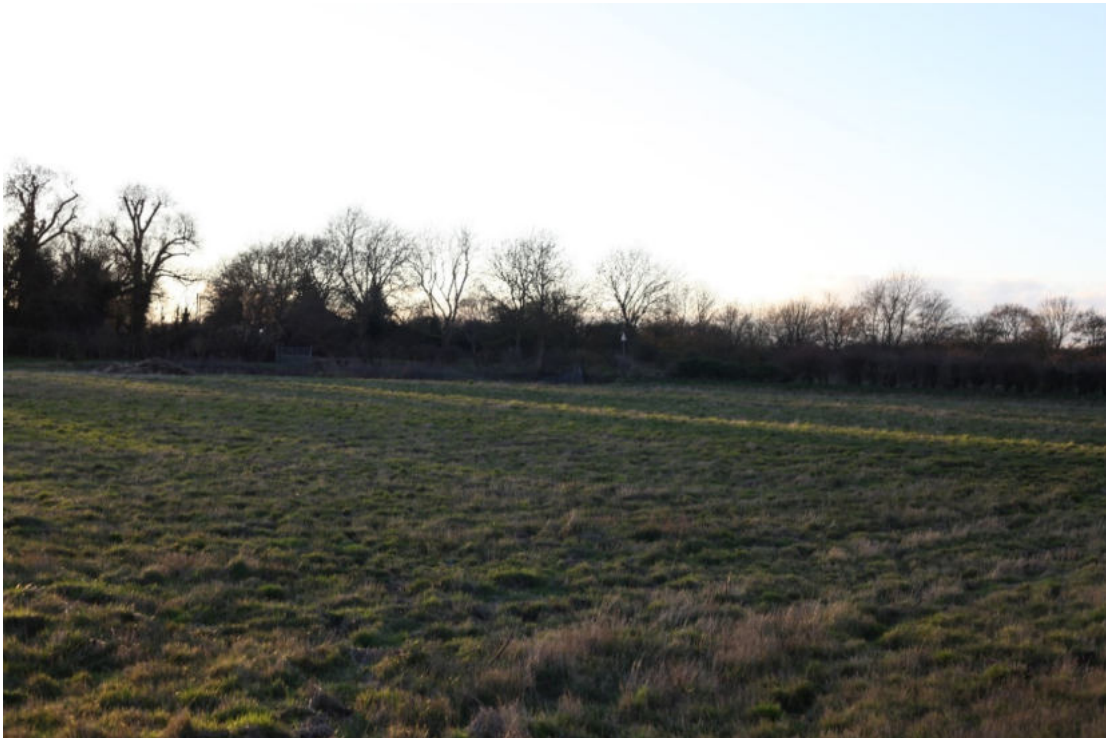
Image EDP 2.3: The site in its current form, taken from Parcel B looking west towards High Street and Bedford Road.

- 2.24 The Western boundary is contained by a native hedgerow, which is low (less than 2m high) and gappy, showing signs of poor management and constant flail cutting at the same height. The high street to immediately adjacent to this boundary is slightly elevated affording clear views over the hedgerow into the site, and onto the wider landscape beyond.

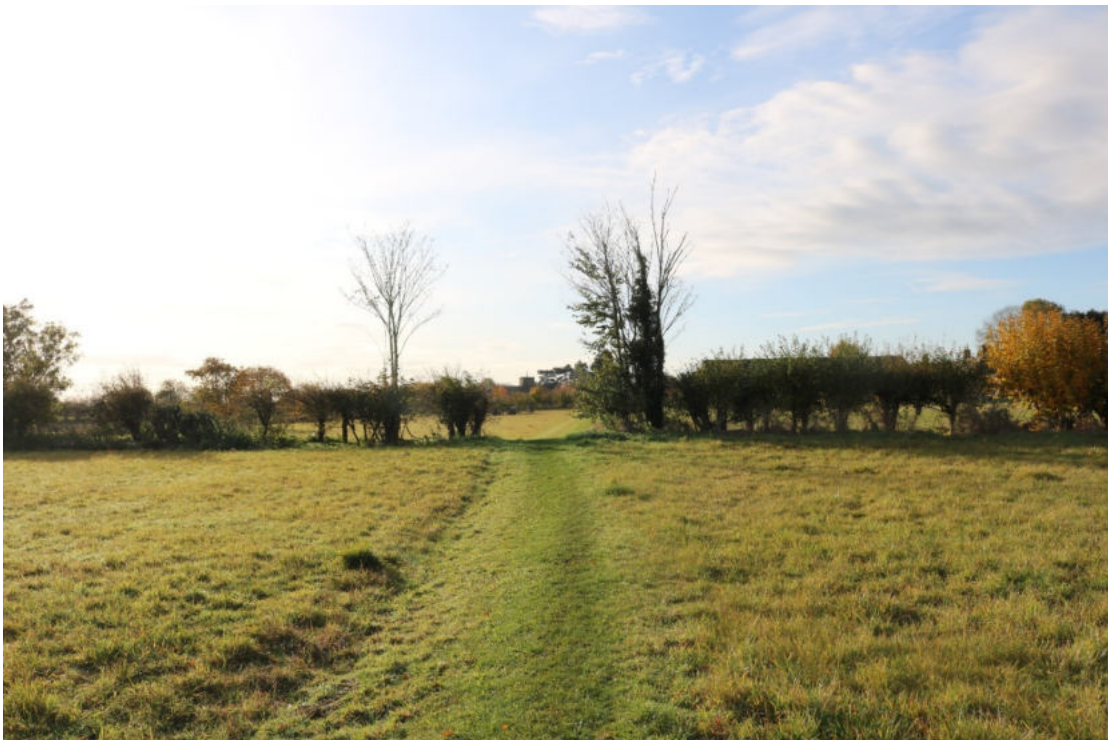
Image EDP 5.2: View from footpath within Parcel A, looking south toward the tower of the Parish Church of St Mary Magdalen.

- 5.10 In terms of Parcel A, there is a PRoW that runs north–south through the eastern half of it. From this, there are medium distance views toward the church tower. Indeed, given that this pathway leads up to a point opposite the church on School Lane, it is plausible that the footpath is aligned on this locally distinct feature. This footpath appears to be a relatively recent creation, only being attested to on late 19th century cartographic sources. As such, this footpath and the approach to the church is considered to make an, albeit very limited, contribution to the significance of this listed building (see **Image EDP 5.2**).

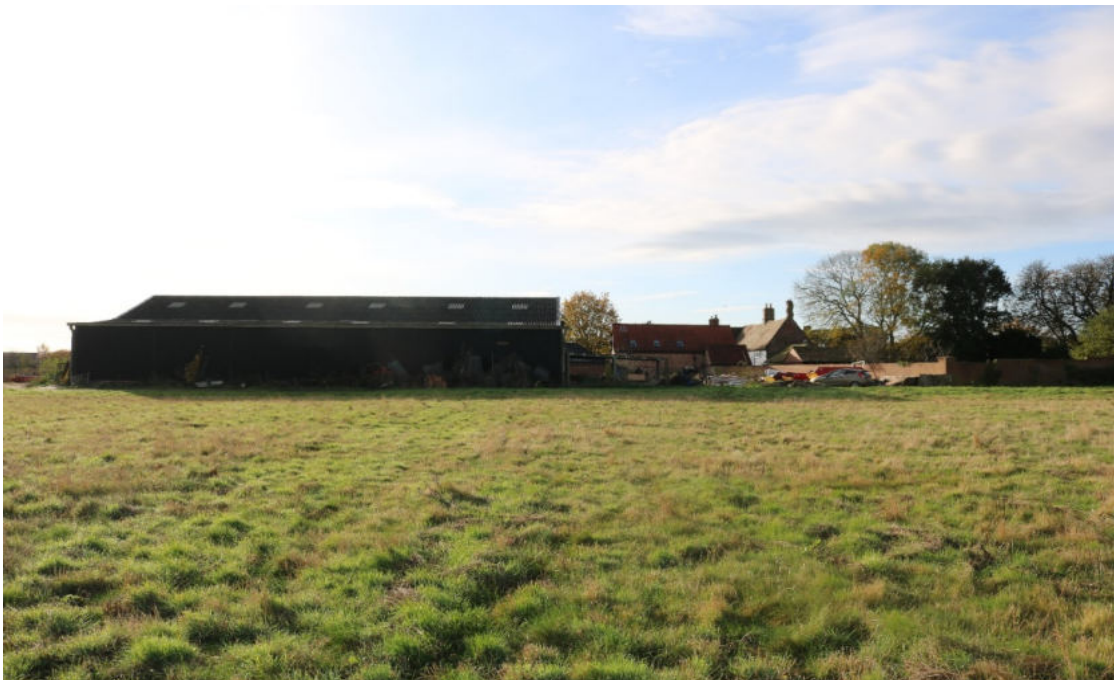
Image EDP 5.3: View from south of Parcel A, looking south toward modern farm barn and College Farmhouse (seen on right, building with chimney stacks).

- 5.16 The Roxton Parish Map of 1813 suggests that the southern field in Parcel A was functionally associated with the farmhouse, but that the northern field was at that time not. However, it should also be considered that this relationship with the southern field is not current today, with the farmhouse no longer the functioning hub of a farm. Furthermore, other than proximity, there is little tangible evidence of this link, with the visual links obscured and physical links severed (if there ever were any) between the two, as described above. Therefore, the contribution of Parcel A to the significance of the farmhouse is considered limited/moderate and deriving almost entirely from the southern field in its former historic and functional links and in limited visual links.

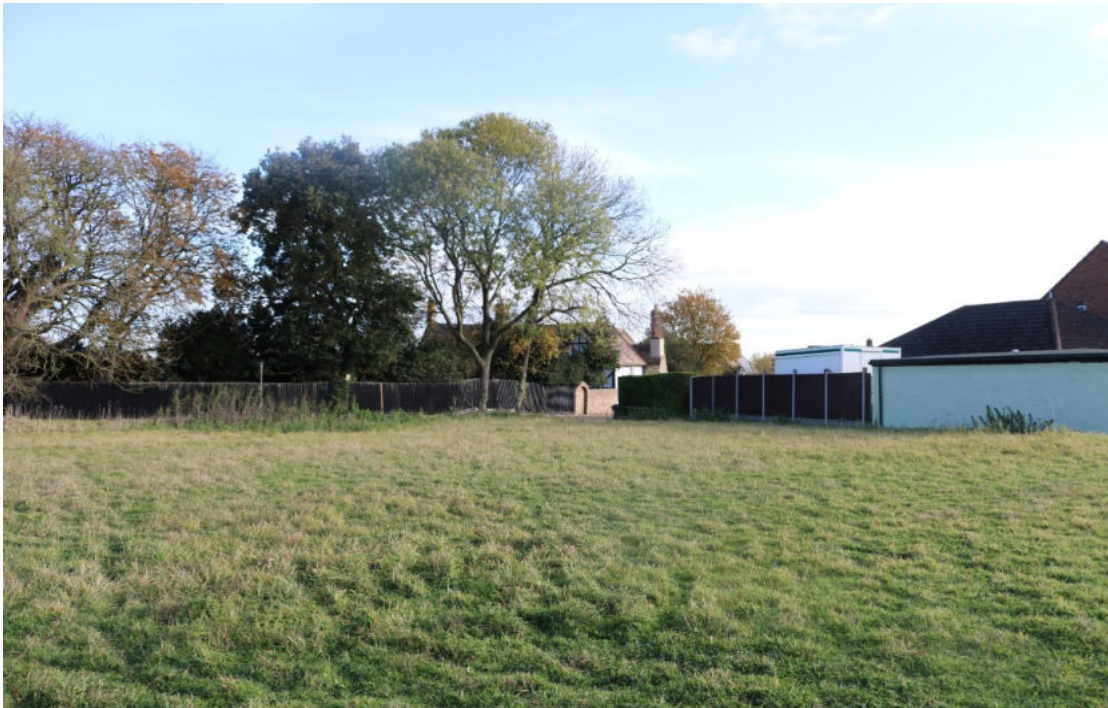
Image EDP 5.4: View from north west corner of Parcel B, looking north toward College Farmhouse.

- 5.18 There is a limited appreciation of the farmhouse from Parcel B due to the built and planted environment. Nevertheless, Parcel B also contributes to the significance of the farmhouse by forming an area of farmland providing rural context in close proximity to the listed building, also considered to be a very limited contribution.

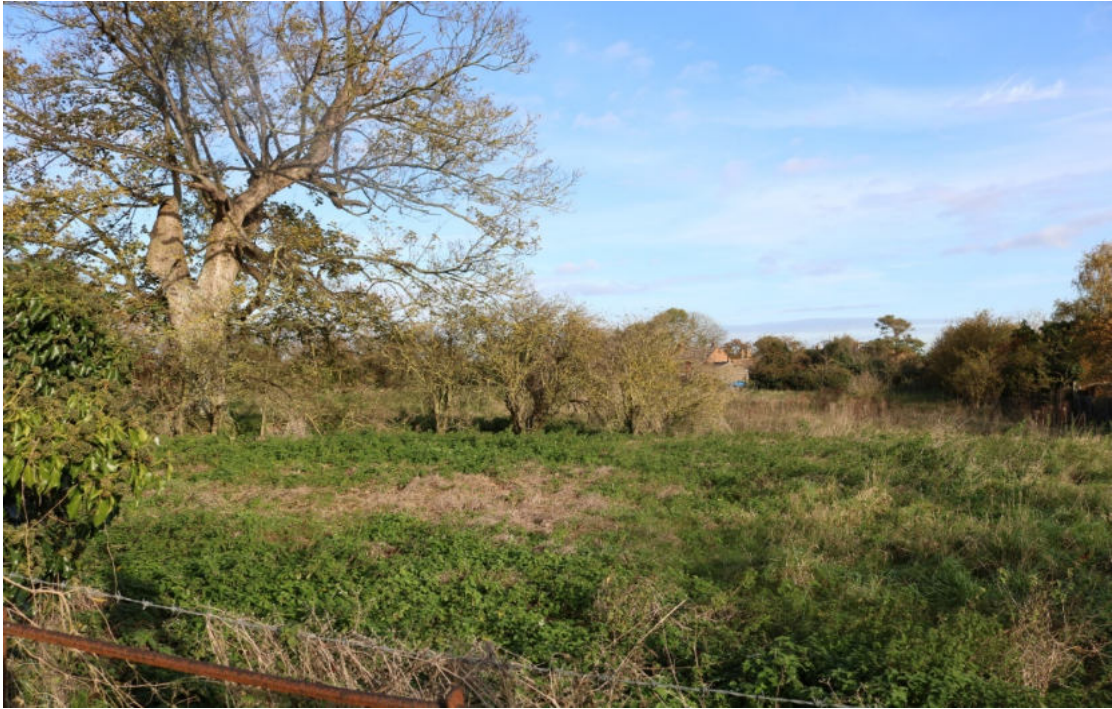
Image EDP 5.5: View from Park Road looking north, across a scrubby paddock within the conservation area, beyond which is Parcel B.

arranged in a mixture of single plots adjacent the road and set back, and in cul-de-sacs. Along the north end of the High Street in particular, this has created a densely packed and closely spaced built environment, with few views into the farmed landscape beyond. One of the exceptions of this enclosed character along the roadways is from Park Road, where the sparsity of boundary planting allows views into a scrubby paddock within the conservation area, beyond which is Parcel B (see **Image EDP 5.5**).

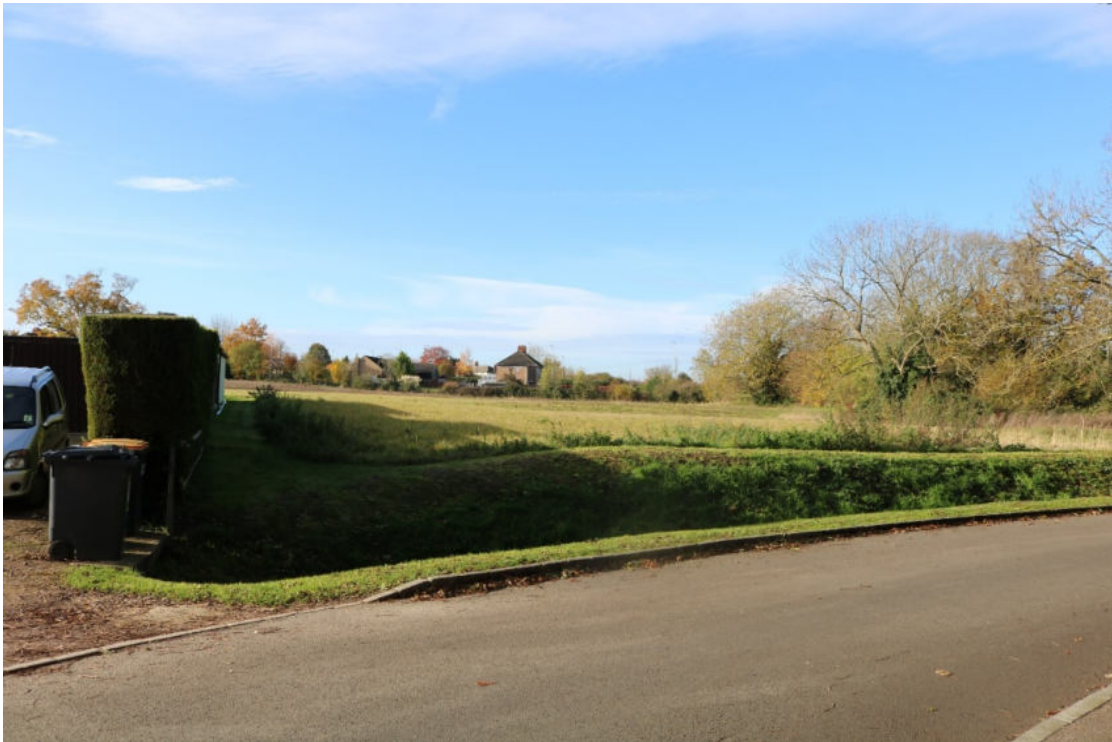
Image EDP 5.6: View from the north end of the High Street, looking south across Parcel B. Note modern housing on its boundary.

- 5.24 In terms of Parcel B, only a small part of this is included in the conservation area, formed by a gravel track that leads from the High Street to a modern poultry shed within the eastern edge of Parcel B. Otherwise the majority of Parcel B is outside of the asset and is mainly experienced through glimpsed views, filtered through the planted and built environment, with the clearest views from the very north end of High Street (see **Image EDP 5.7**) and part of Park Road (see **Image EDP 5.5**), where boundaries are more permeable. In terms of these views, Parcel B is appreciated as an area of grassland enclosed by mainly 20th century development and cut off from the wider landscape.
