# Phase I DESK TOP STUDY REPORT

Site at Heddings Farm, The Lane, Wyboston. Bedford MK44 3AS

> June 2019 Report No. 15441

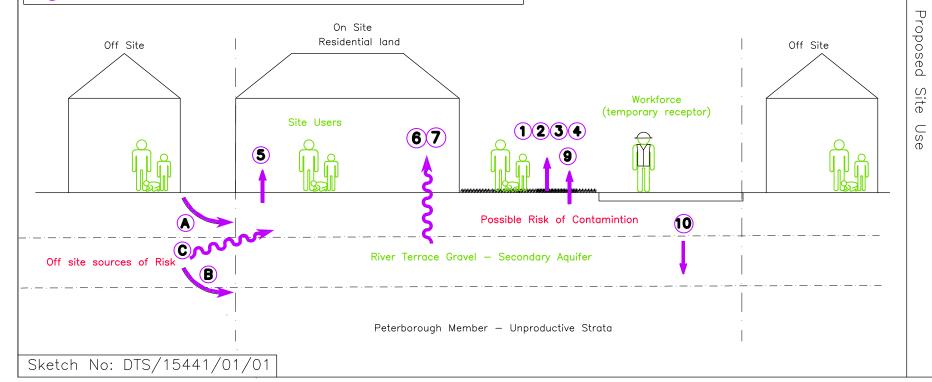
#### <u>Key</u>

Purple=Possible pathways
Green =Possible receptors
Red =Possible sources
