Bedford River Valley Park, Bedford

Historic Environment Desk-Based Assessment

CA Project: MK0431

CA Report: MK0431_1

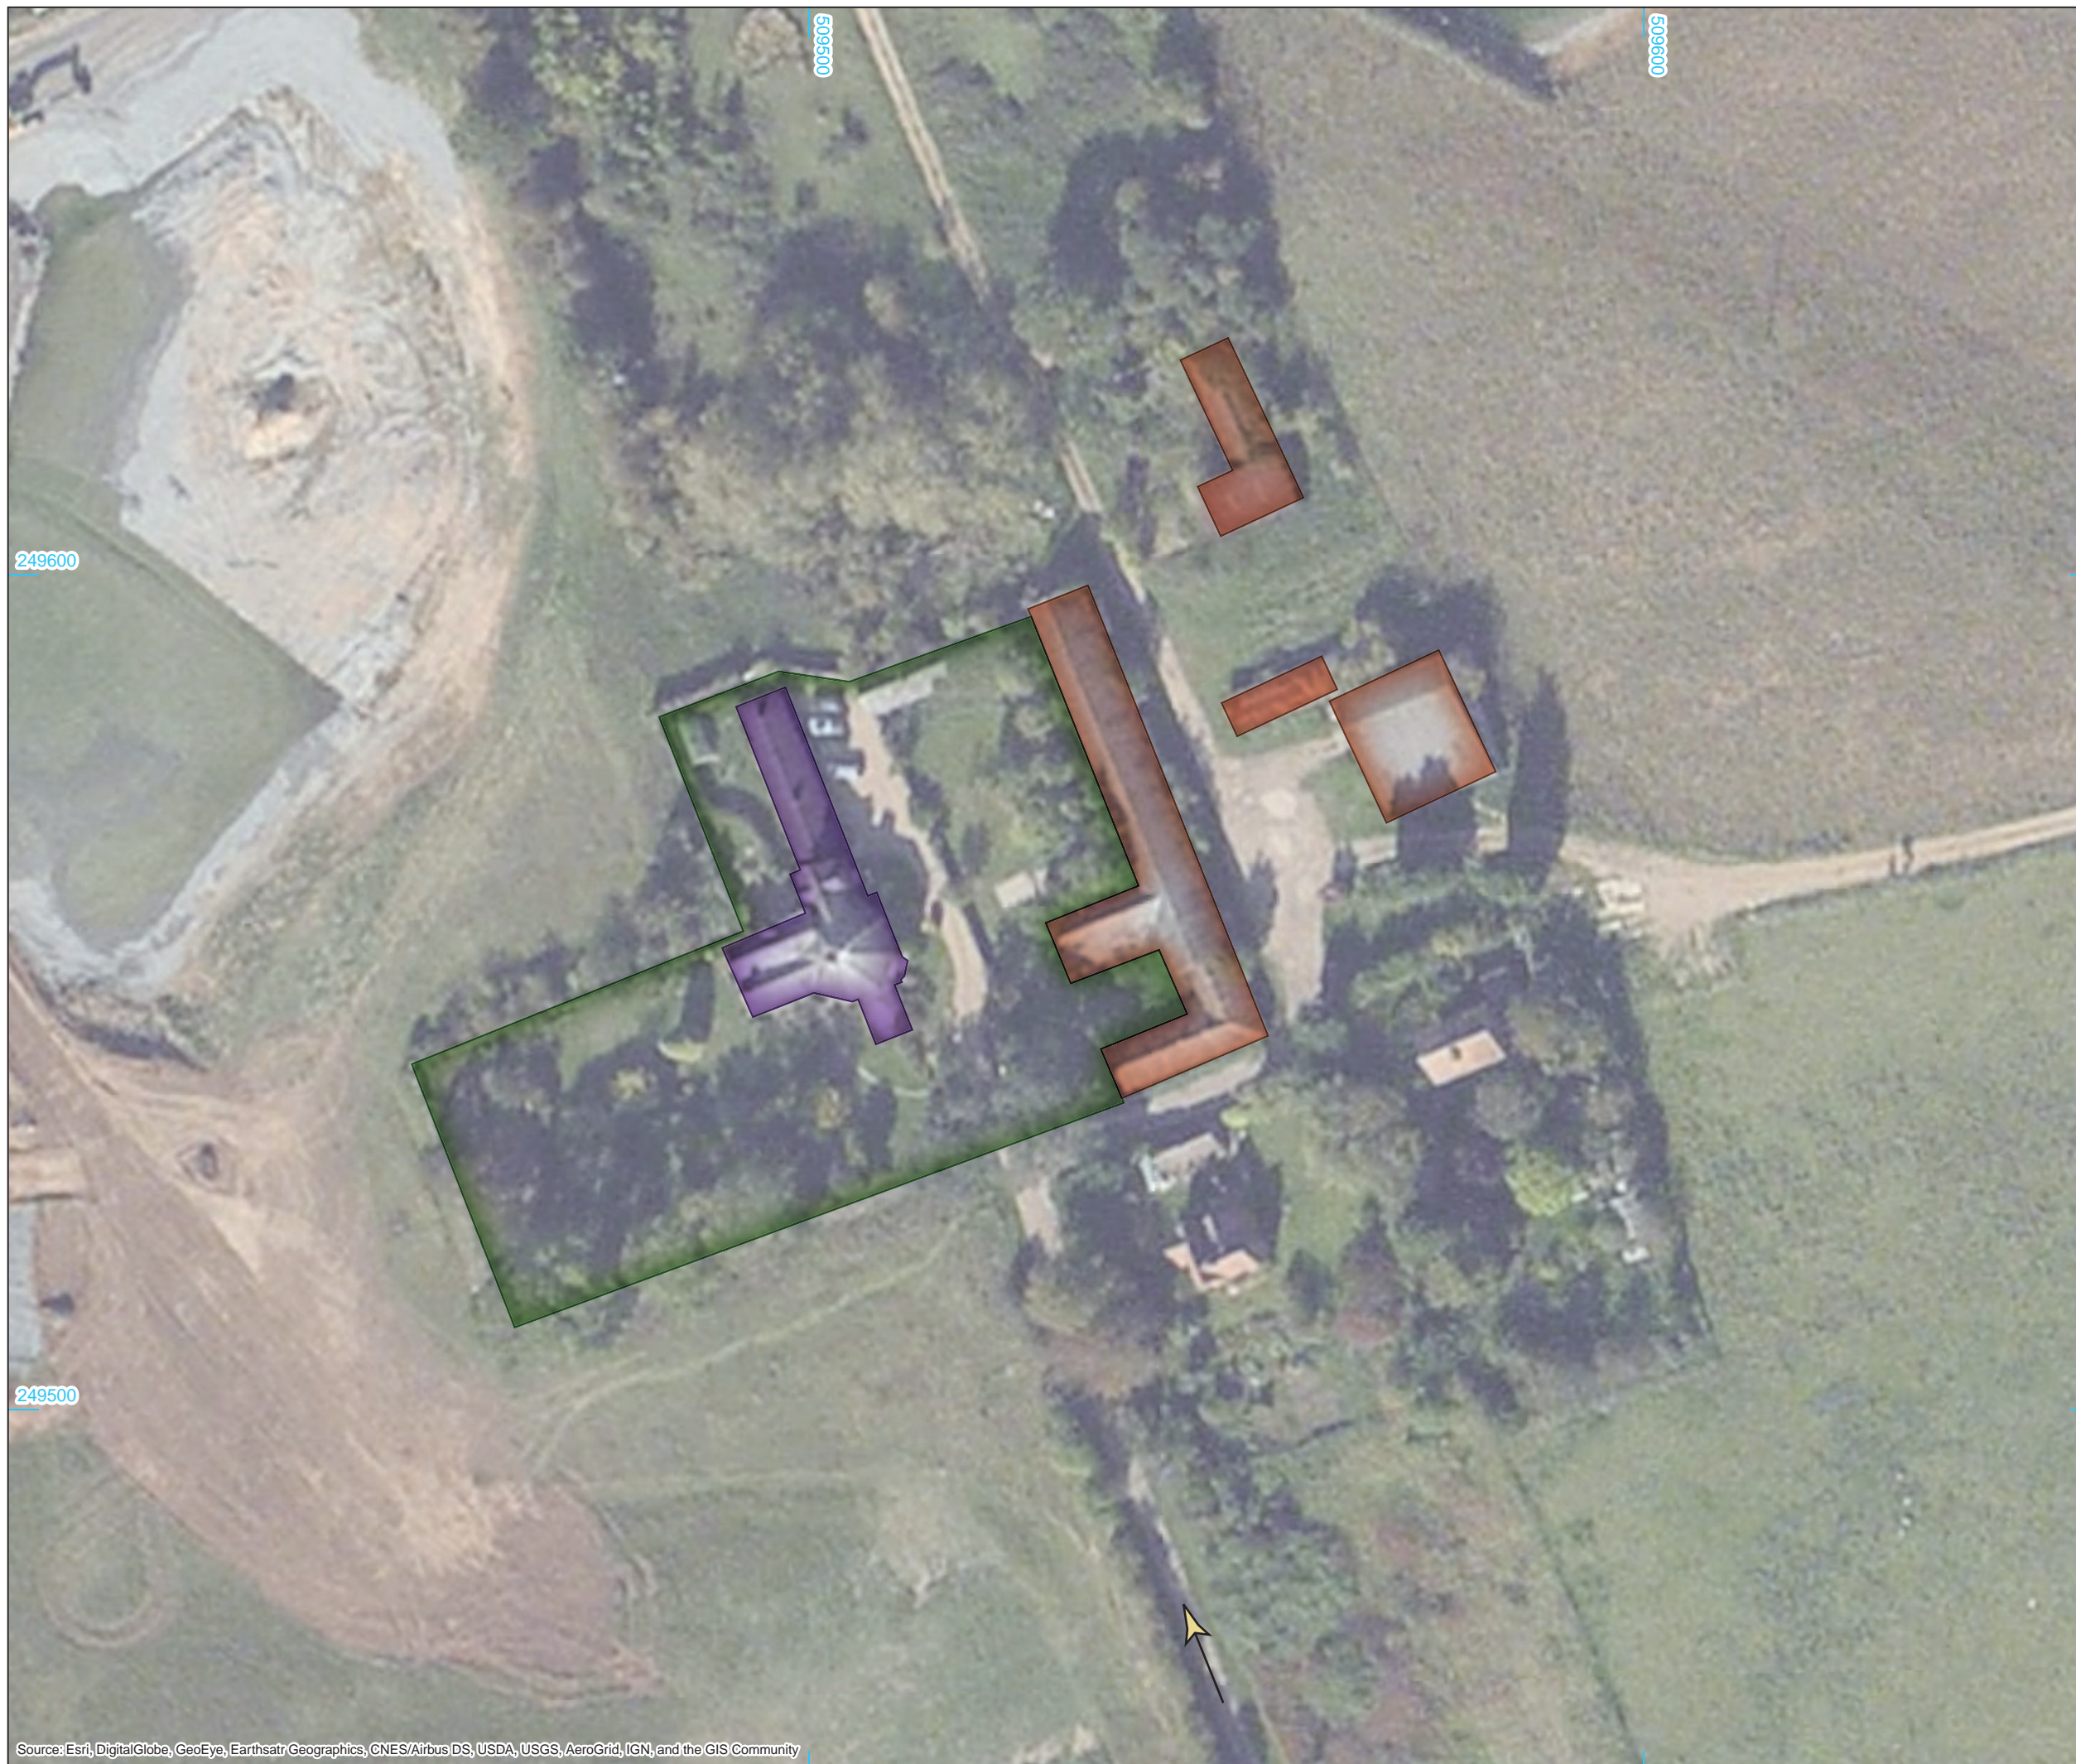
- Octagon Farm
(Grade II Listed Farmhouse)
- Farmhouse Garden
- Redundant farm building
- Intended view down main
driveway towards The Octagon

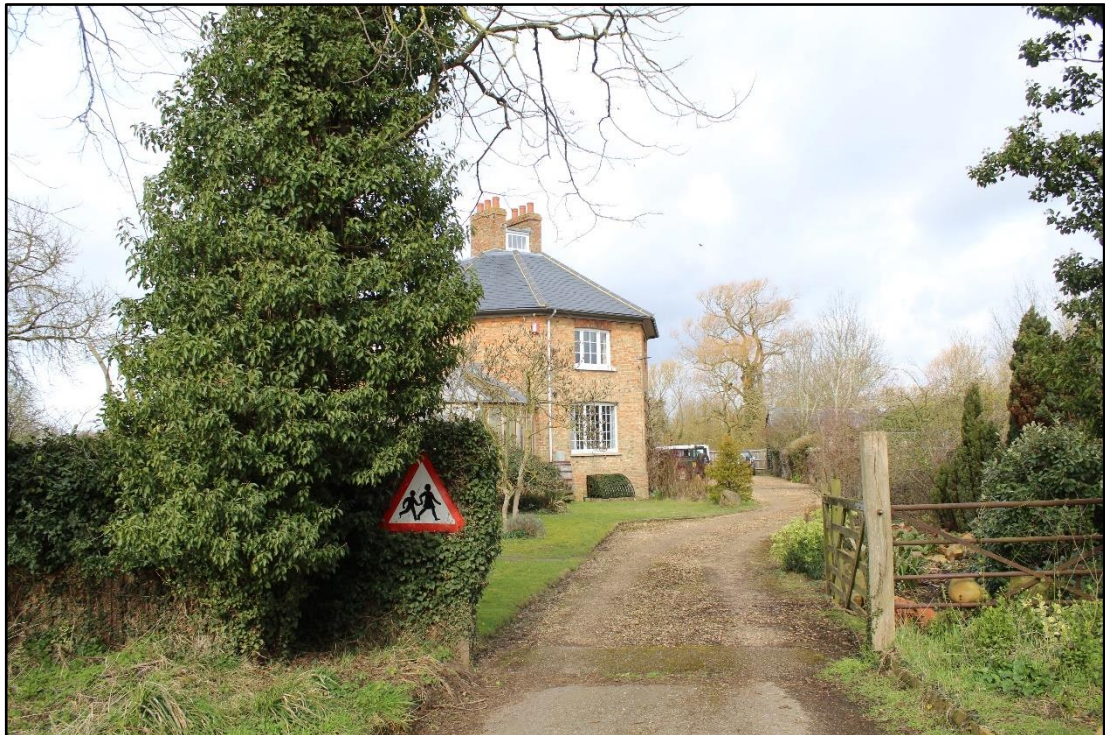
Photograph 1. Octagon Farmhouse, taken from the driveway to the farm, looking north west.

5.12. As emphasised in the above description, the octagonal main block is the principal contributor to its heritage significance due to its unusual design. This part of the building appears to have been constructed primarily for its aesthetic value. The Octagon was intended to be the focus of this farm, and its position at the end of the straight driveway emphasises this – this would have been the first part of the farmhouse a visitor would have seen as they approached the farmhouse from Bedford Road. With this in mind, it is considered that the significance derives from the aesthetic value of the building, and less so from its historical use as a farmhouse.

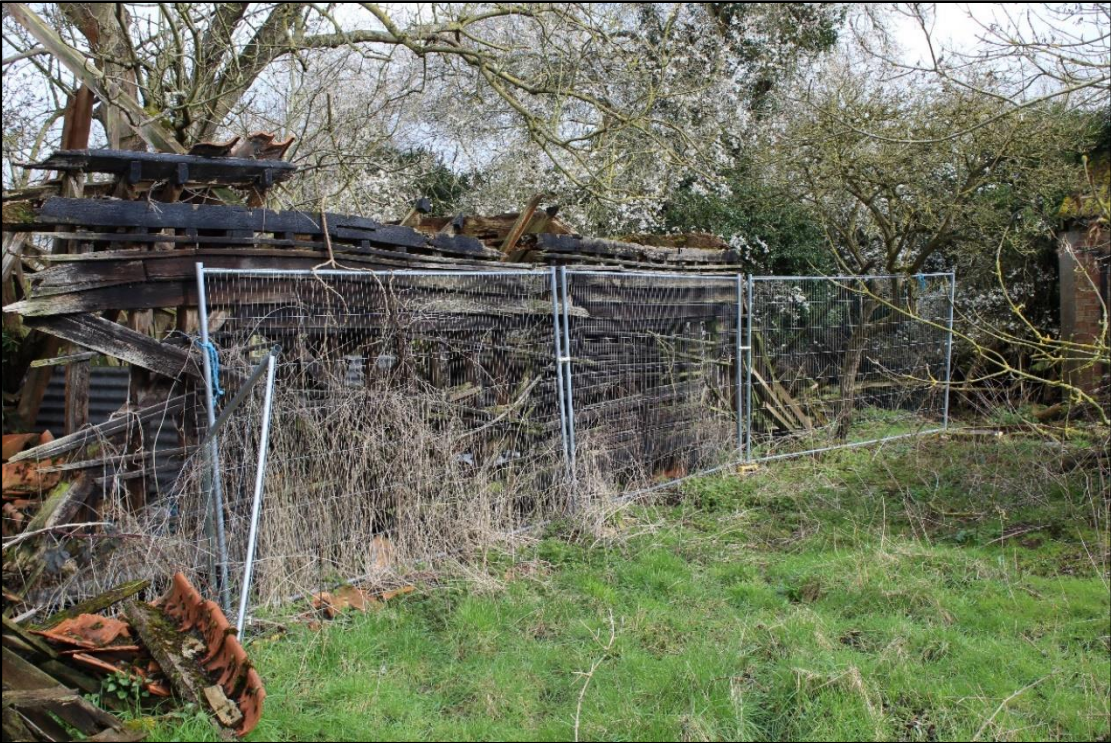
Photograph 3. Burnt out granary.

5.14. The land the farmhouse is located on is currently owned by Bedford Borough Council, and Octagon Farmhouse is rented to tenants who have occupied the property for at least fifteen years. These tenants do not farm the landscape. A range of farm buildings are located in a courtyard to the east of the farmhouse, and comprise barns, stables and other agricultural buildings, but all of these buildings are in a very poor state and many are fenced off. A probable eighteenth to nineteenth century granary located in the northern part of the courtyard has burnt down.

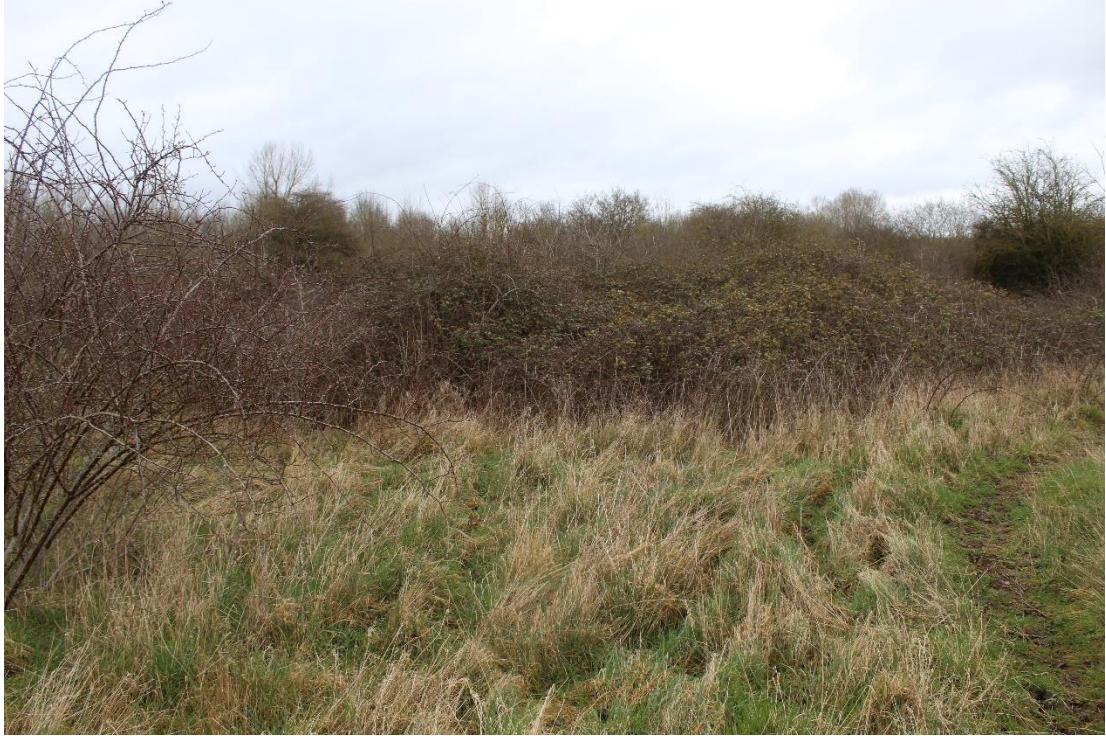
Photograph 5. View of 'Two Barrows 500m NE of Octagon Farm', a Scheduled Monument (CA Ref: 2)

5.25. As shown in Photograph 5, ‘Two barrows 500m NE of Octagon Farm’, located on the Site’s boundary, is no longer visible at ground level. The monument was first identified as a series of cropmarks on aerial photographs and its presence was confirmed by a geophysical survey which suggests some level of preservation of archaeological remains below ground. ‘A barrow 400m north of Octagon Farm’ is also no longer visible at ground level.

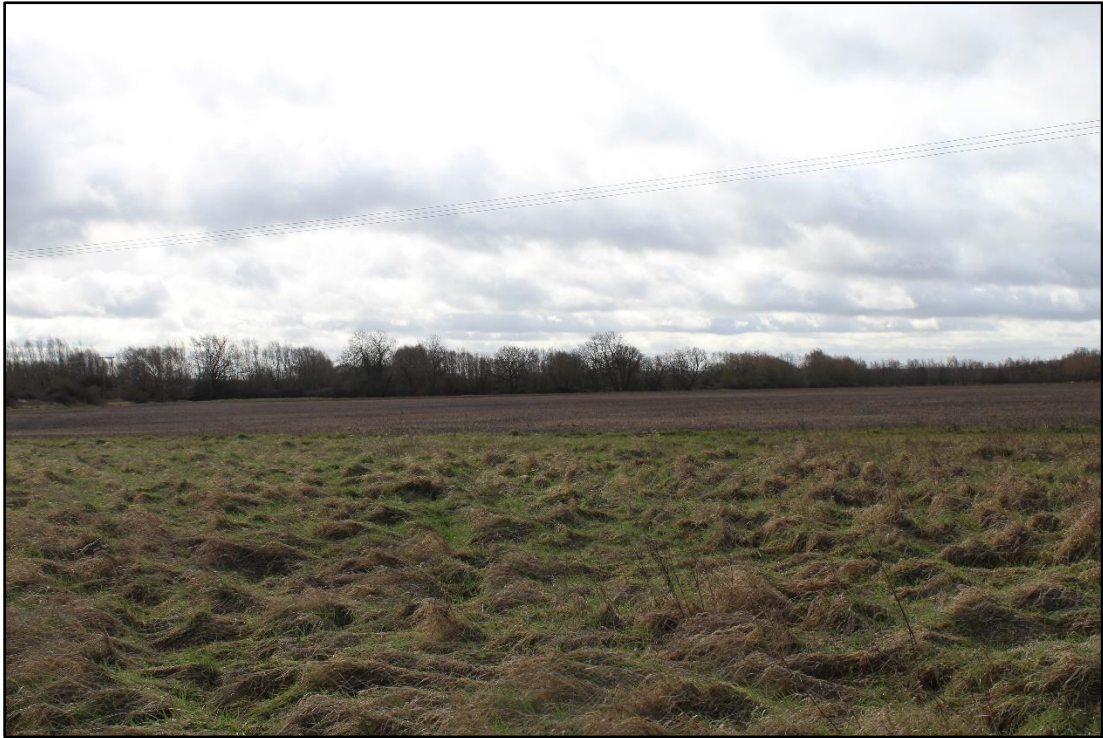
Photograph 6. Neolithic and Bronze Age mortuary complex 600m NW of Octagon Farm (CA Ref: 4)

- 5.26. 'Neolithic and Bronze Age Mortuary Complex 600m NW of Octagon Farm' does contain some cut features which are visible at ground level, though no barrow mounds survive.
