SITE 883 LAND AT TWINWOODS BEDFORDSHIRE HERITAGE IMPACT ASSESSMENT

Document Title	Heritage Impact Assessment
Prepared for	iSec and Bedfordia
Prepared by	TEP - Market Harborough
Document Ref	8699.001

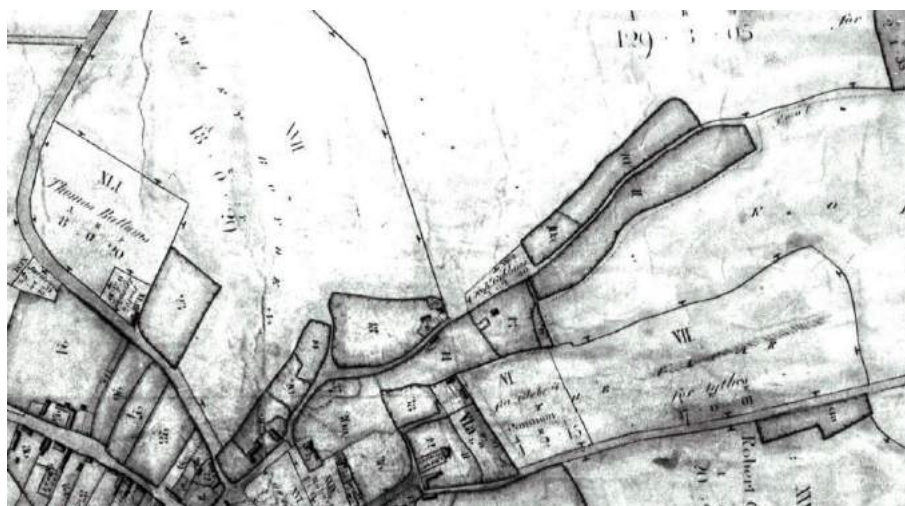
Figure 2: Extract of the inclosure map for Milton Ernest [MA16/2] showing the edge of the village fields within the north-west edge of the site boundary © Bedfordshire Archives

- 4.48 The inclosure map for Milton Ernest dated to 1803 (Figure 2) records the earlier settlement to be clustered around Radwell Road, Bedford Road and Rushden Road. Within the boundary of the site to the north of Milton Ernest, there are a number of enclosures to the north side of Rushden Road which are no longer extant, but can be partly seen as cropmarks on aerial imagery. The Grade II Listed Building of Stone Cottage can be seen on the map within the site boundary, as well as a number of enclosures containing buildings no longer extant in this area, most of which are now part of the Scheduled Monument of the Shrunken medieval village at Milton Ernest, Bedfordshire

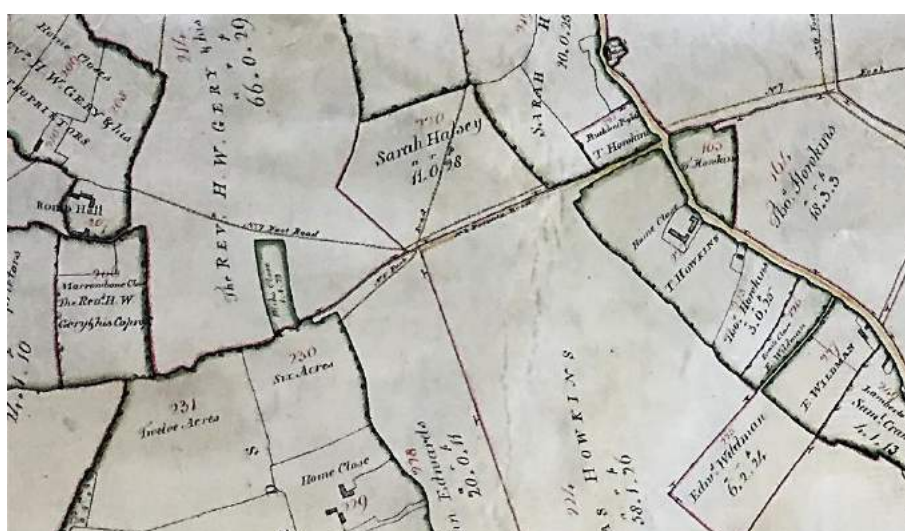
Figure 3: Extract of the inclosure map for Thurleigh dated to 1808 [WG954 (MA47/3)] showing the north-east edge of the site boundary. Rutter's Farm is in the lower centre of the image, Romp Hall is seen to the western edge and Waterfall Farm and 8 Mill Road are to the east side. © Bedfordshire Archives

4.49 The inclosure map for Thurleigh dated to 1808 (Figure 3) [WG954 (MA47/3)] records the field pattern at the north-east edge of the site boundary close to Thurleigh. Farmstead settlement along Mill Road, including the Grade II Listed Buildings of Waterfall Farm, 8 Mill Road is seen to the east, the barns at Rutter's Farm are seen to the southern edge and Romp Hall to the western edge. The north-east site boundary edge which is aligned with Mill Lane is seen to be extant on this map forming the edge of the enclosures marked in green along this road. Waterfall Farm is shown to be in the ownership of Thomas Howkins, who also utilised the fields to the south-west of the farm within the site boundary. Some of the field boundaries here are still extant and most likely have survived where they follow natural features such as the watercourse which crosses or are still mark out property boundaries where the dwellings or farm are still in use.

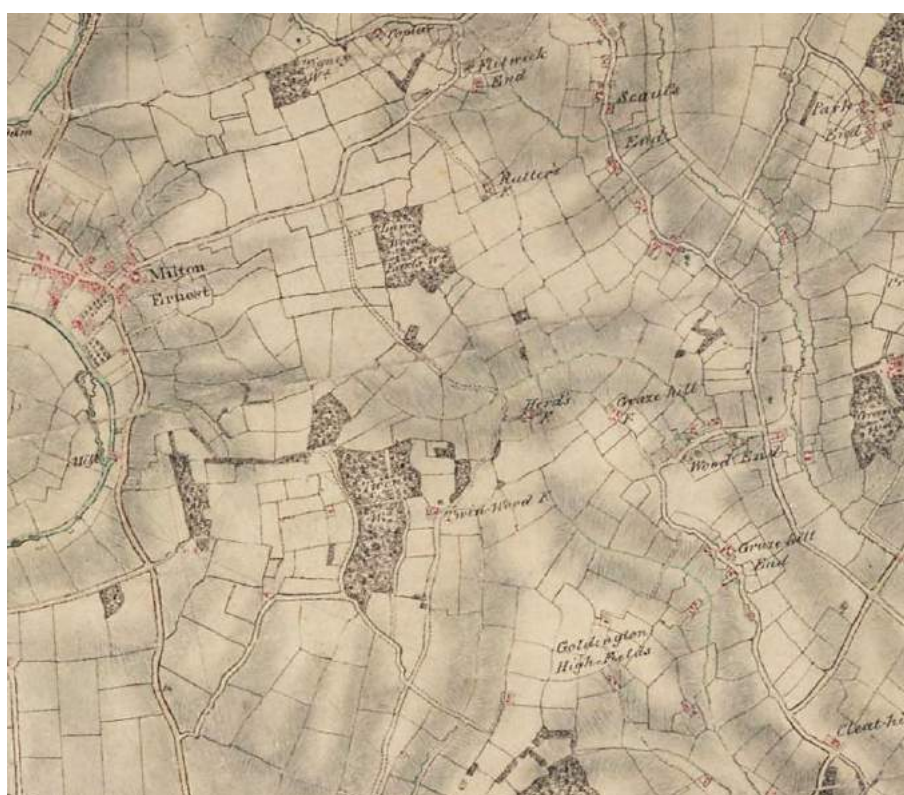
Figure 4: William Hyett's Map of Lancashire 1815 © The British Library

- 4.50 William Hyett's Map of Lancashire 1815 (Figure 4) records the site as within a landscape of regular and irregular fields interspersed with parcels of woodland. Wigney Wood is present in the north, however it was at this time within a large square enclosure, since bisected by Thurleigh Road. To the south-west of Rutter's Farm are two square parcels of woodland named Lawn Wood and Earl Wood which are now much reduced and named Yarl's Wood. A number of farmsteads are also shown to be extant by this time including Rutter's Farm, those along Mill Road, Wood End and Graze Hill to the east and south-east and Twinwoods Farm, adjacent to Twin Wood. Only the northern and southern extent of Twin Wood now survives. The hand drawn map contour lines demonstrate that the pattern of settlements, including isolated farmsteads tend at this time to follow higher elevations above valleys with a river or stream.

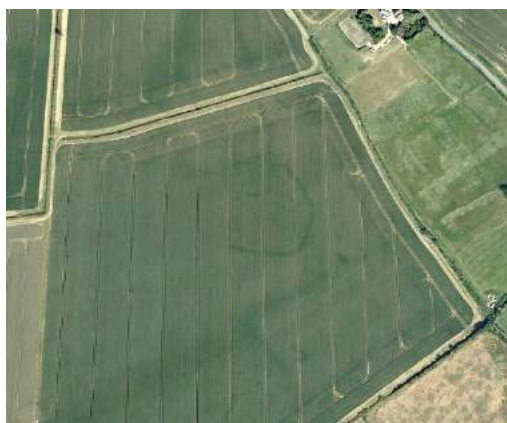
Figure 5: Possible prehistoric enclosure cropmark, east of Rutter's Farm © Getmapping Plc

- 4.63 Available aerial imagery also records cropmarks within the site and study area, including the remains of the former Twinwood Farm Airfield, earlier field boundaries to the north of Milton Ernest, possible prehistoric enclosure cropmarks east and west of Rutter's Farm, areas of ridge and furrow remains at Milton Ernest and a number of palaeochannels across the site, which represent the remains of historic watercourses, no longer extant.

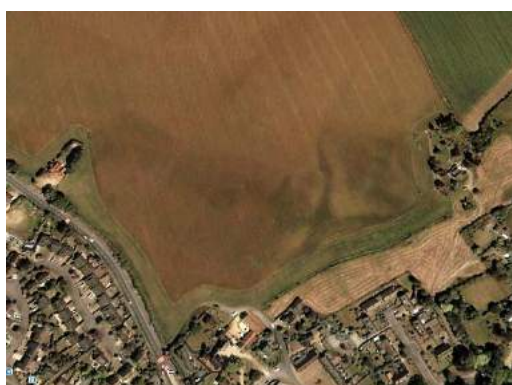
Figure 7: Medieval to post medieval village cropmarks north of Milton Ernest © Getmapping Plc
