**Archaeological and
Heritage Assessment**

November 2019
Report Reference
edp5721_r001a

- S1 This Archaeological and Heritage assessment has been prepared by the Environmental Dimension Partnership Ltd (EDP), on behalf of [REDACTED] [REDACTED] inform planning proposals for a residential development on Land North of Barford Road, Willington, Bedfordshire.

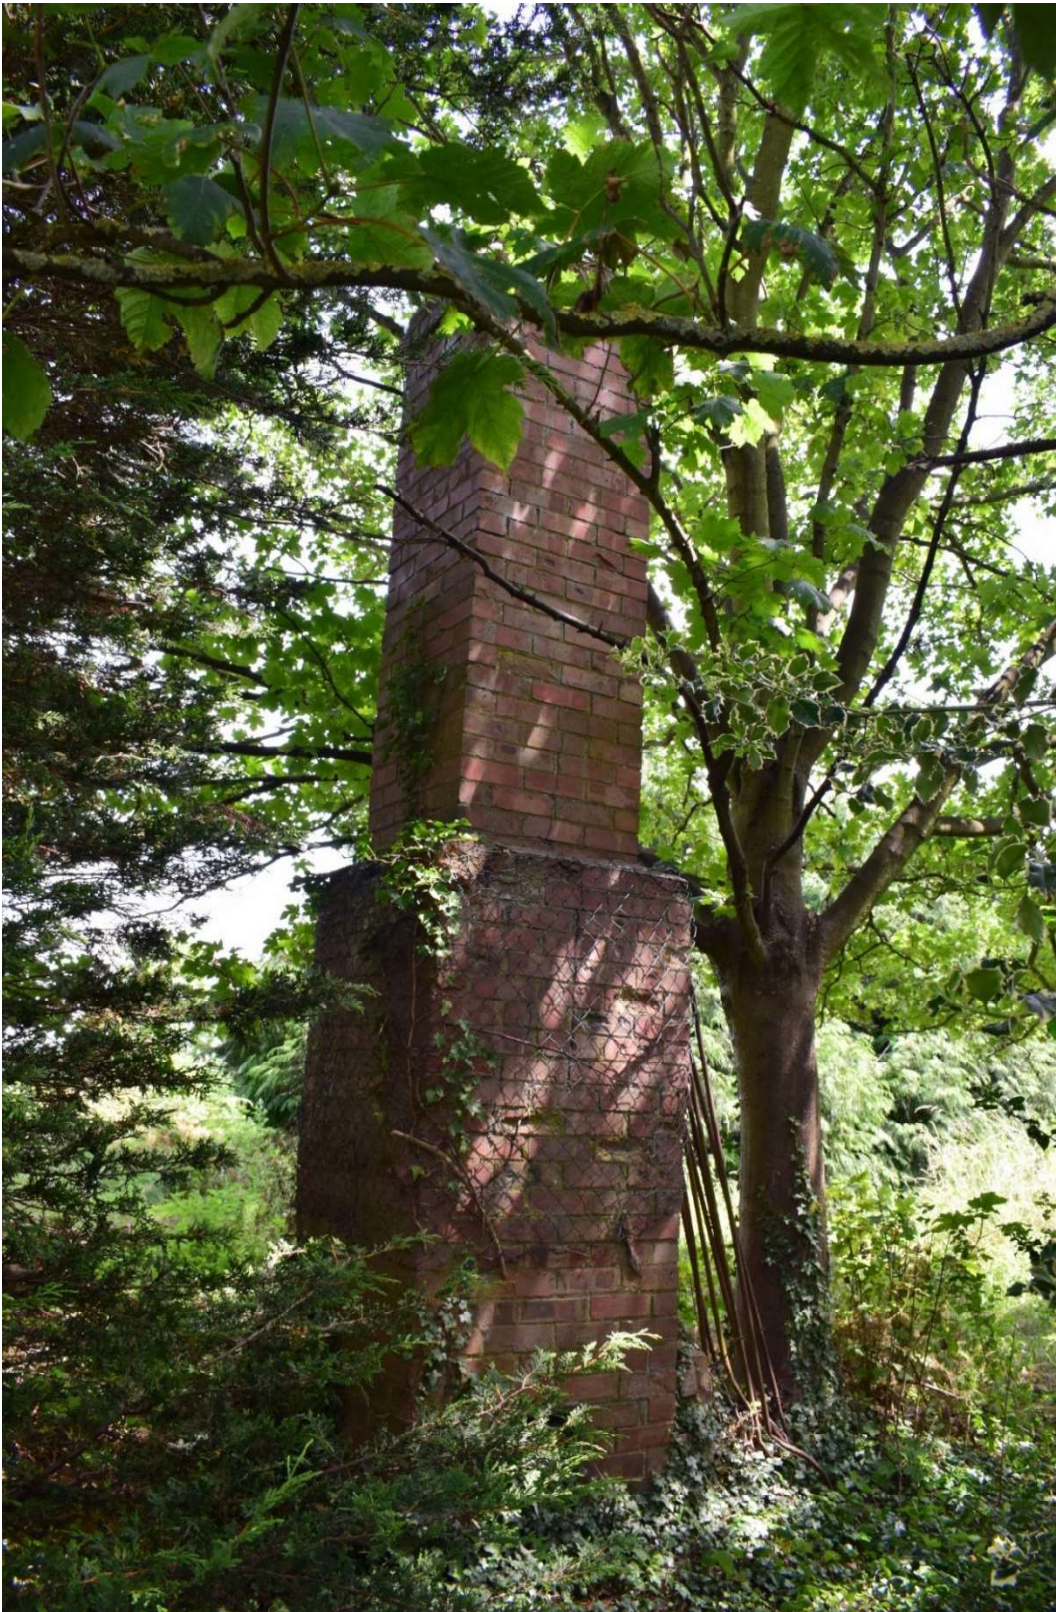
- 4.88 The site was visited in July 2019 to assess the current ground conditions and topography within it, as well as to confirm the continuing survival of any known archaeological remains and to identify any hitherto unknown remains of significance. At the time of the visit the western part of the site comprised mown grass with clumps of mature trees, with the eastern part of the site comprising tall waist high grass.
- 4.89 The vegetation on the eastern part of the site obscured any potential earthworks or features. Within the western part of the site the mown grass allowed for good visibility of the natural topography and the identification of potential earthworks. It was observed that in the south-western area one of the boiler towers (**Image EDP 1**) and foundations of the

Image EDP 1: View of a surviving boiler tower within the site. This is associated with the 20th century nursery on site.

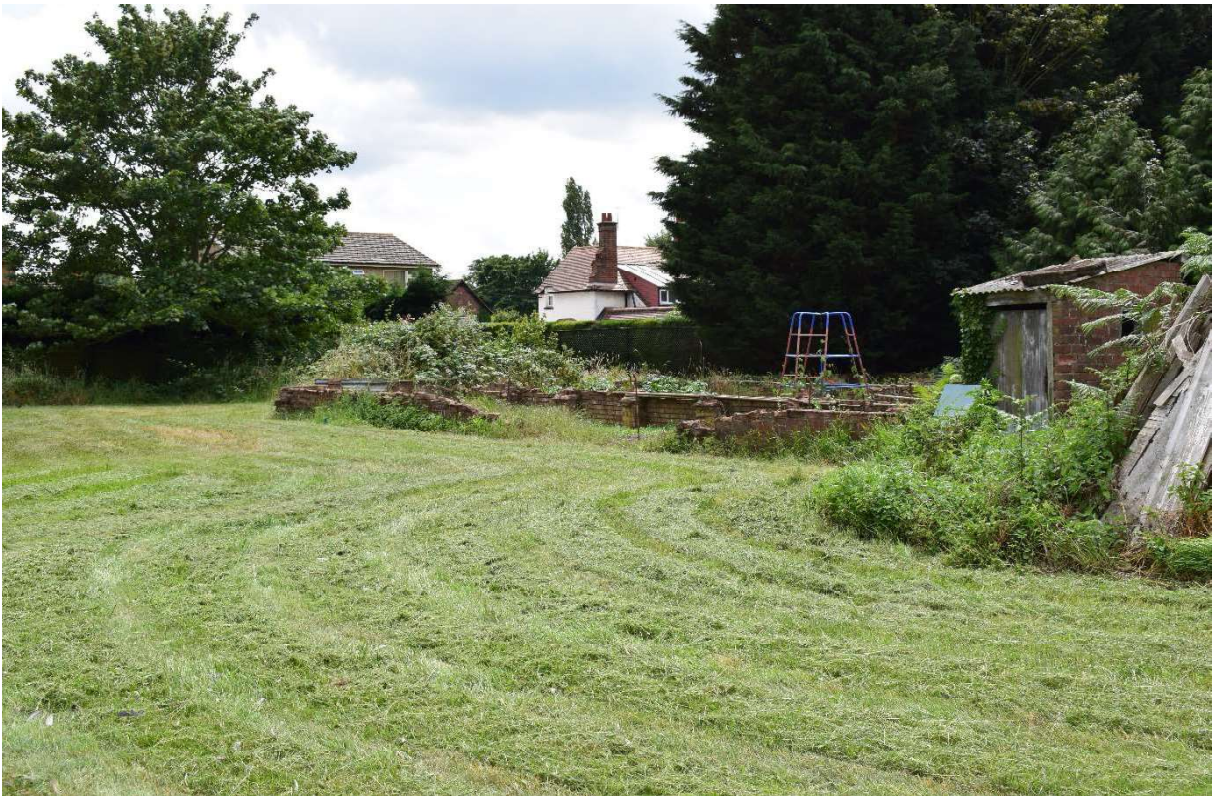
former greenhouses survived (**Image EDP 2**), along with a former outhouse and other building remains (**Image EDP 3**). These remains are relatively substantial and would have likely required some level of previous below ground works for foundations and utilities.

Image EDP 2: View of the remains of the 20th century nursery buildings within the south-western part of the site.

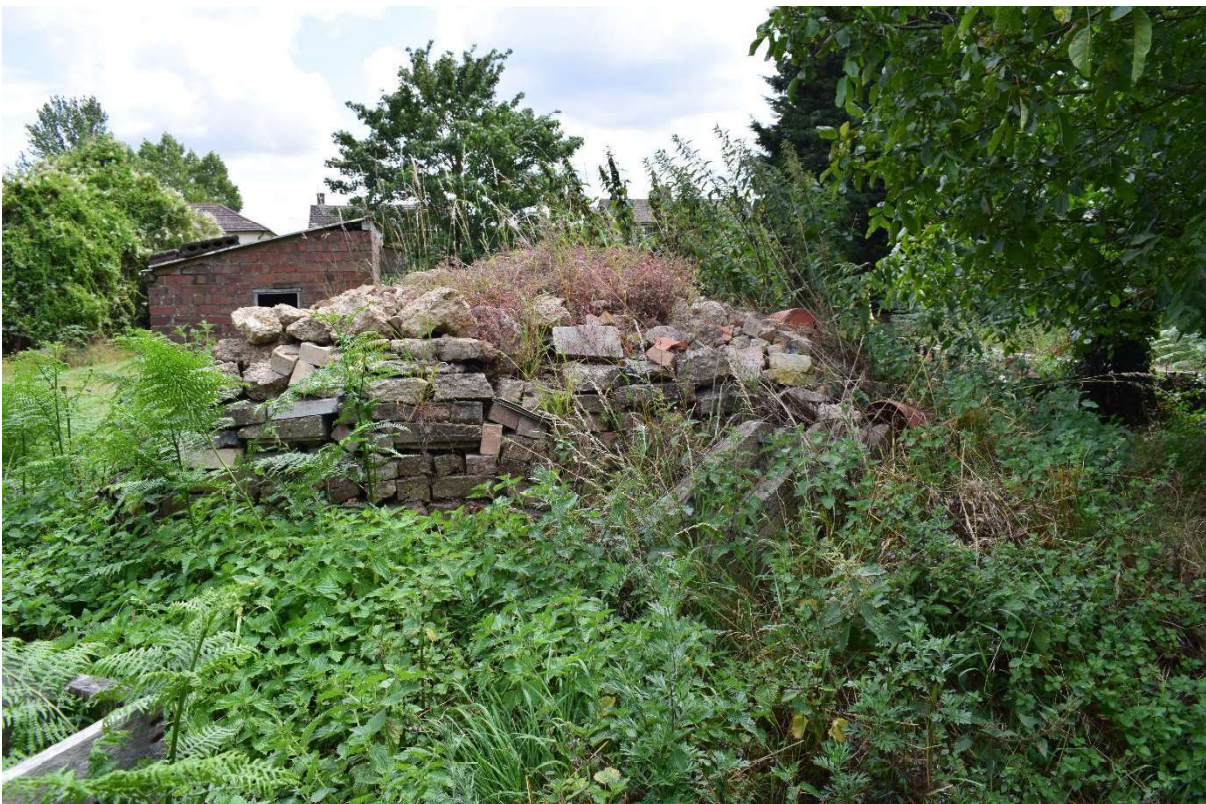
Image EDP 3: View of extant outhouse and partially extant structure within the south-western part of the site.

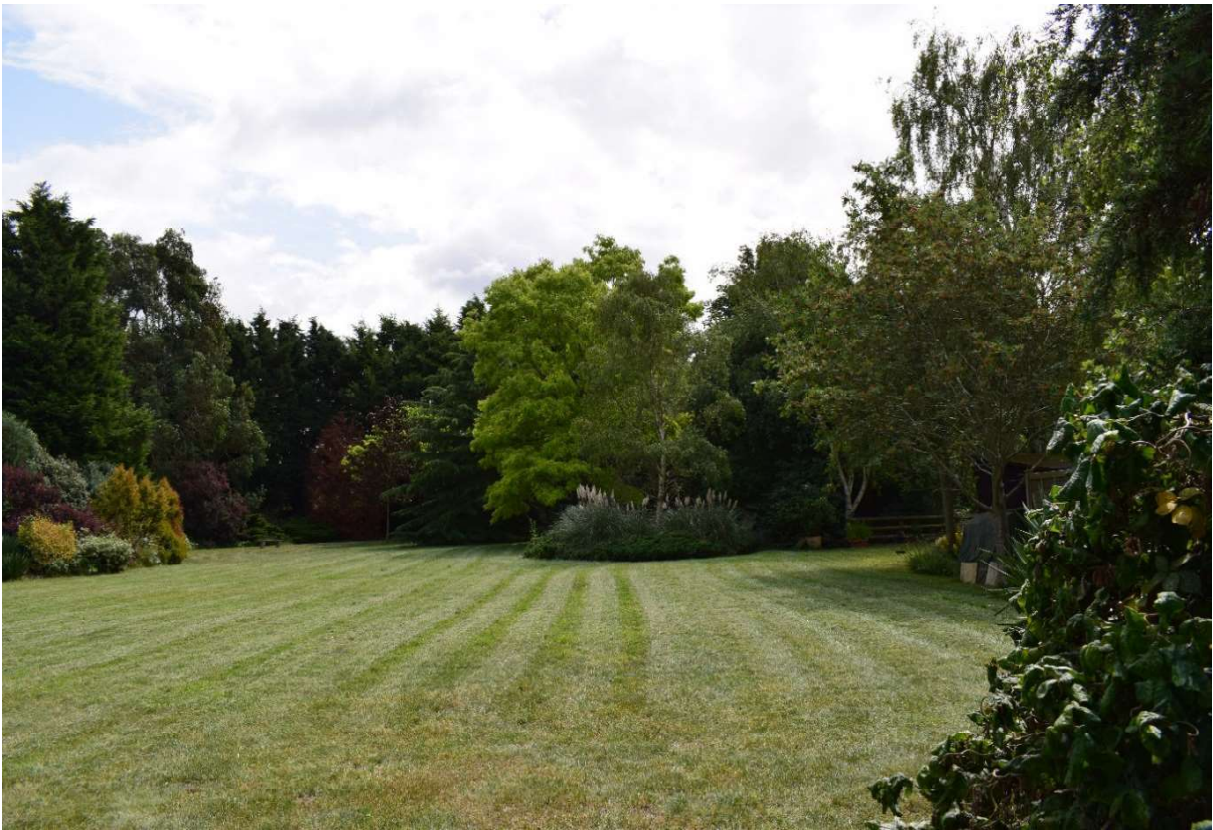
- 5.7 The tithe map (**Plan EDP 4**) shows that the site formally formed part of the land associated with The Timbers when it was White Hart Farm. By the mid-20th century, however, the site was no longer associated with The Timbers. Modern development to the north and east of the building has further disassociated it with the land within the site. It was observed during the site visit that there is no intervisibility between the site and the asset (**Image EDP 4**).

Image EDP 4: View from within the site, facing south towards The Timbers, illustrating the lack of intervisibility between the listed building and site.

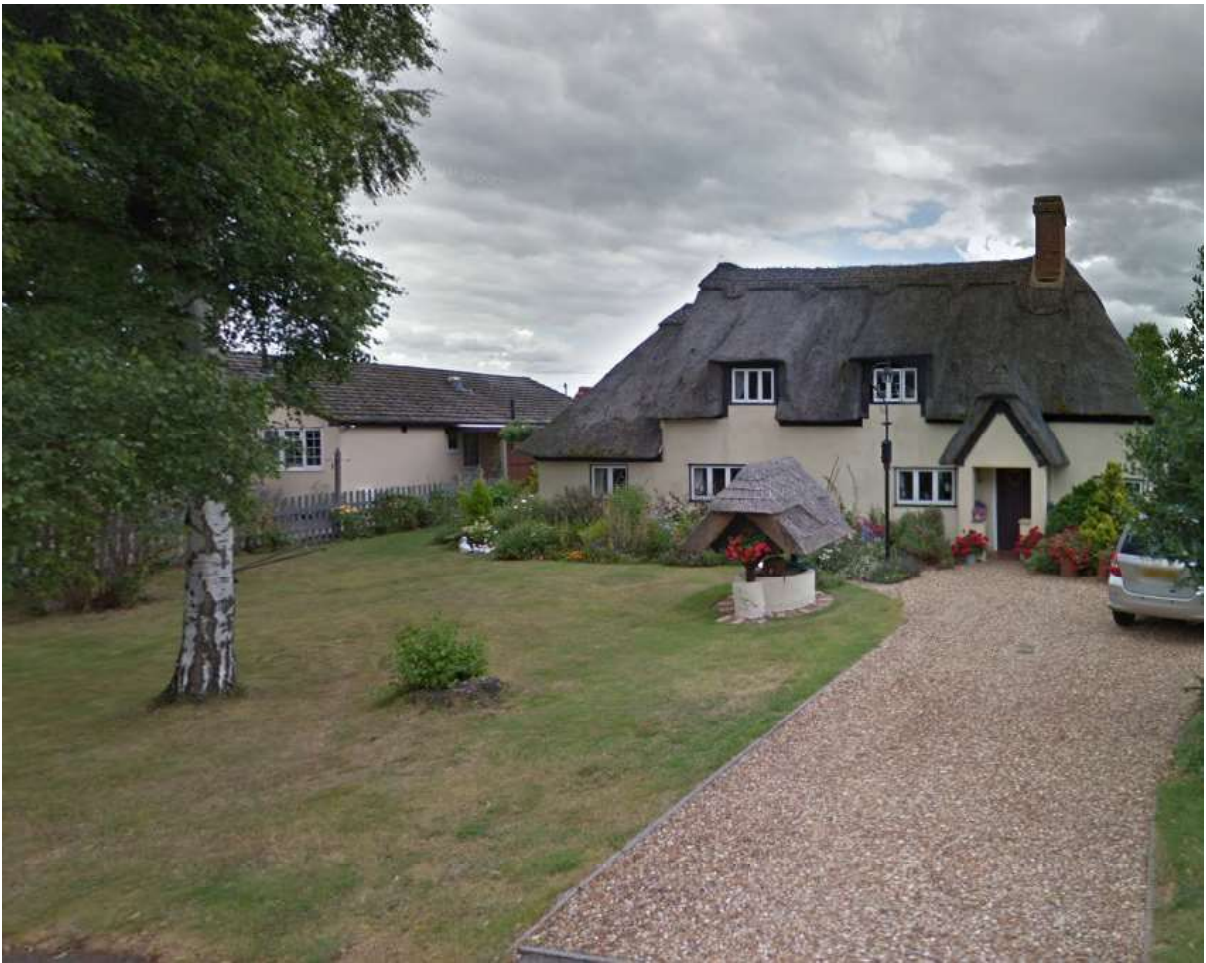
Image EDP 5: View of the Grade II listed Clumbercote house, facing east, illustrating the road side placement and front garden area.

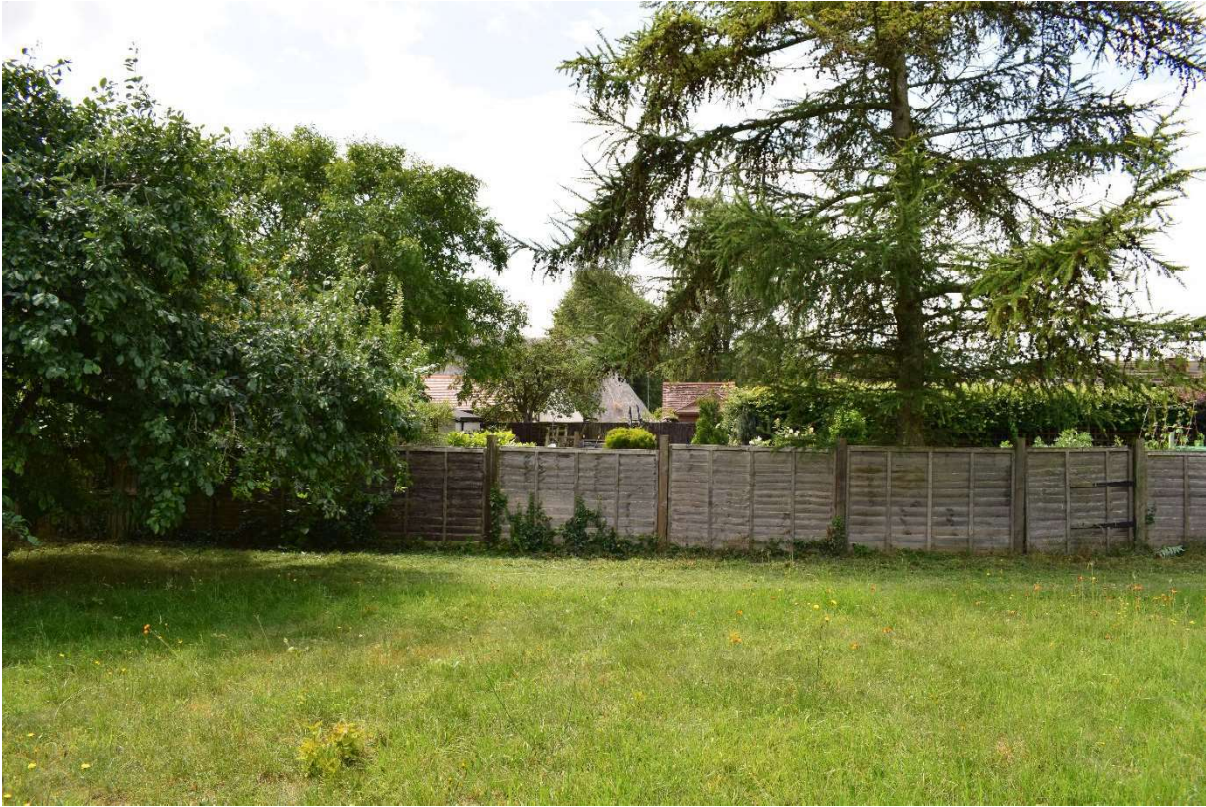
- 5.14 During the site visit it was observed that there are glimpsed views from within the site, mainly of parts the roof, of the asset. (**Image EDP 6**). However, this is within the context of the surrounding modern development, with partial screening from vegetation and does not form the key appreciation of the building's significance. The site is not perceptible in views of the asset from the west, which are limited to the trees within and bounding the site, and the area itself is not discernible (**Image EDP 7**). Furthermore, it is not considered that any of the views of the asset from the site or the site from the asset convey any heritage interest or contribute to its significance.

Image EDP 6: View from within the site, along the western boundary facing west, towards the Grade II listed Clumbercote house, illustrating the intervisibility between the site and the asset.

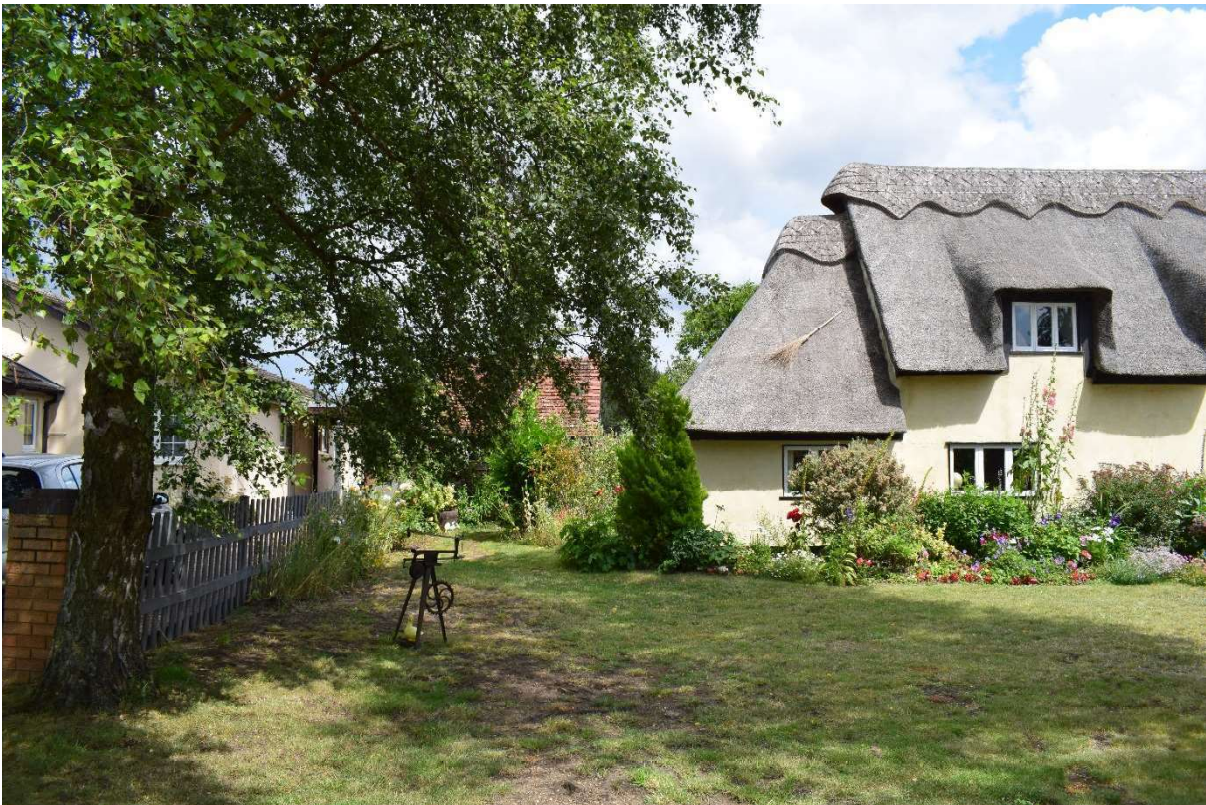
Image EDP 7: View from Station Road, facing east towards the Grade II listed Clumbercote house and the site, illustrating the lack of visibility of the site area from the asset and the placement of the outbuilding within the garden area of Clumbercote.
