Transport Assessment Addendum

**Proposed Residential Development
Land north of Hookhams Lane
Salph End
Bedford**

Report Reference: 248-TA-02-0

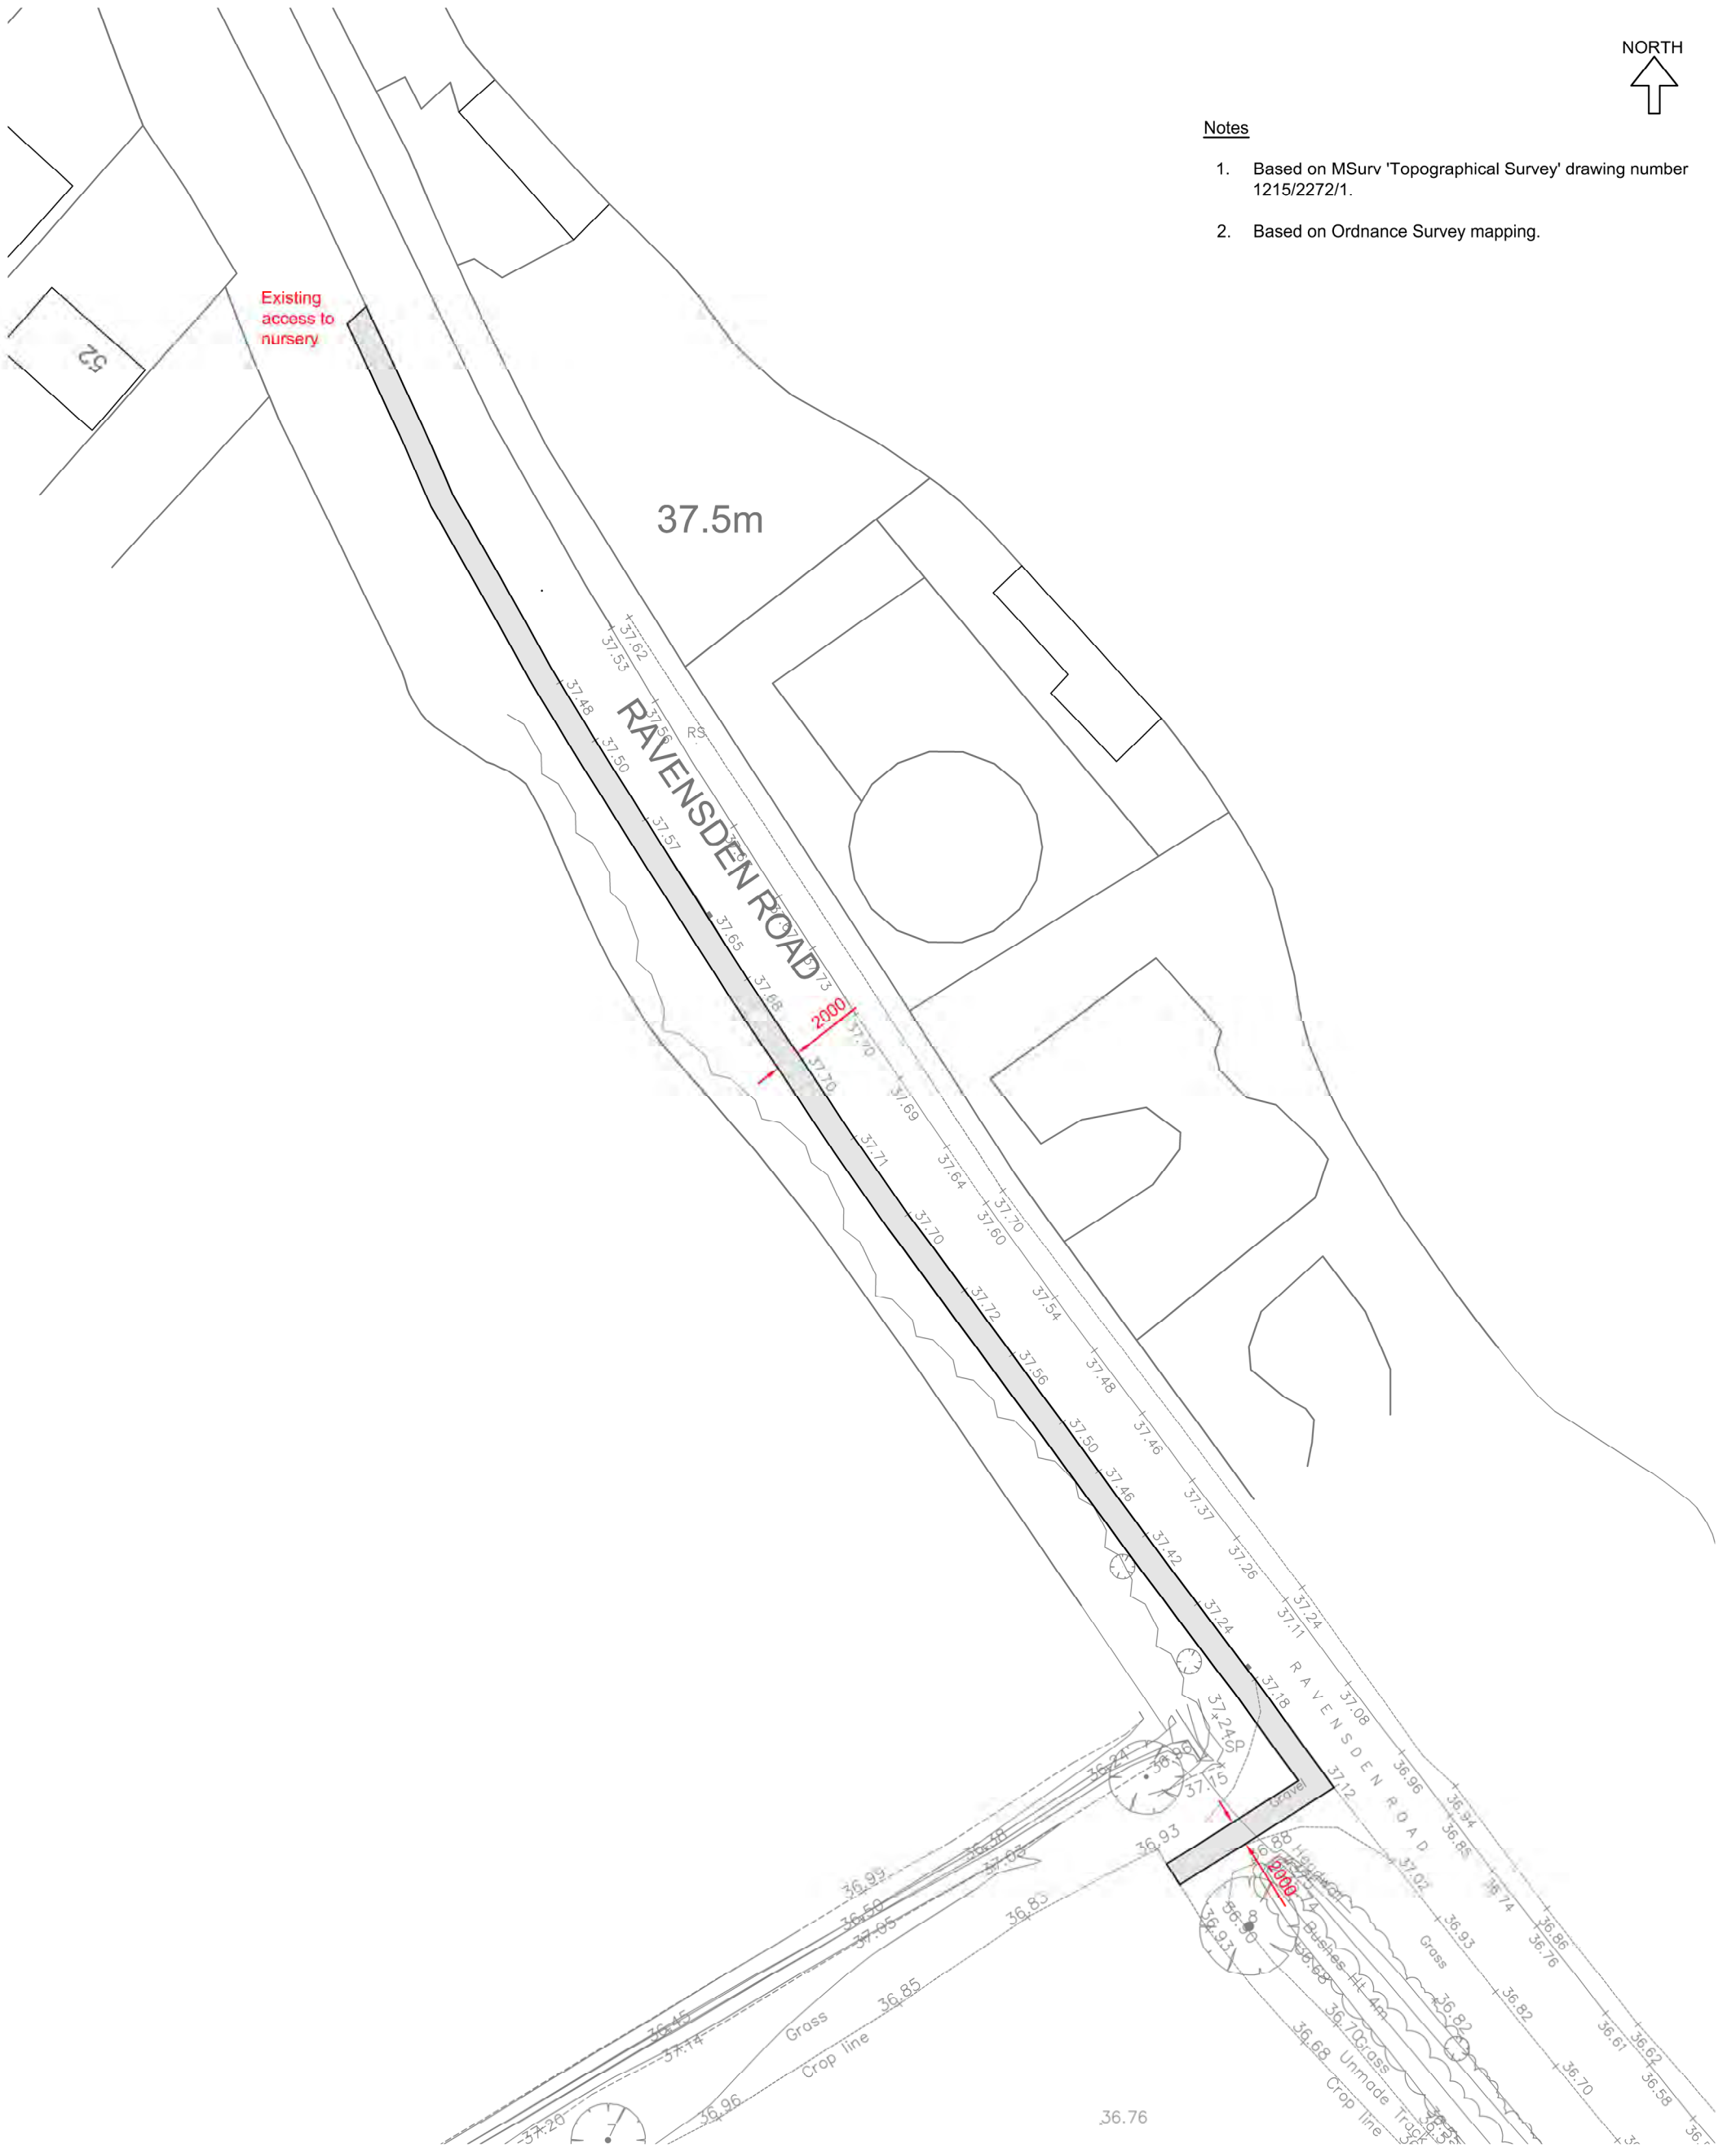
MAC T: 01604 340544 Northampton Office E: info@mac-ltd.co.uk W: mac-ltd.co.uk Martin Andrews Consulting Ltd	<ul style="list-style-type: none"> • Transport Assessments • Flood Risk Assessments • Highway Advice • Access Design • Drainage Strategies • Vehicle tracking 	Client: Manor Oak Homes		Project: Land North of Hookhams Lane Salph End		
		Title: Footway Improvements: Ravensden Road			Date: 12/06/20	
		Drawing No: 248-TA17			Revision: -	
					Drw: MJA Chk: MJA Scale: 1:500 Size: A3
