# Transport Assessment Addendum

**Proposed Residential Development  
Land north of Hookhams Lane  
Salph End  
Bedford**

**Report Reference: 248-TA-02-0**

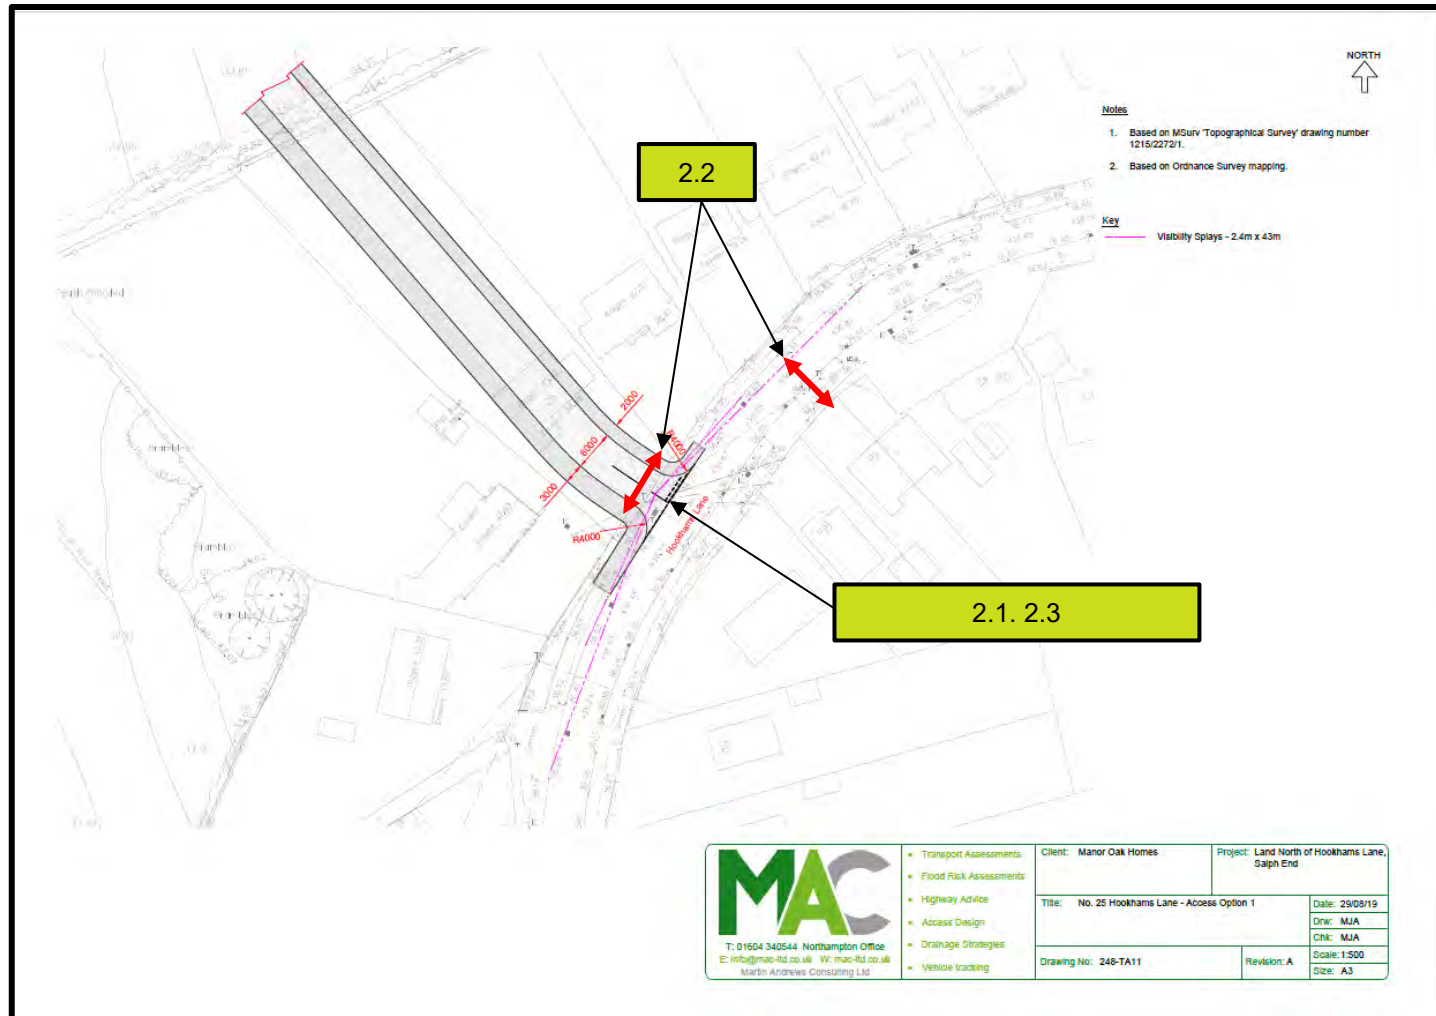
Please refer to the following page for a plan illustrating the locations of the problems identified as part of this audit (location numbers refer to paragraph numbers in the report).

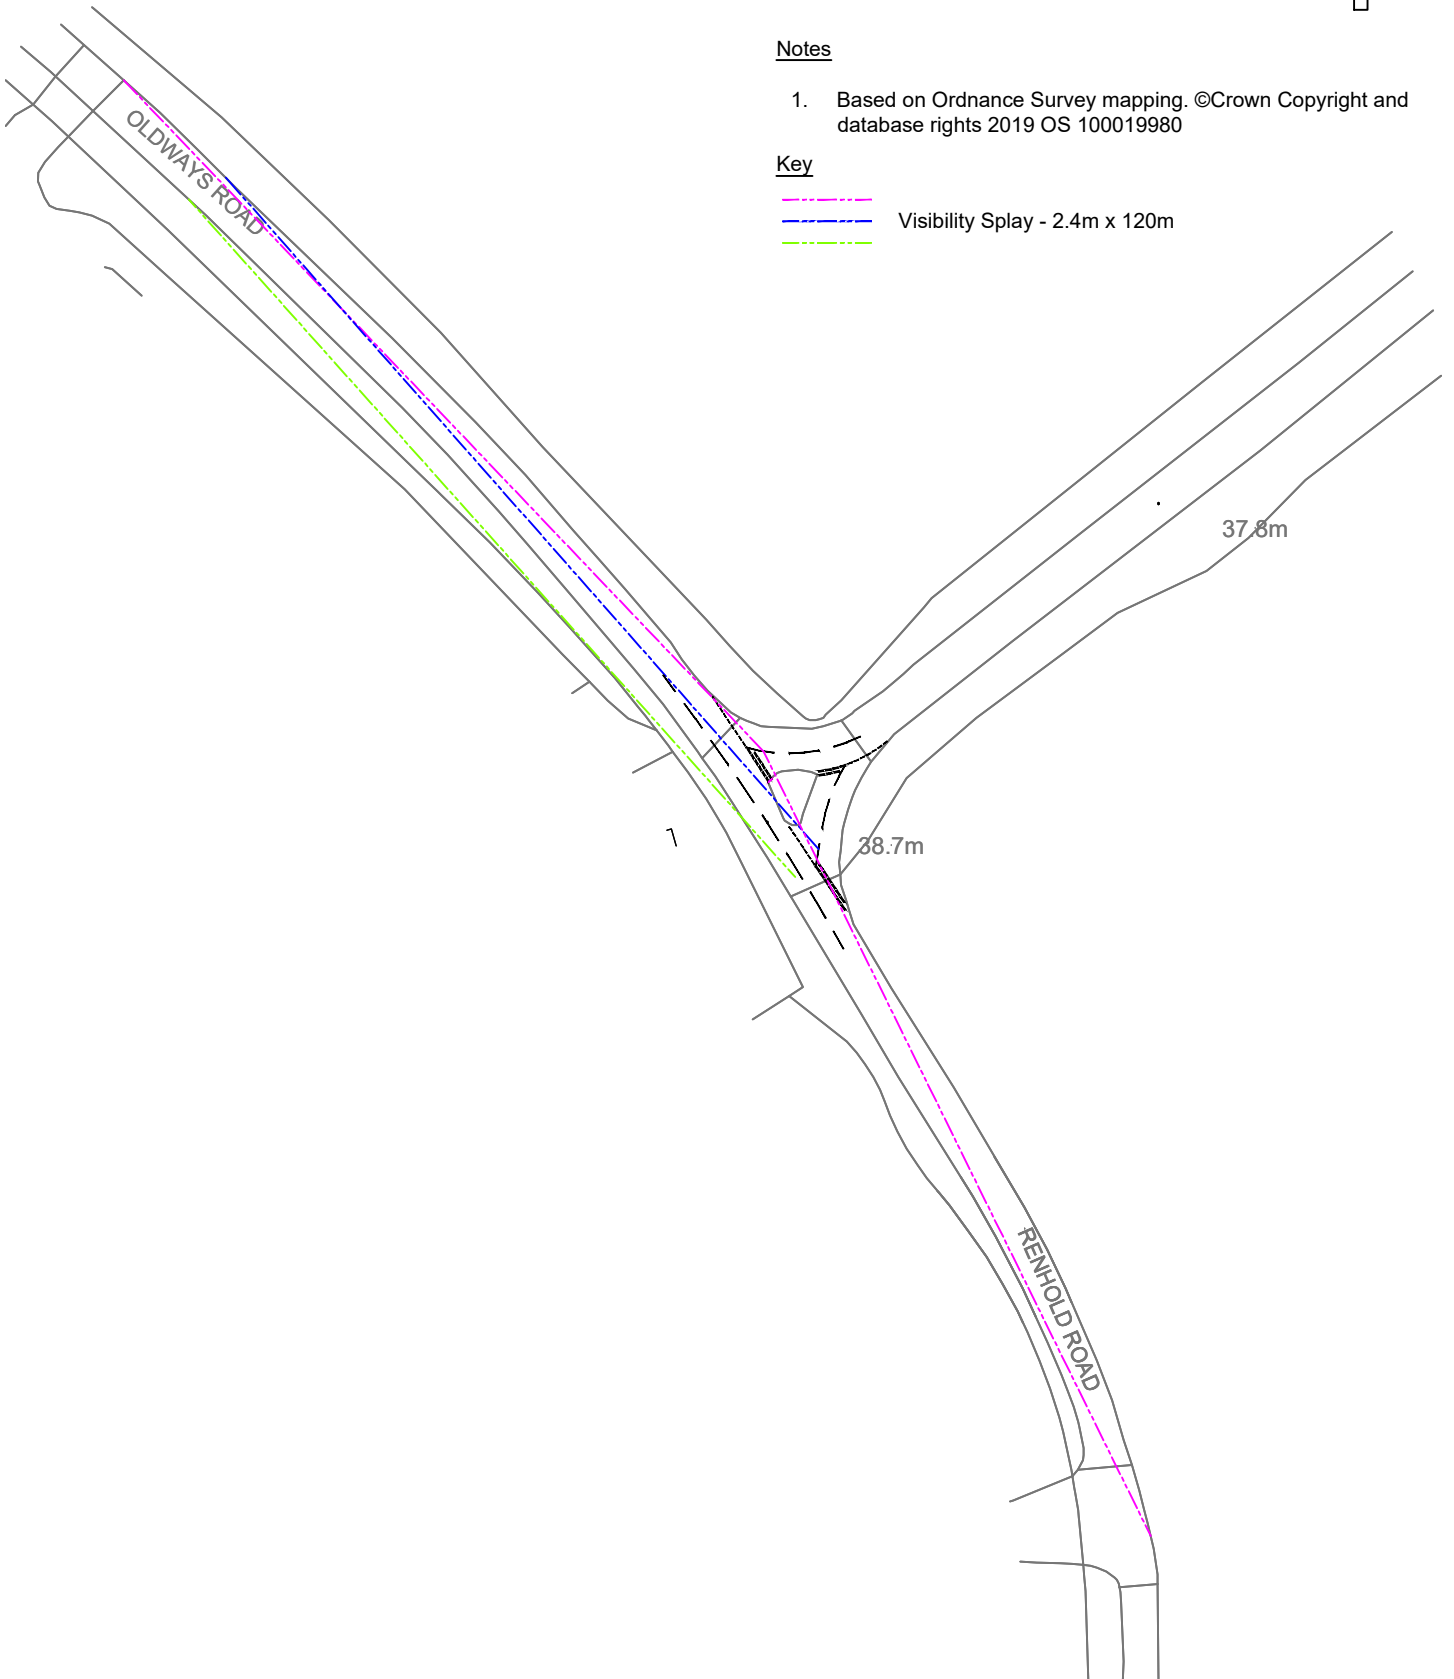
Key

- Visibility Splay - 2.4m x 120m
- Visibility Splay - 2.4m x 120m
- Visibility Splay - 2.4m x 120m

3.6.1 The highway authority in their response state that the accidents were caused as the junction has “a low visibility”. The existing visibility has been reviewed, see drawing enclosed in Appendix G. This shows that visibility splays of 2.4m x 120m can be achieved which are appropriate for the 40mph speed limit of the road.
